**National Highway  
Traffic Safety  
Administration**

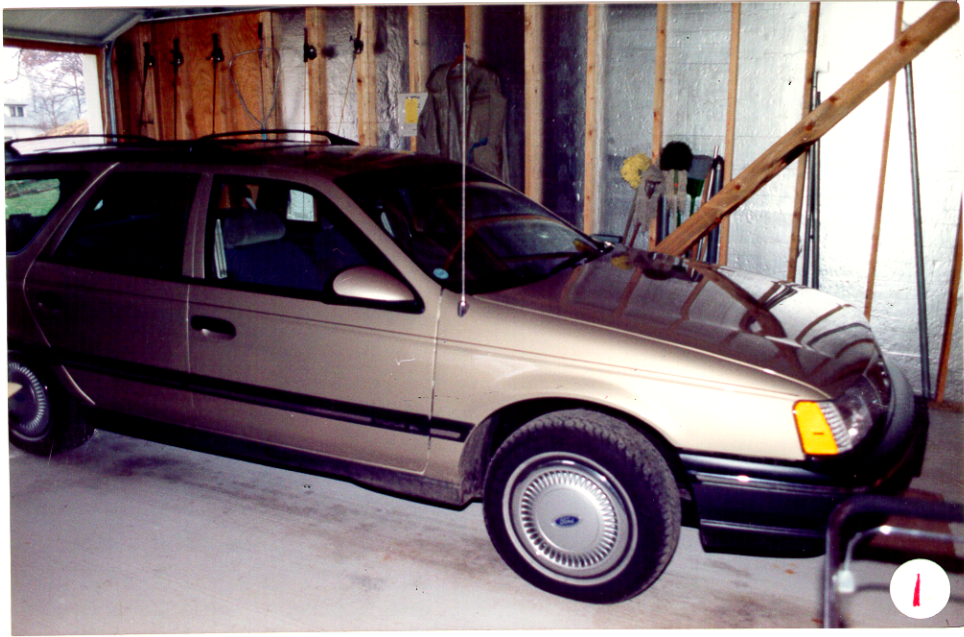
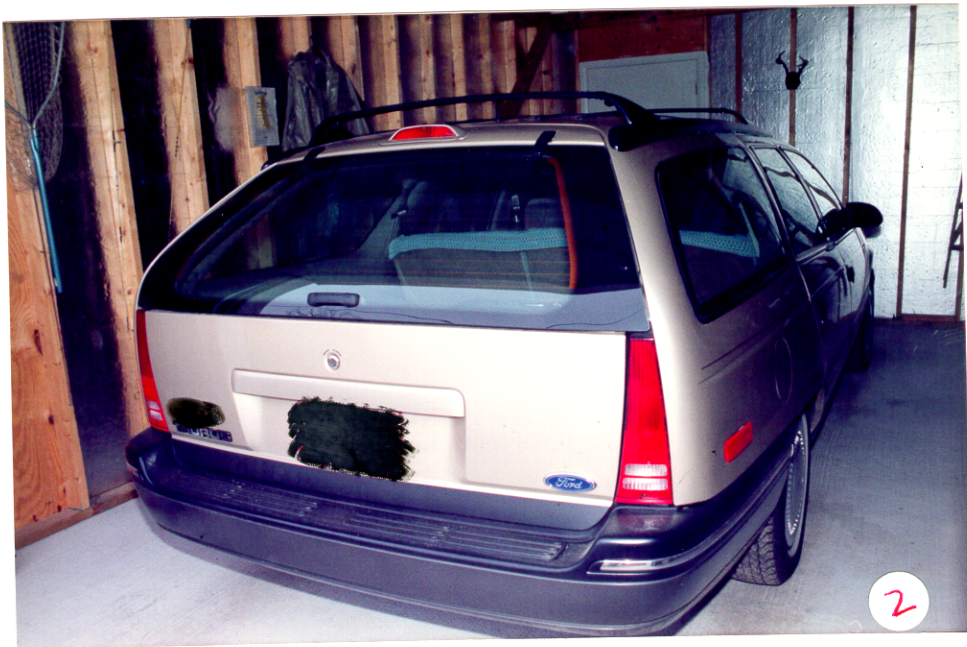
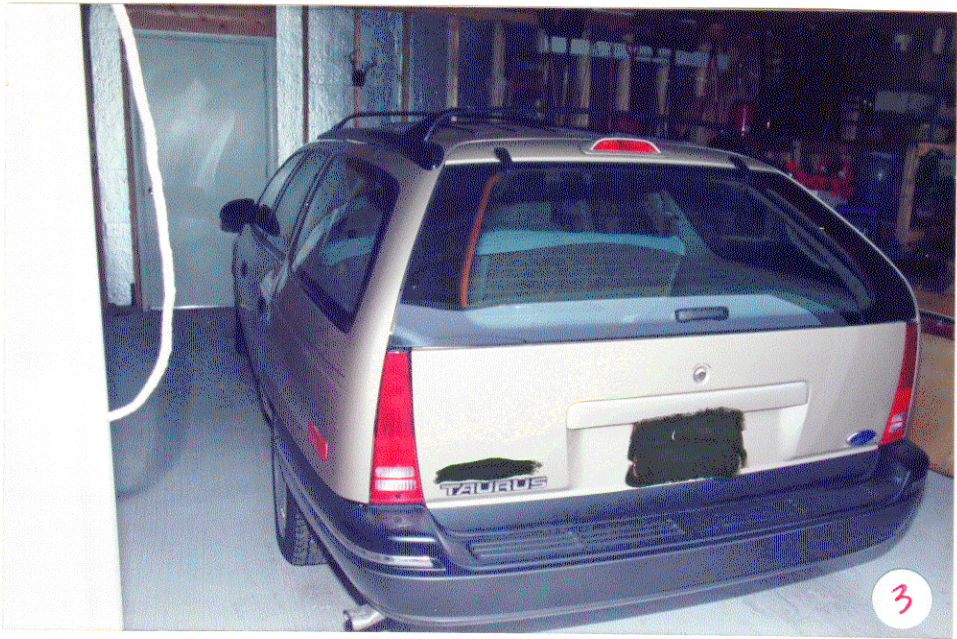
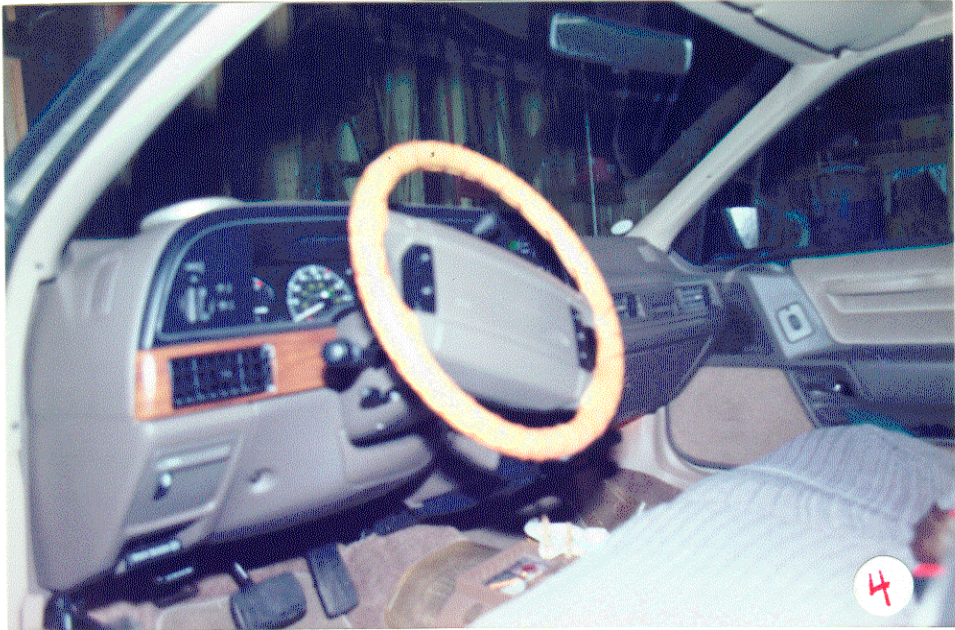
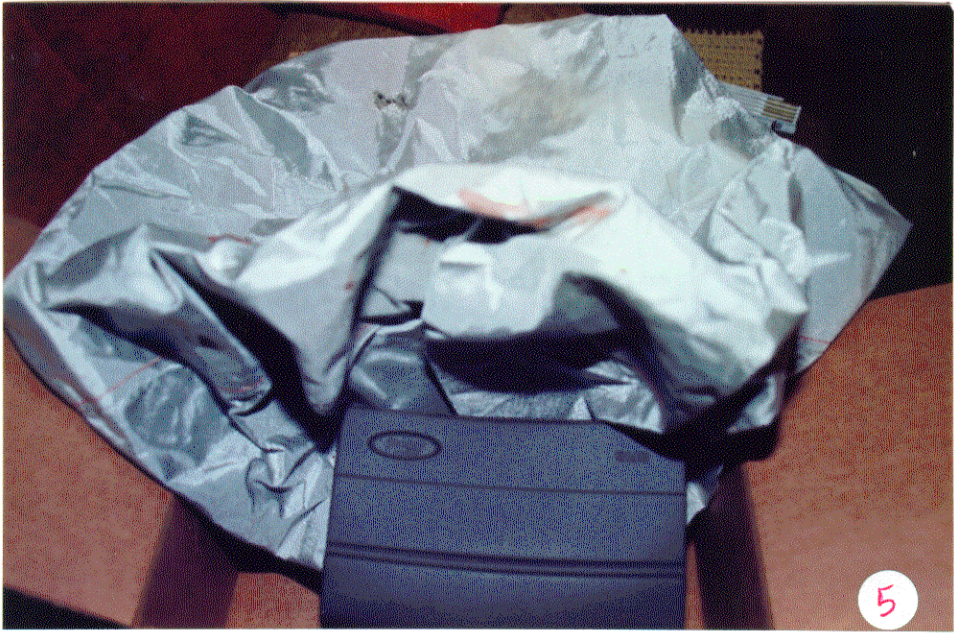
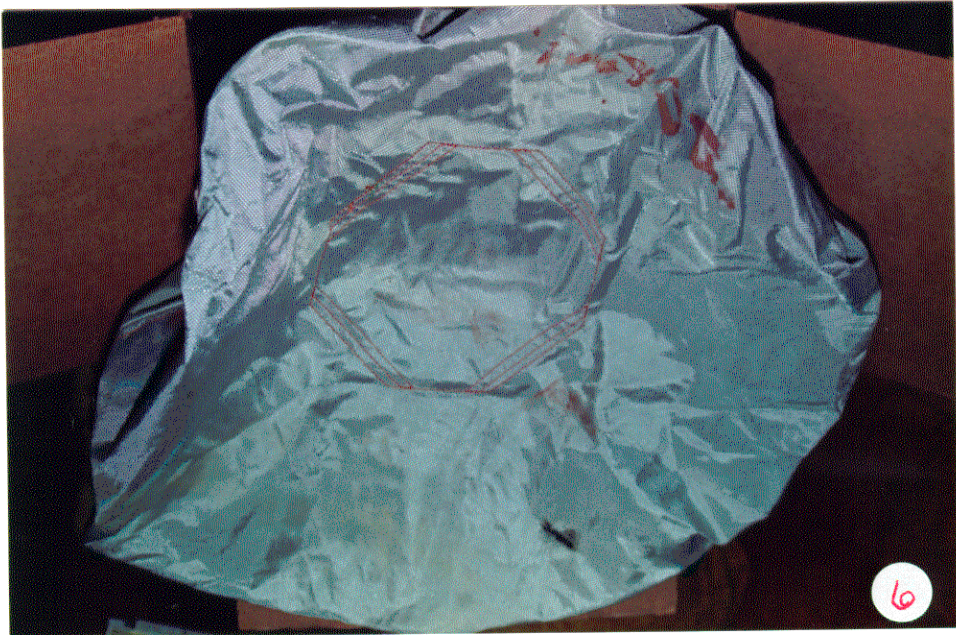
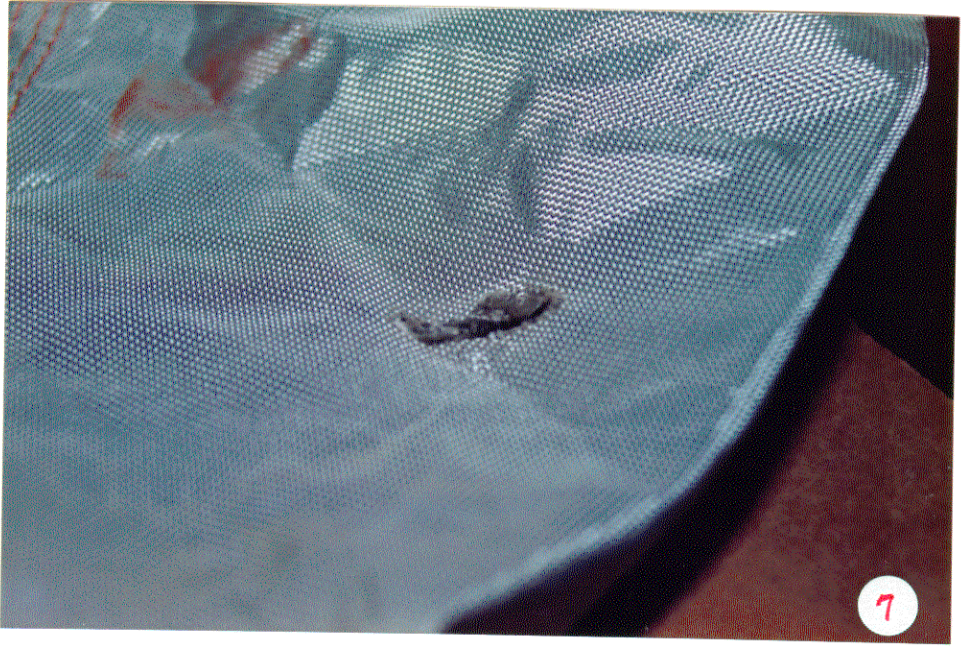
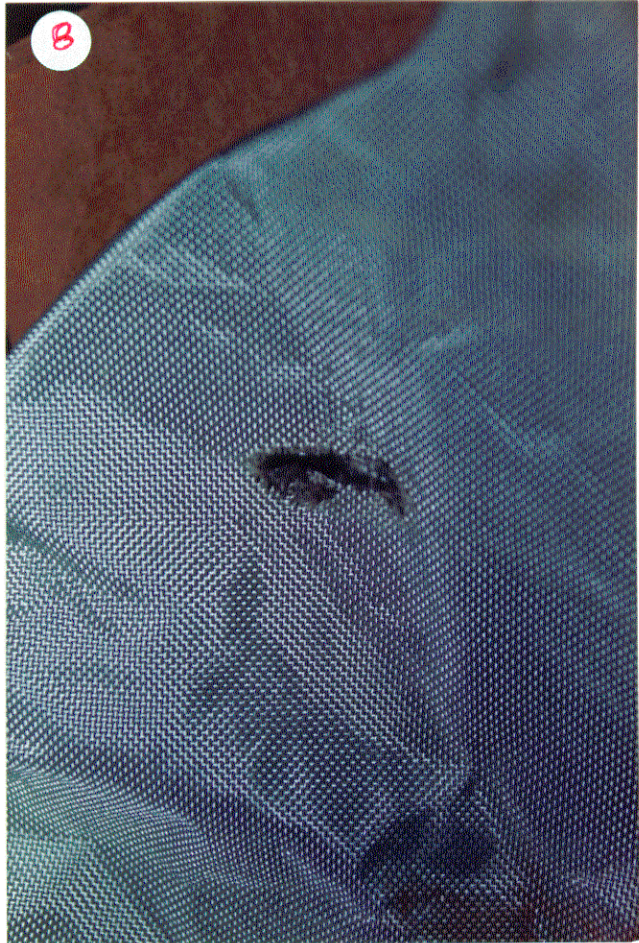
Inspection of the airbag showed a small (1.5 inch) tear in the material. The hole was on the frontal surface at roughly 4 o'clock. The driver stated hot gas escaped from this hole and caused the burns to her face.

Initial impact damage was noted to front right corner of the Taurus and the front left corner of the Camaro. Damage to the Taurus was repaired for approximately \$5500.00. Both vehicles were towed from the scene due to disabling damage. The airbag module of the Taurus deployed during the impact with vehicle #2.
