**SAFETY COMPLIANCE TESTING FOR FMVSS 201
RIGID POLE SIDE IMPACT TEST**

GENERAL MOTORS CORPORATION
2008 CHEVROLET IMPALA
4-DOOR SEDAN

NHTSA NUMBER: C80108

CALSPAN TEST NUMBER: 8863-F201P-02

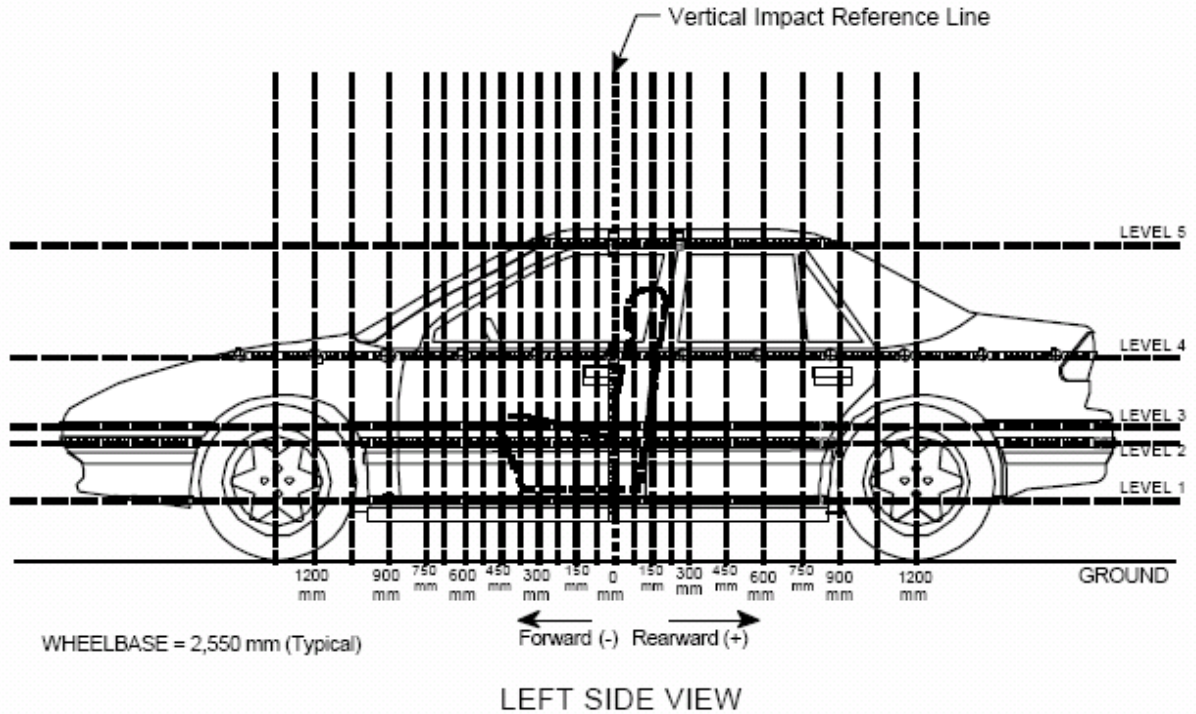
MEASUREMENTS ARE TAKEN WHEN THE VEHICLE IS IN THE "AS TESTED" CONFIGURATION.

Measurements Along the Vertical 0 mm Line Shown Above:

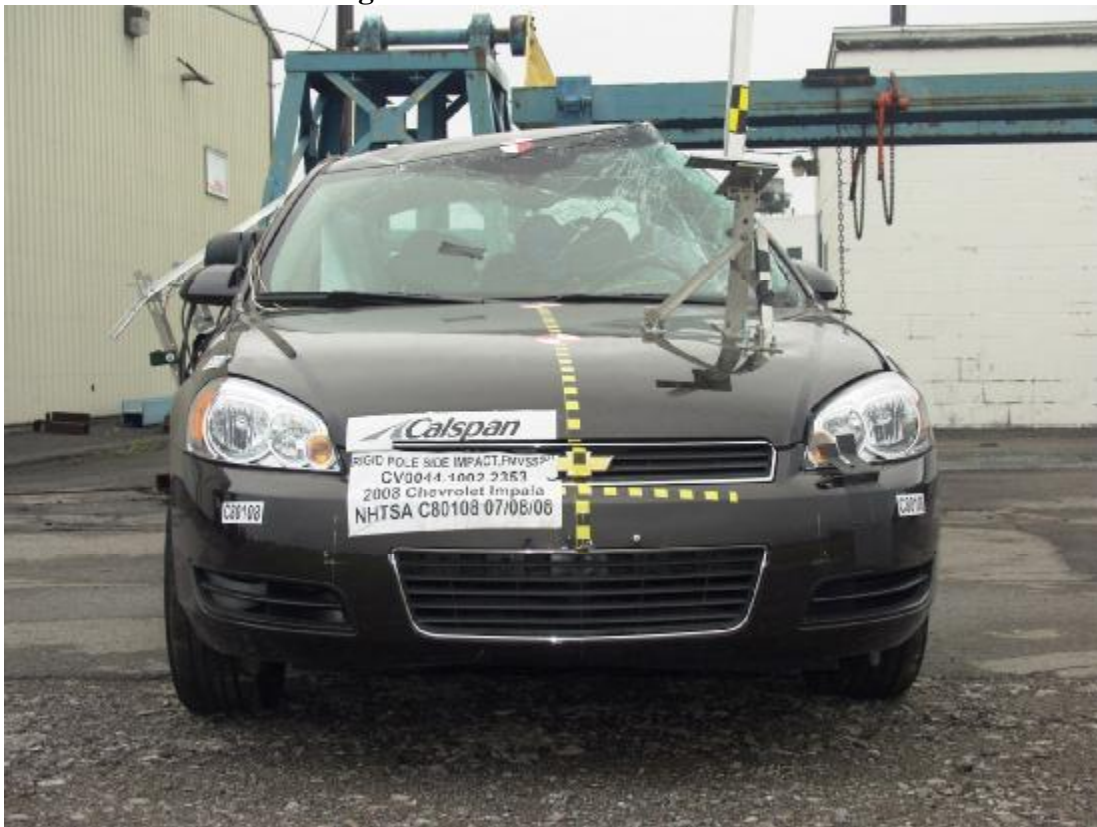
Figure A-6: Post-Test Front View

Windshield:	Severe cracking on left side
Window:	Not Applicable

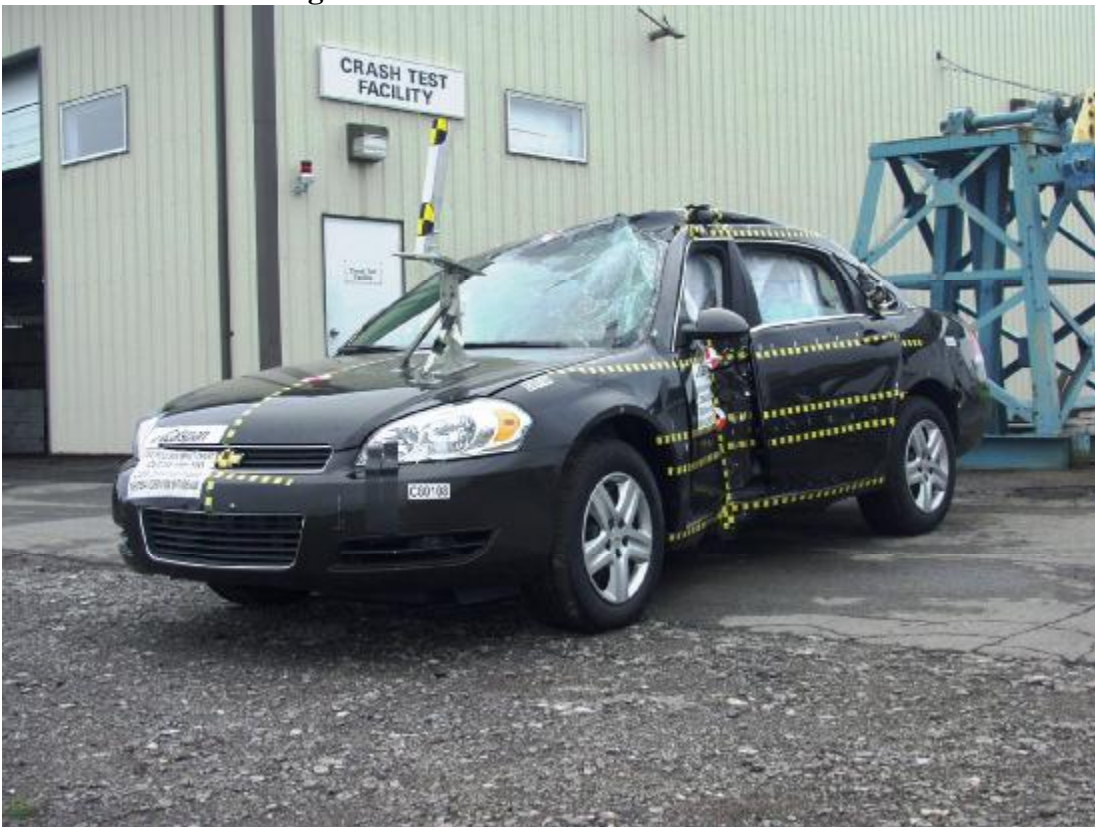
Figure A-8: Post-Test Left Front ¾ View

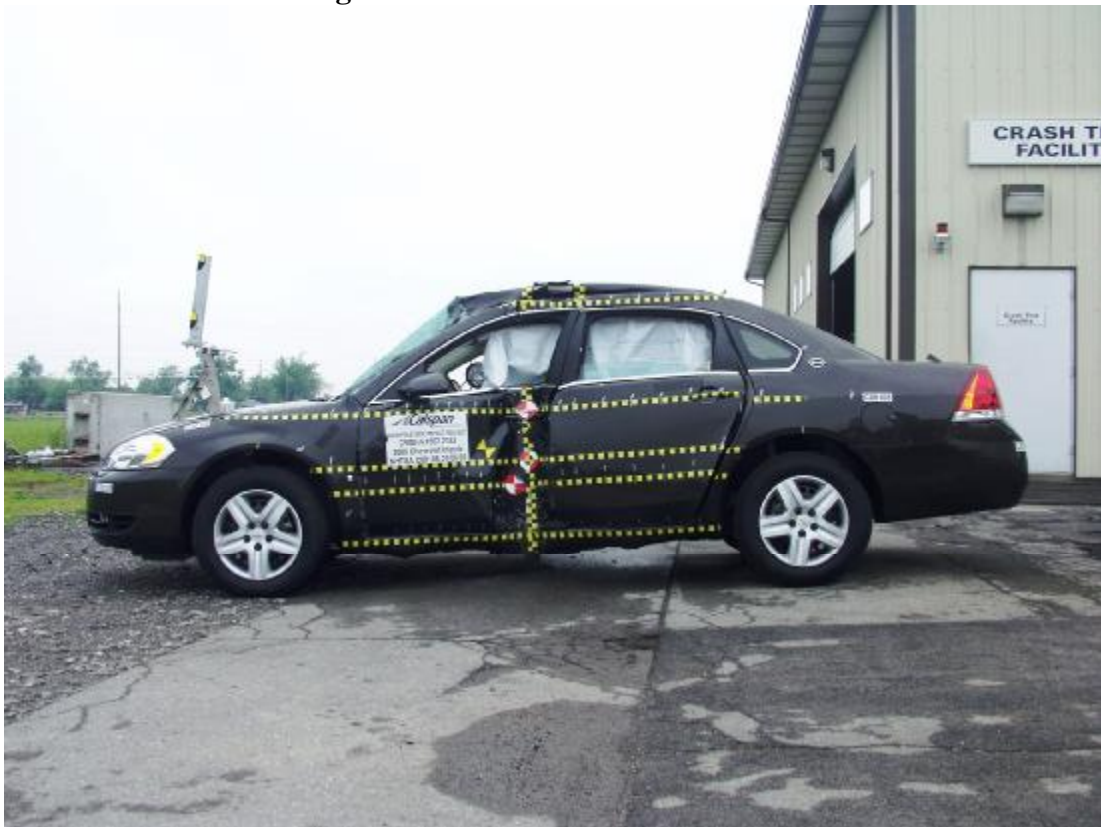
Figure A-10: Post-Test Left Side View

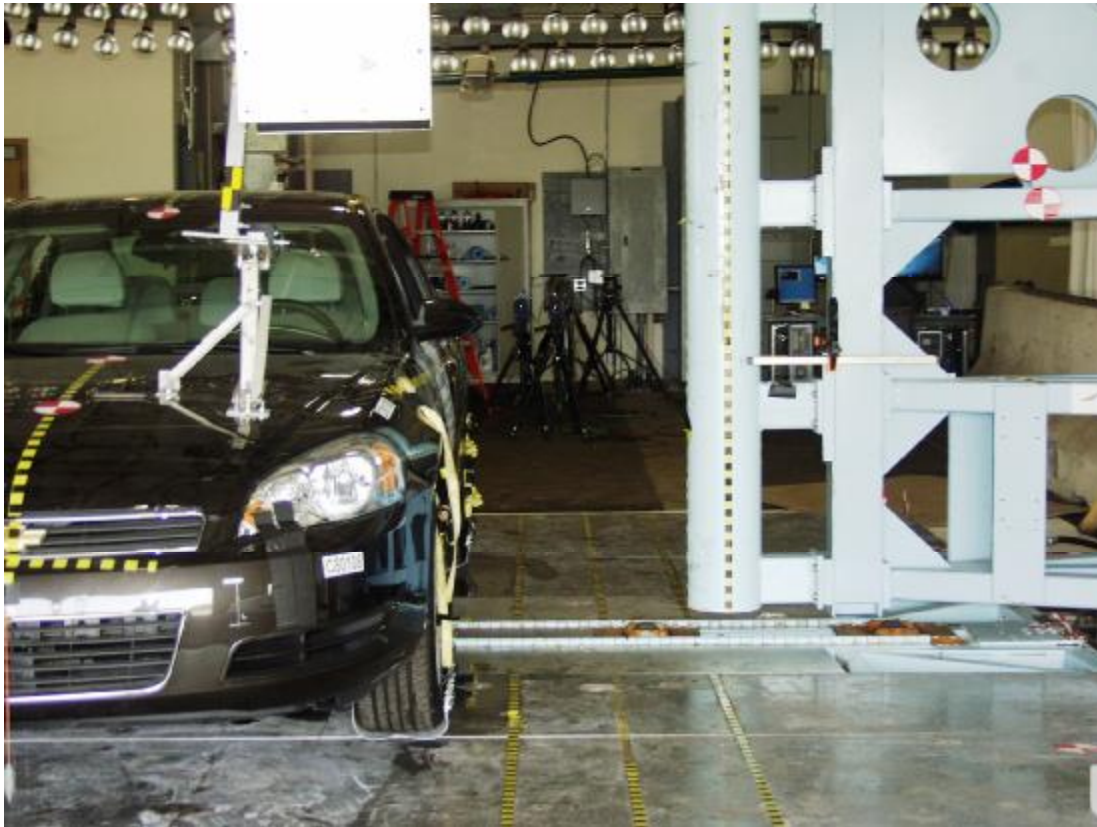
Figure A-21: Pre-Test Left Side View of Aligned Vehicle and Pole

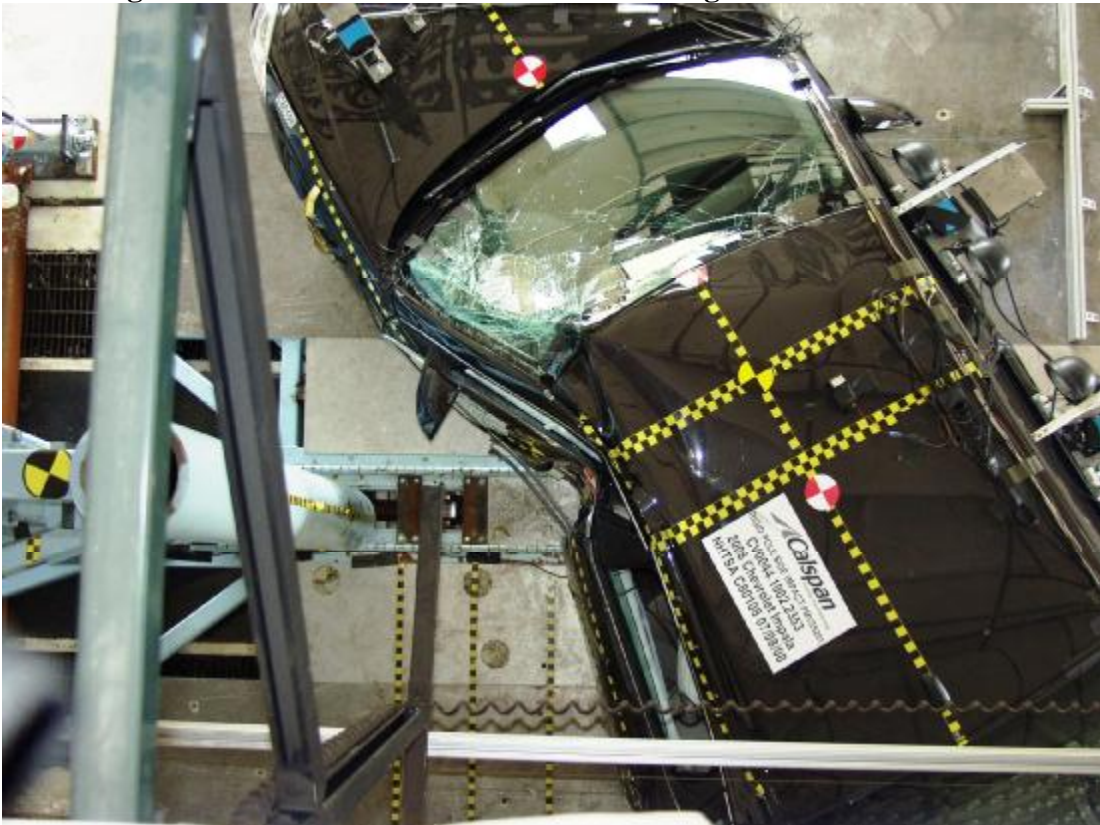
Figure A-24: Post-Test Overhead View of Vehicle and Pole

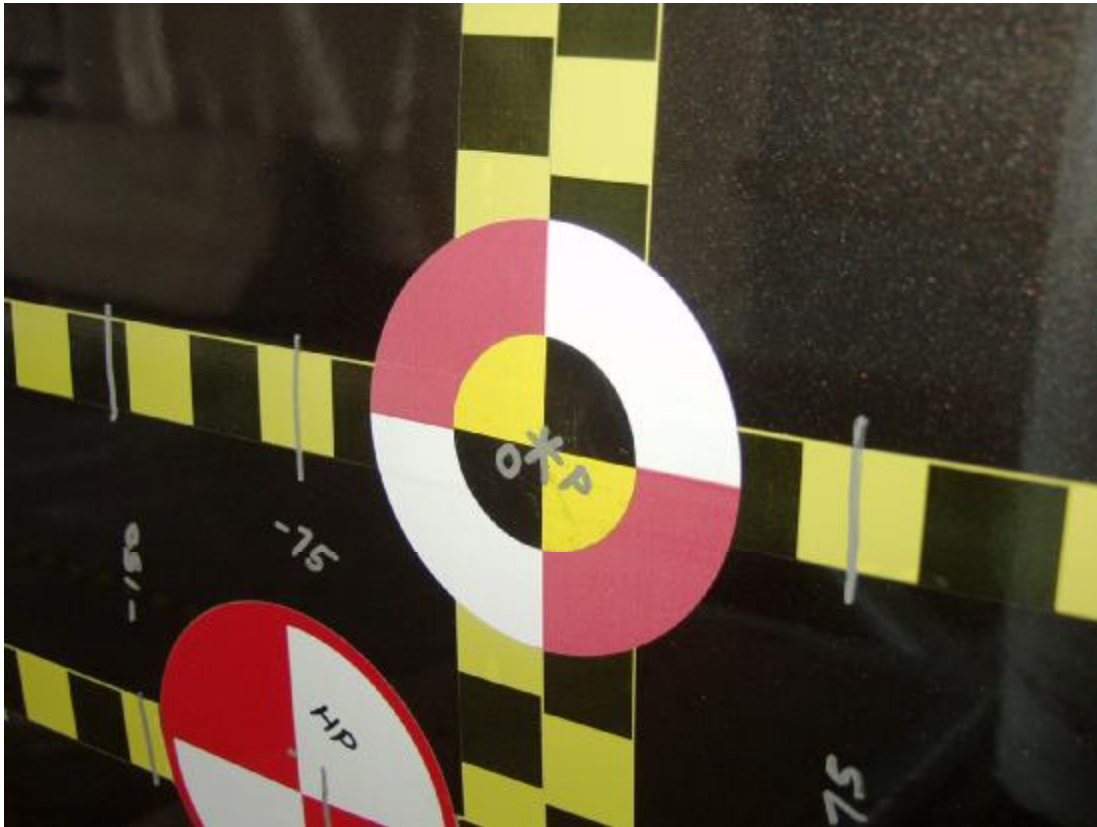
Figure A-25: Pre-Test Close-Up View of Impact Point Target

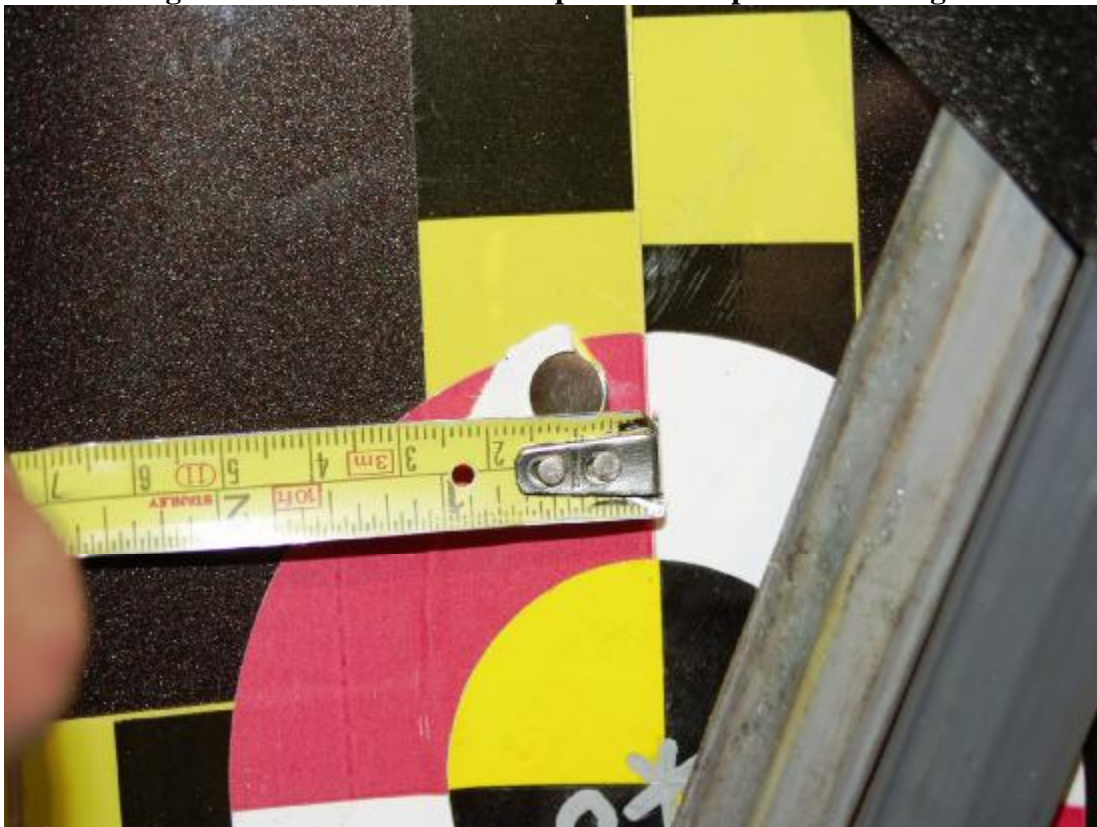
Figure A-26: Post-Test Close-Up View of Impact Point Target

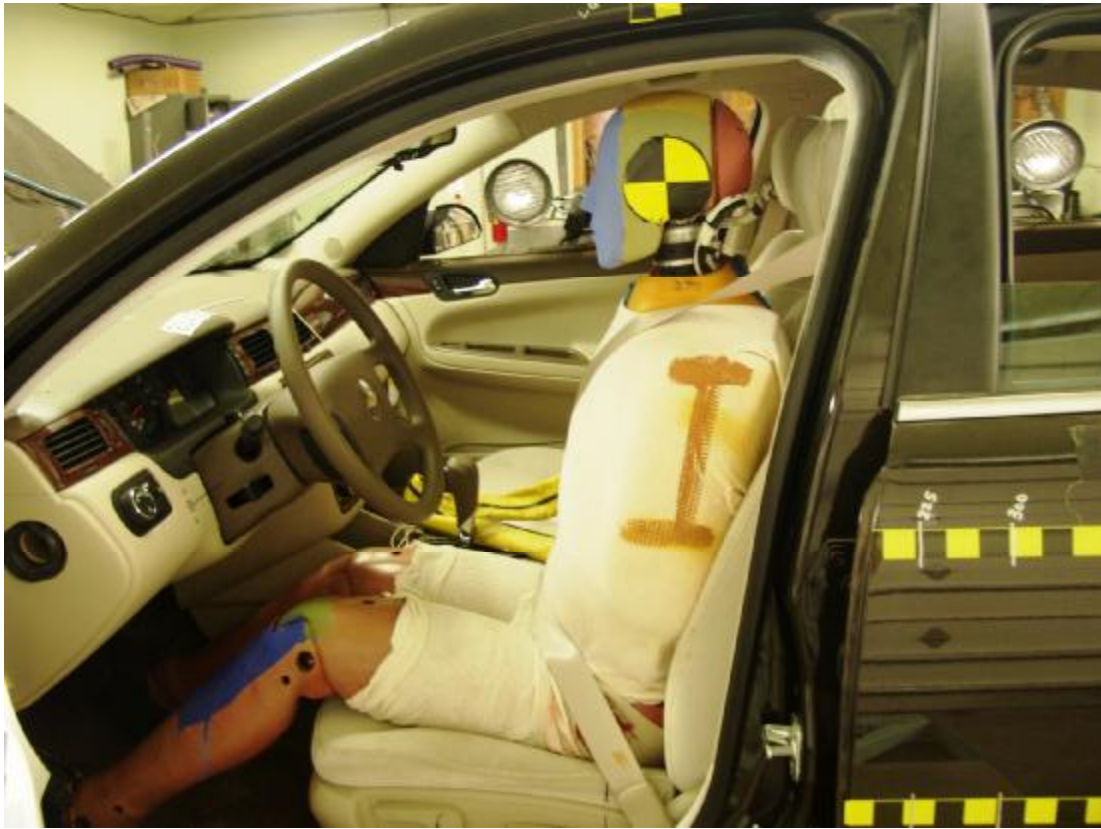
Figure A-29: Pre-Test Impact Side View of SID HIII with Door Open

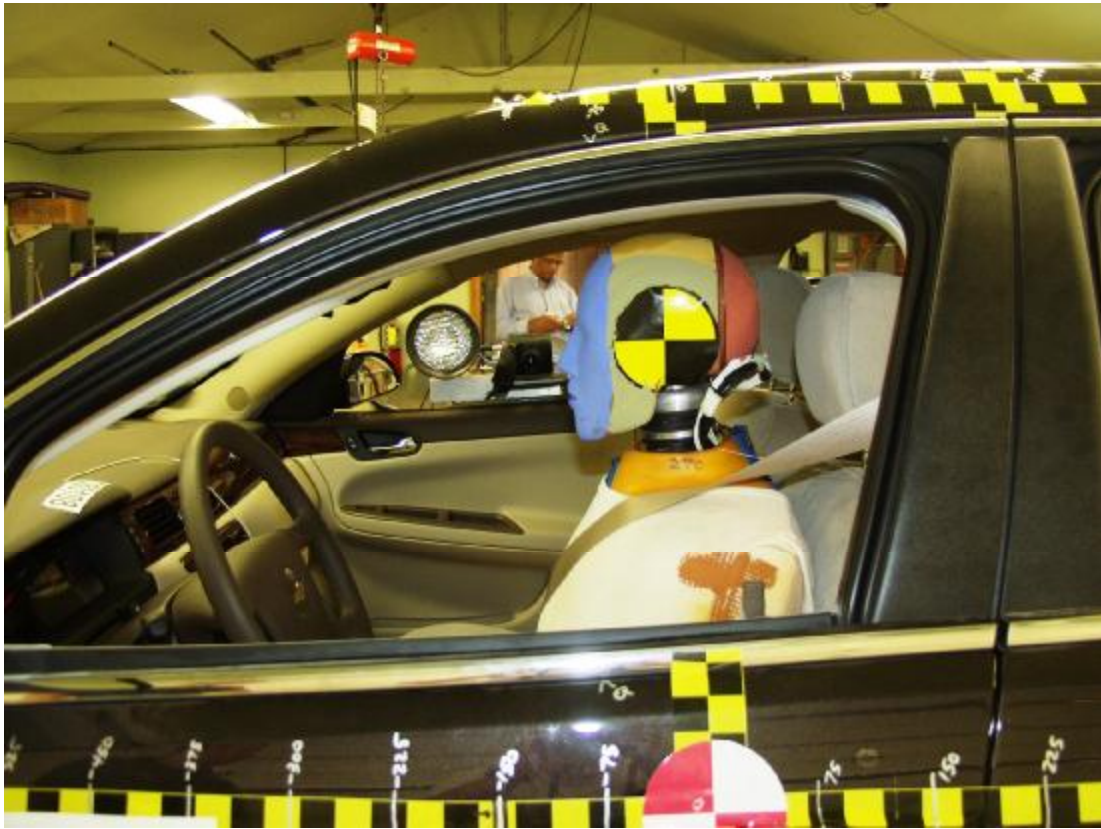
Figure A-30: Pre-Test Impact Side View of SID HIII

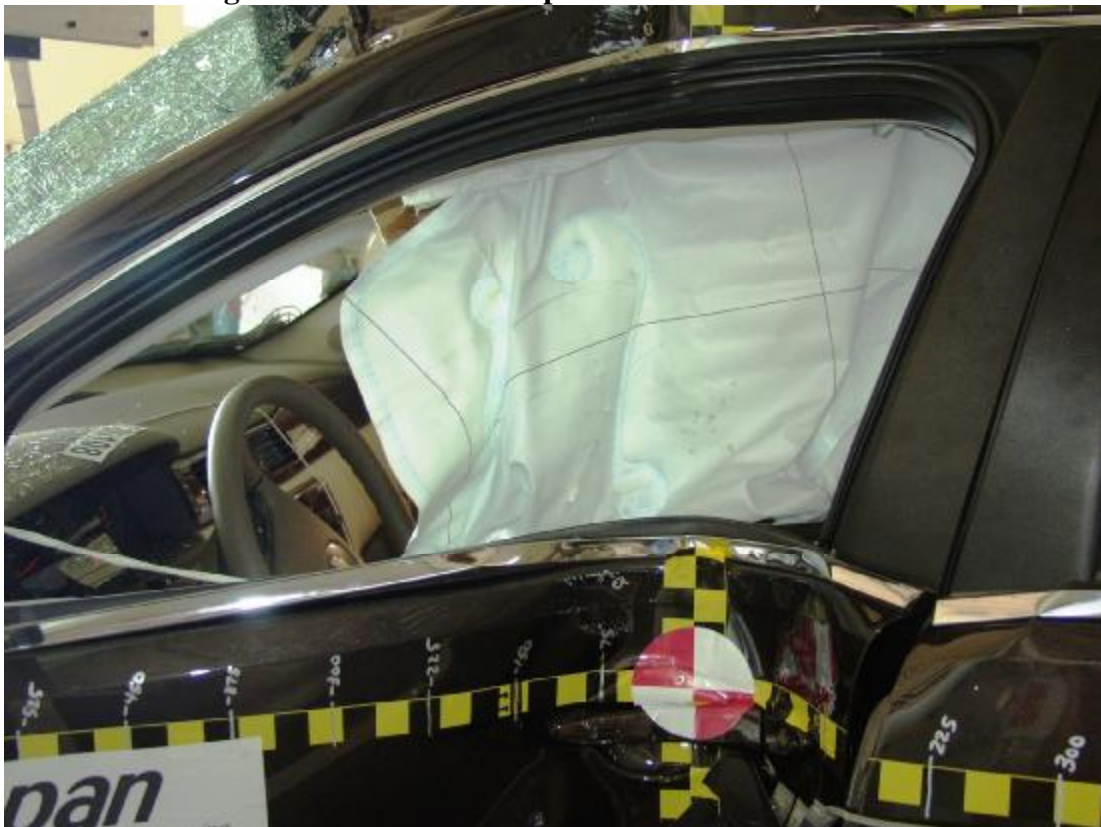
Figure A-31: Post-Test Impact Side View of SID HIII

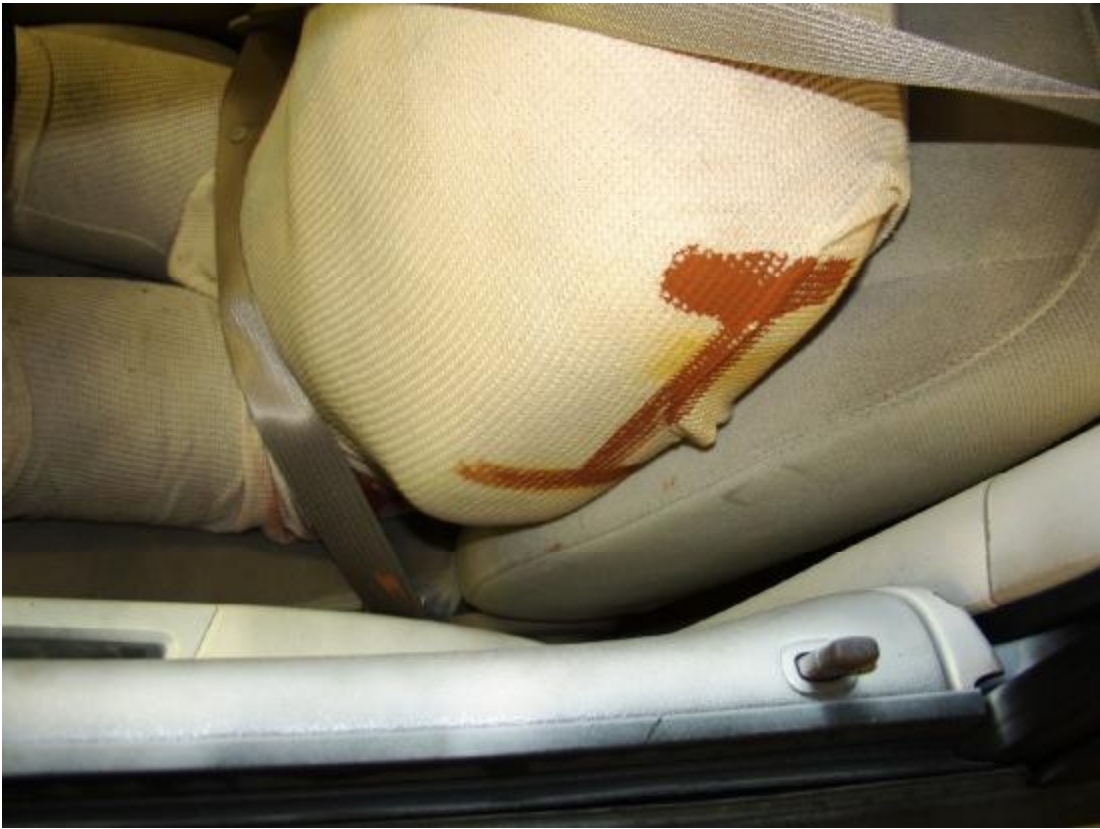
Figure A-32: Pre-Test Dummy Shoulder and Door Top View

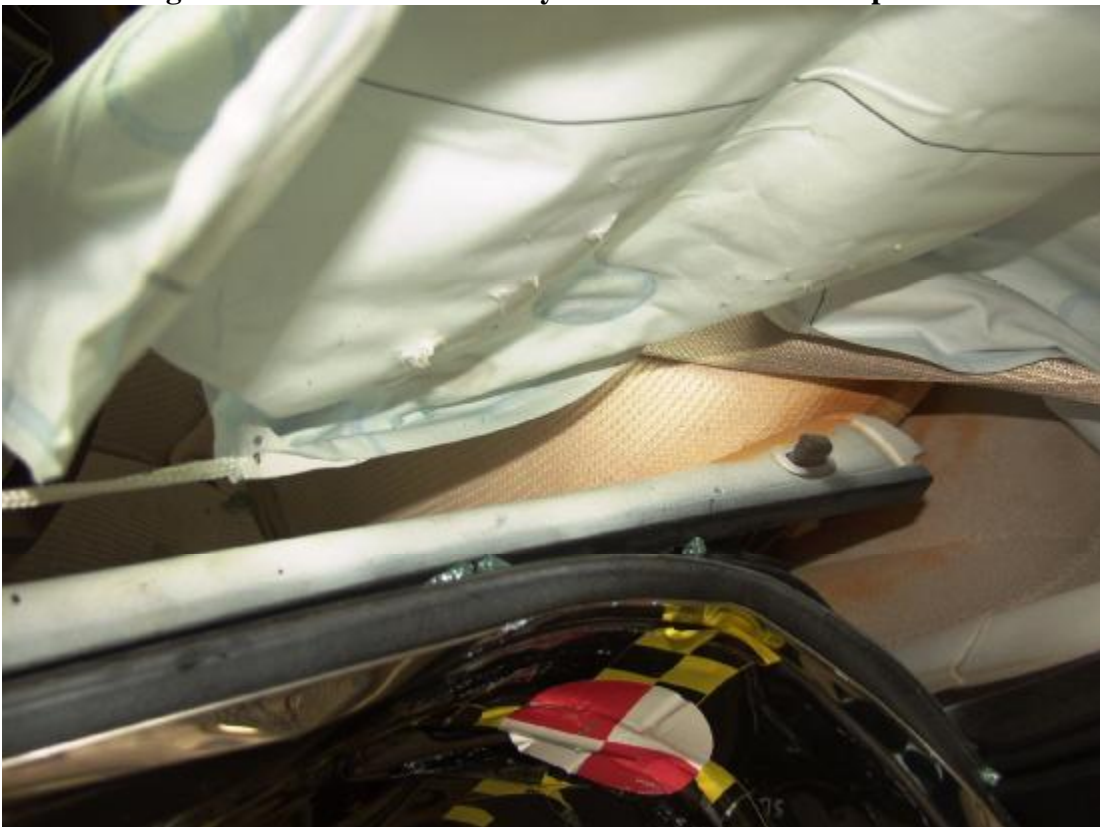
Figure A-33: Post-Test Dummy Shoulder and Door Top View

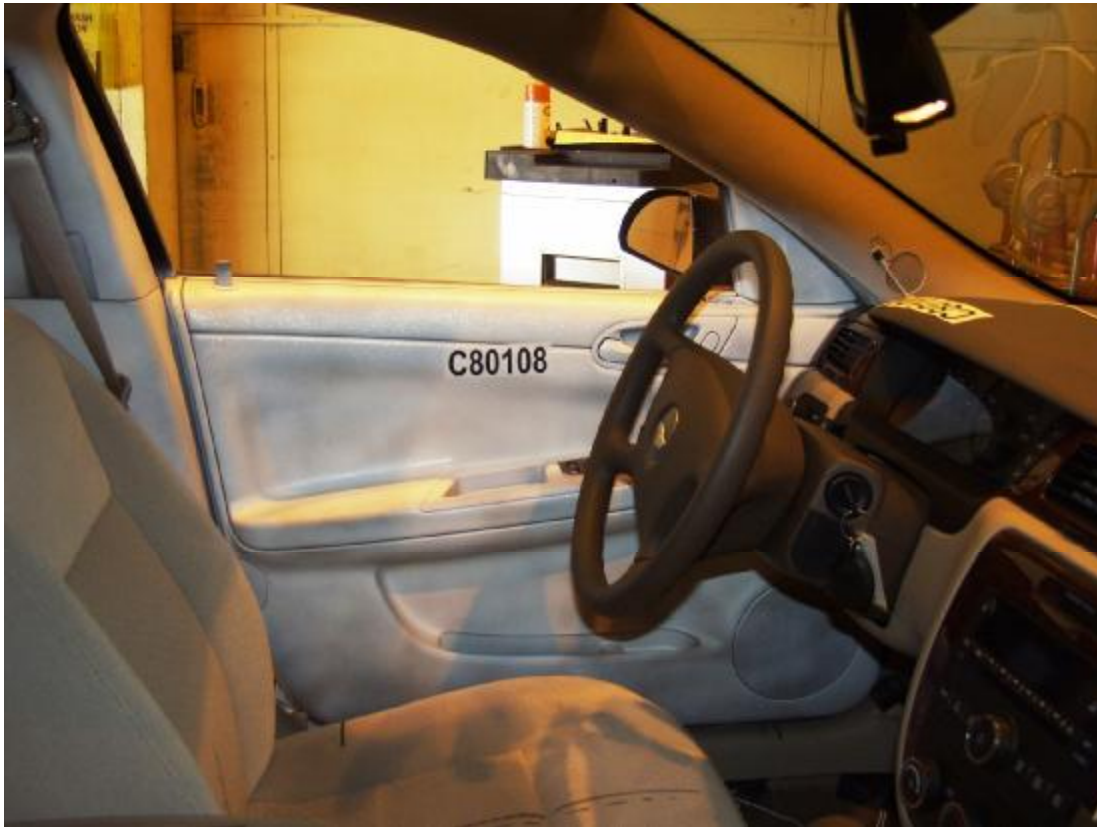
Figure A-34: Pre-Test Impact Side Front Interior Trim

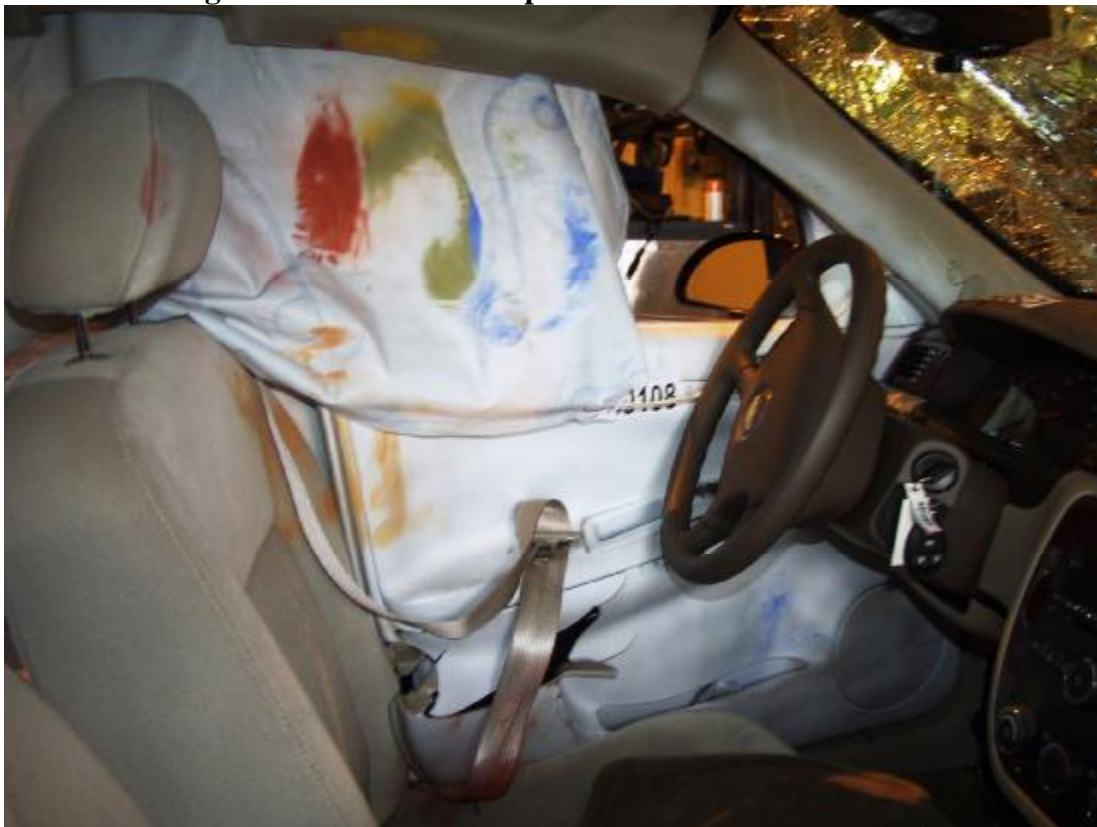
Figure A-35: Post-Test Impact Side Front Interior Trim

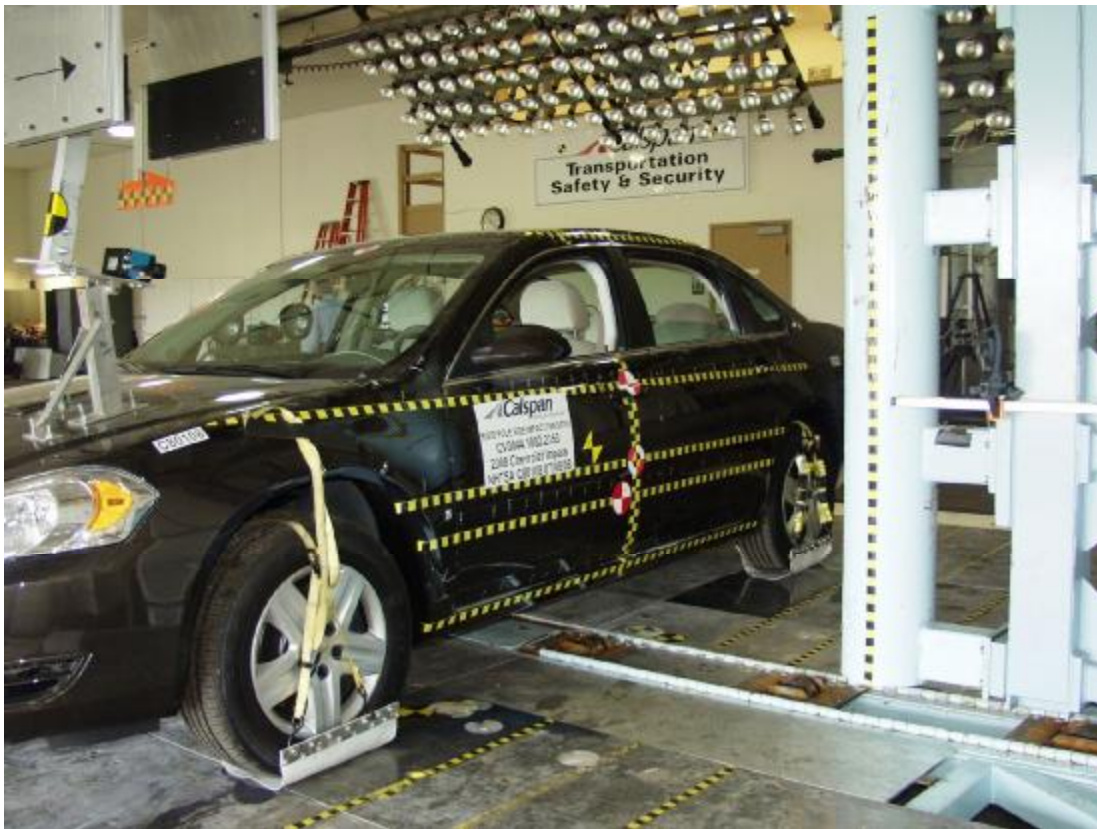
Figure A-36: Pre-Test Left Front $\frac{3}{4}$ View of Impact Zone

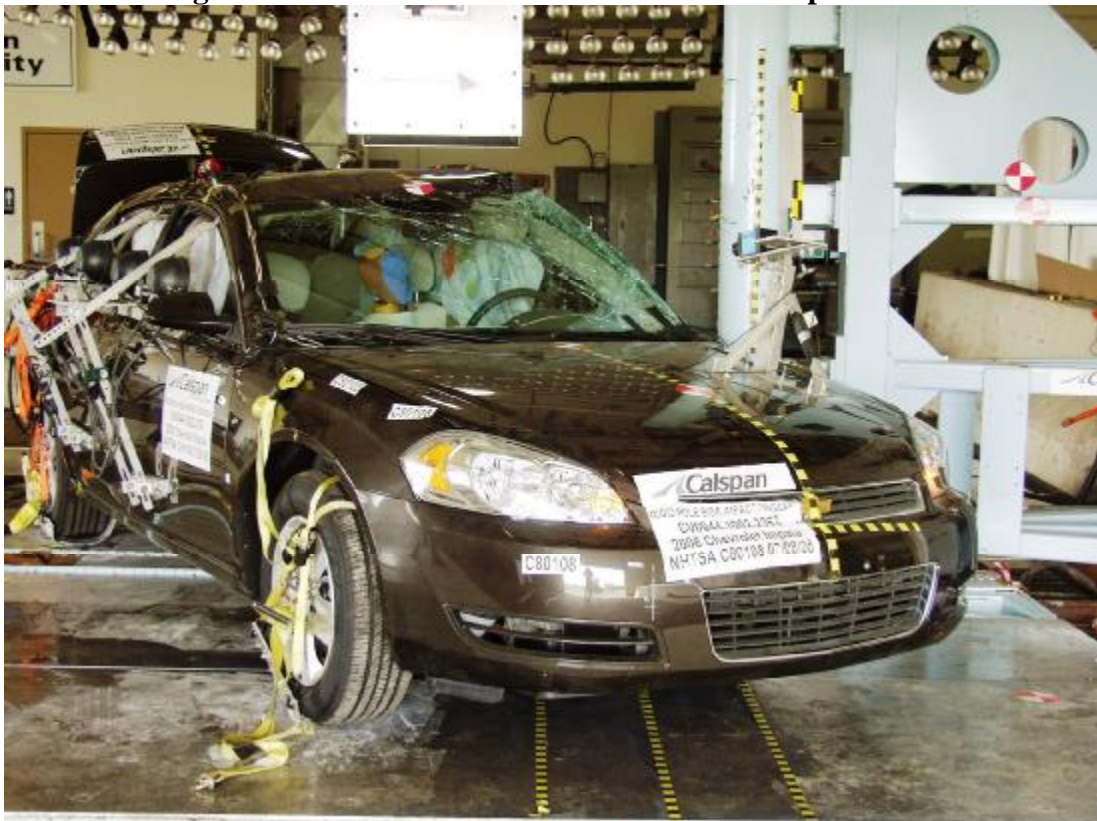
Figure A-37: Post-Test Left Front $\frac{3}{4}$ View of Impact Zone

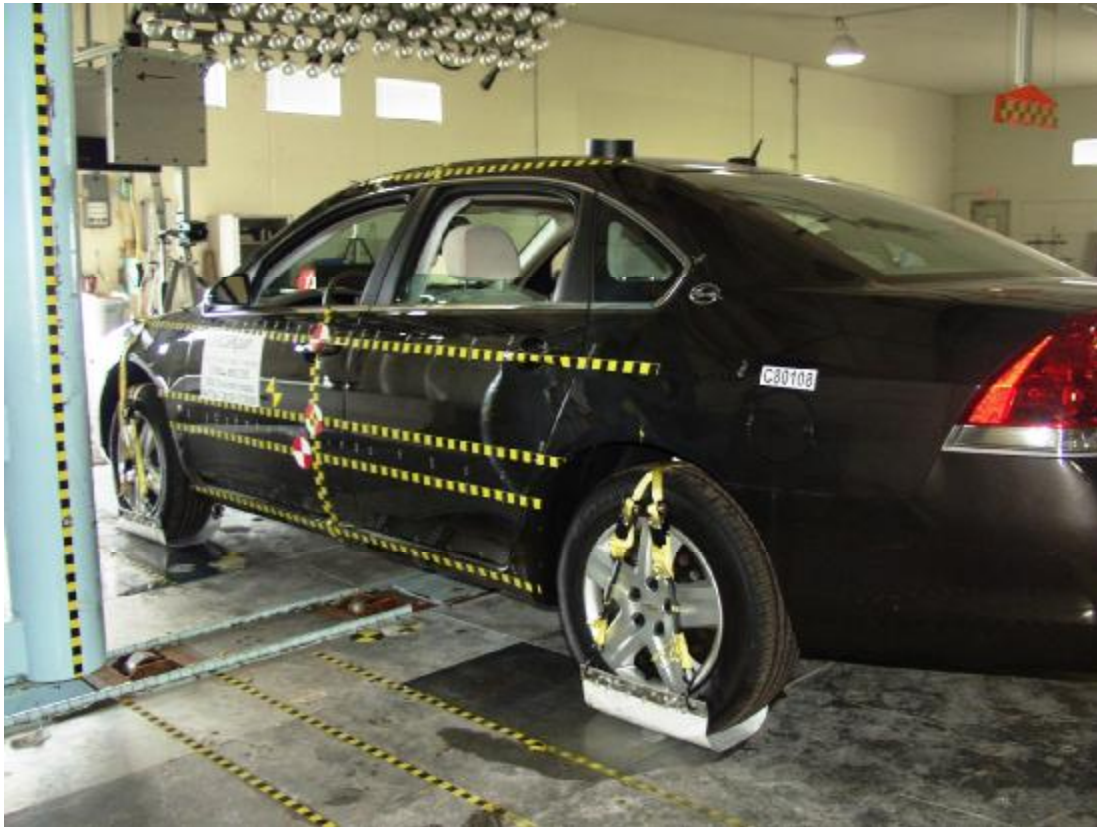
Figure A-38: Pre-Test Left Rear $\frac{3}{4}$ View of Impact Zone

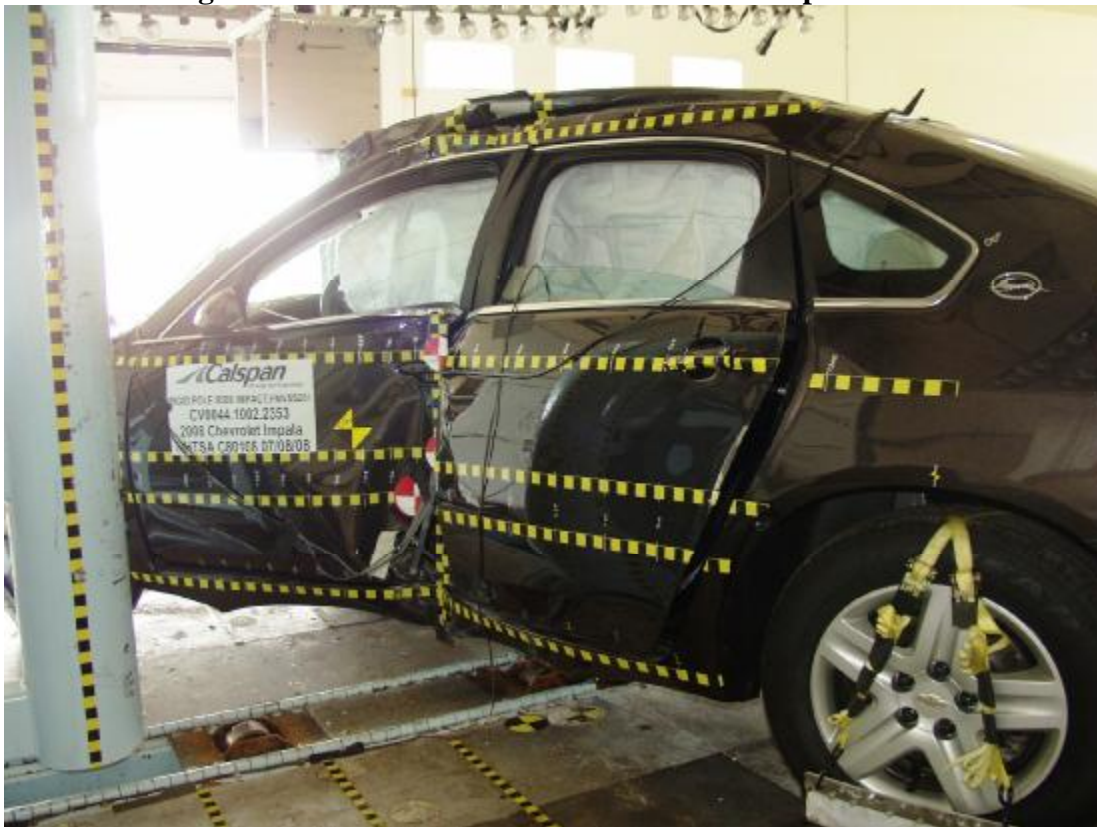
Figure A-39: Post-Test Left Rear $\frac{3}{4}$ View of Impact Zone

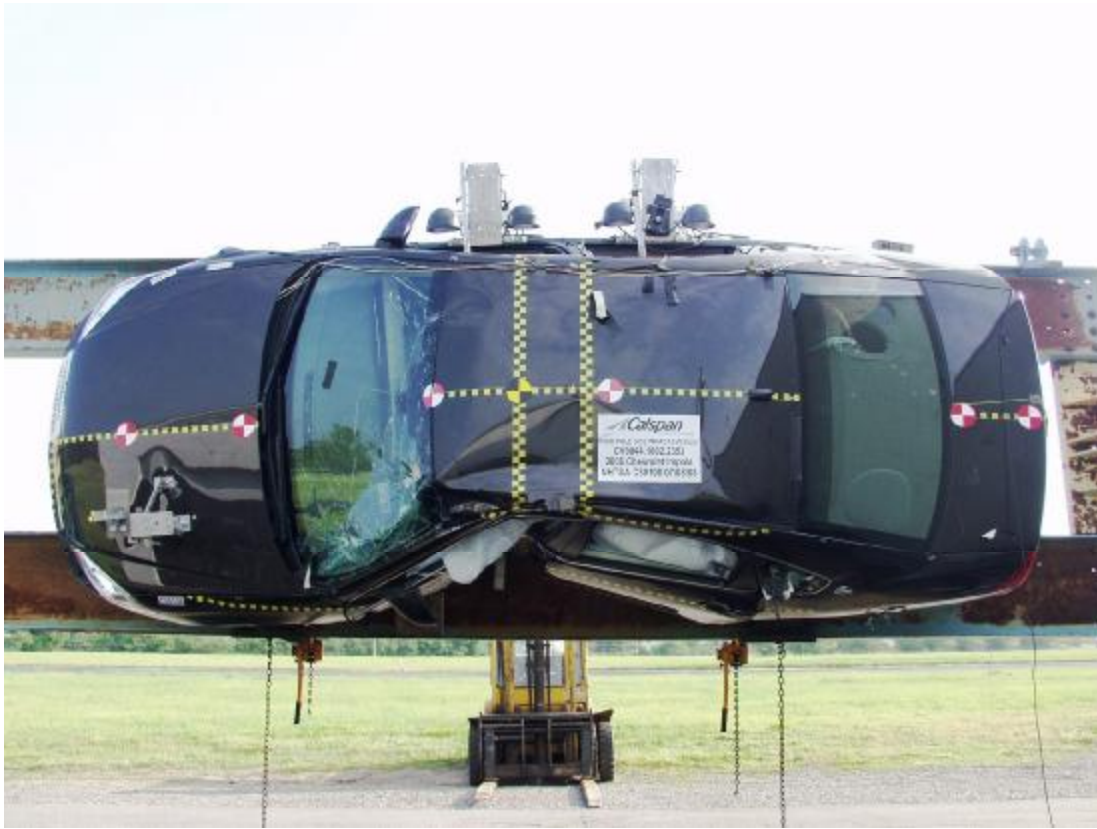
Figure A-40: Rollover 90 Degrees

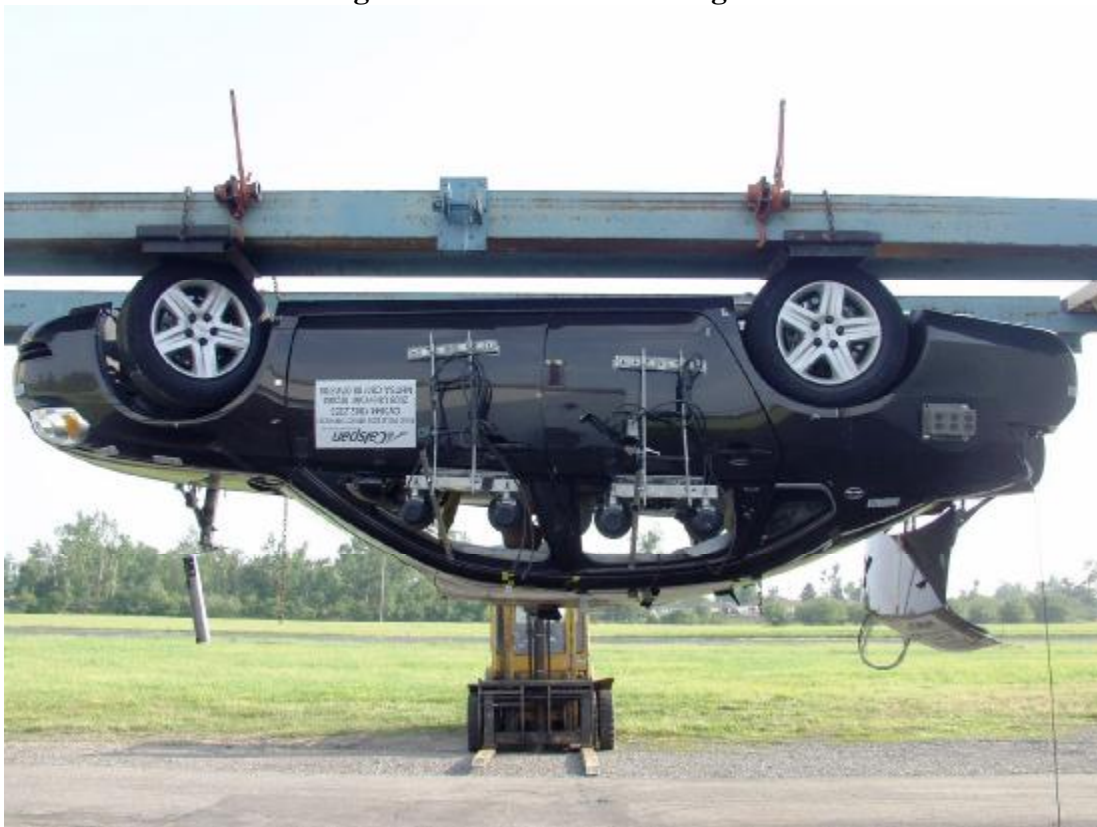
Figure A-41: Rollover 180 Degrees

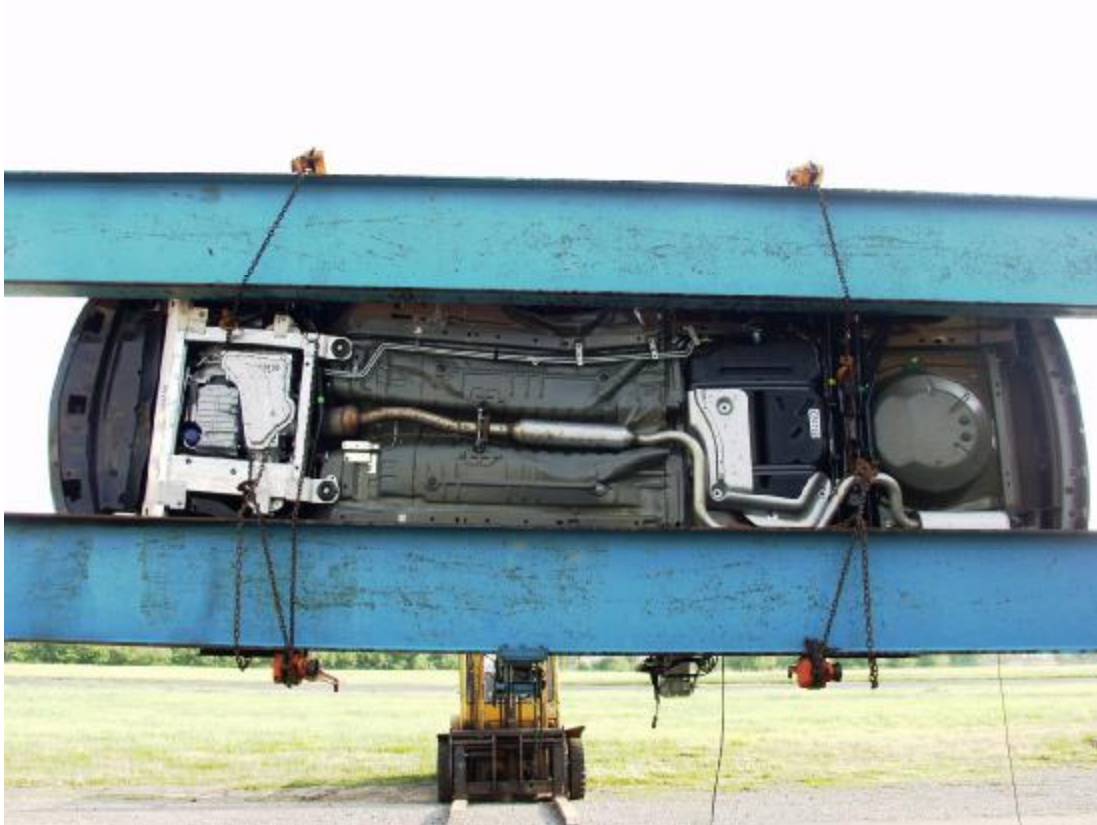
Figure A-42: Rollover 270 Degrees

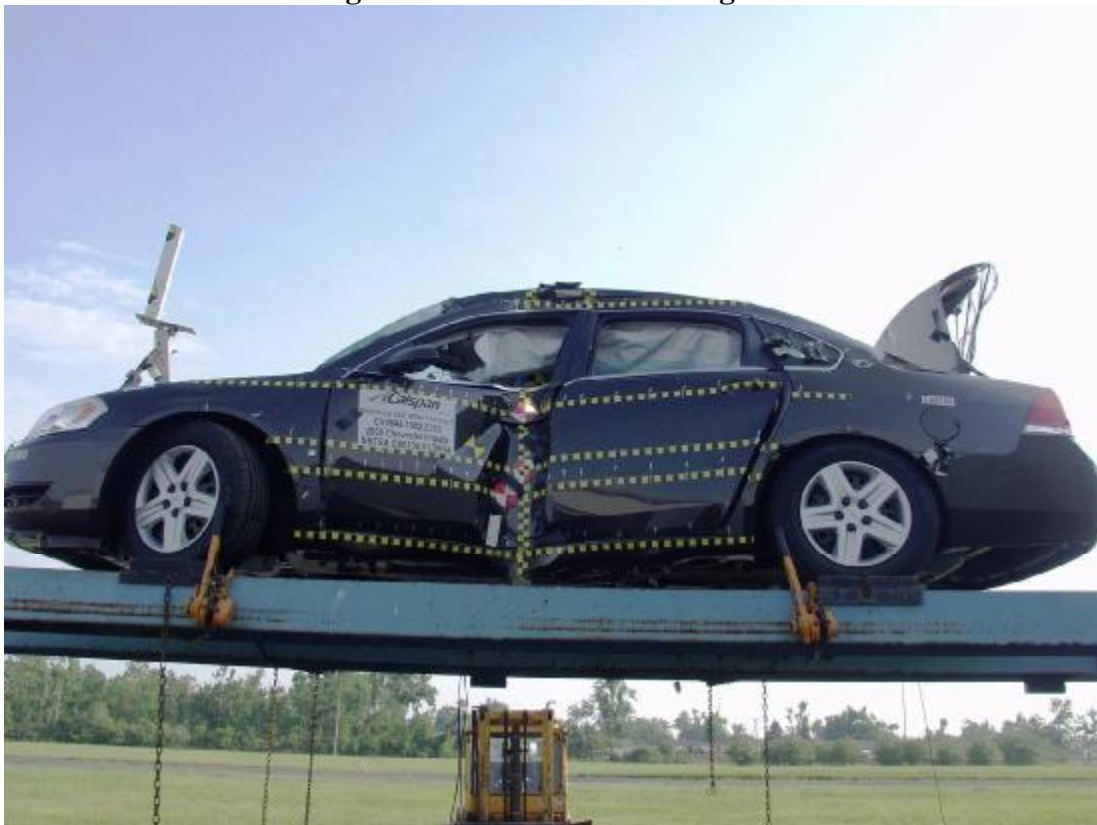
Figure A-43: Rollover 360 Degrees

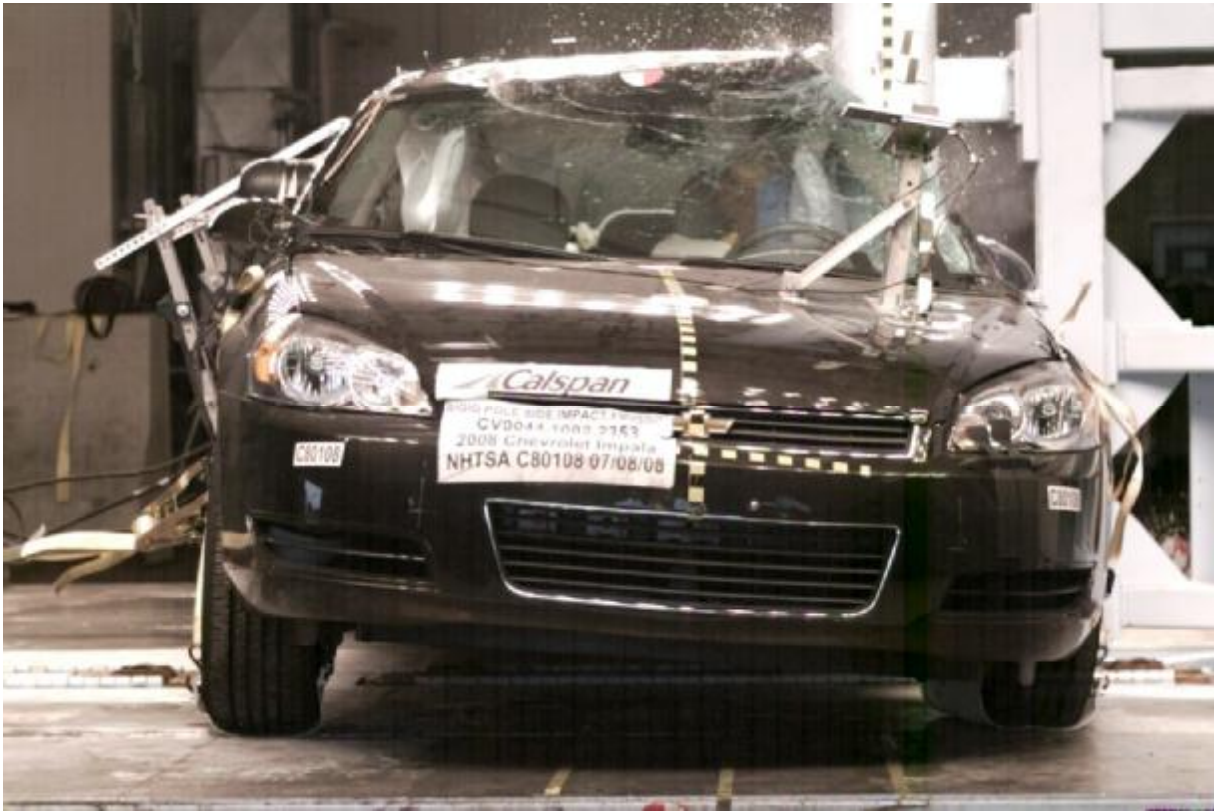
Figure A-44: Impact Photo
