# Case 414 : Narrative

Case Vehicle (A): 2003 Honda
Type: Accord EX, 4-door sedan
Driver: 57-year-old male
CDC: 12-FDEW-3

Case No.: 414  
Case Vehicle (A): 2003 Honda  
Type: Accord EX, 4-door sedan  
Driver: 57-year-old male

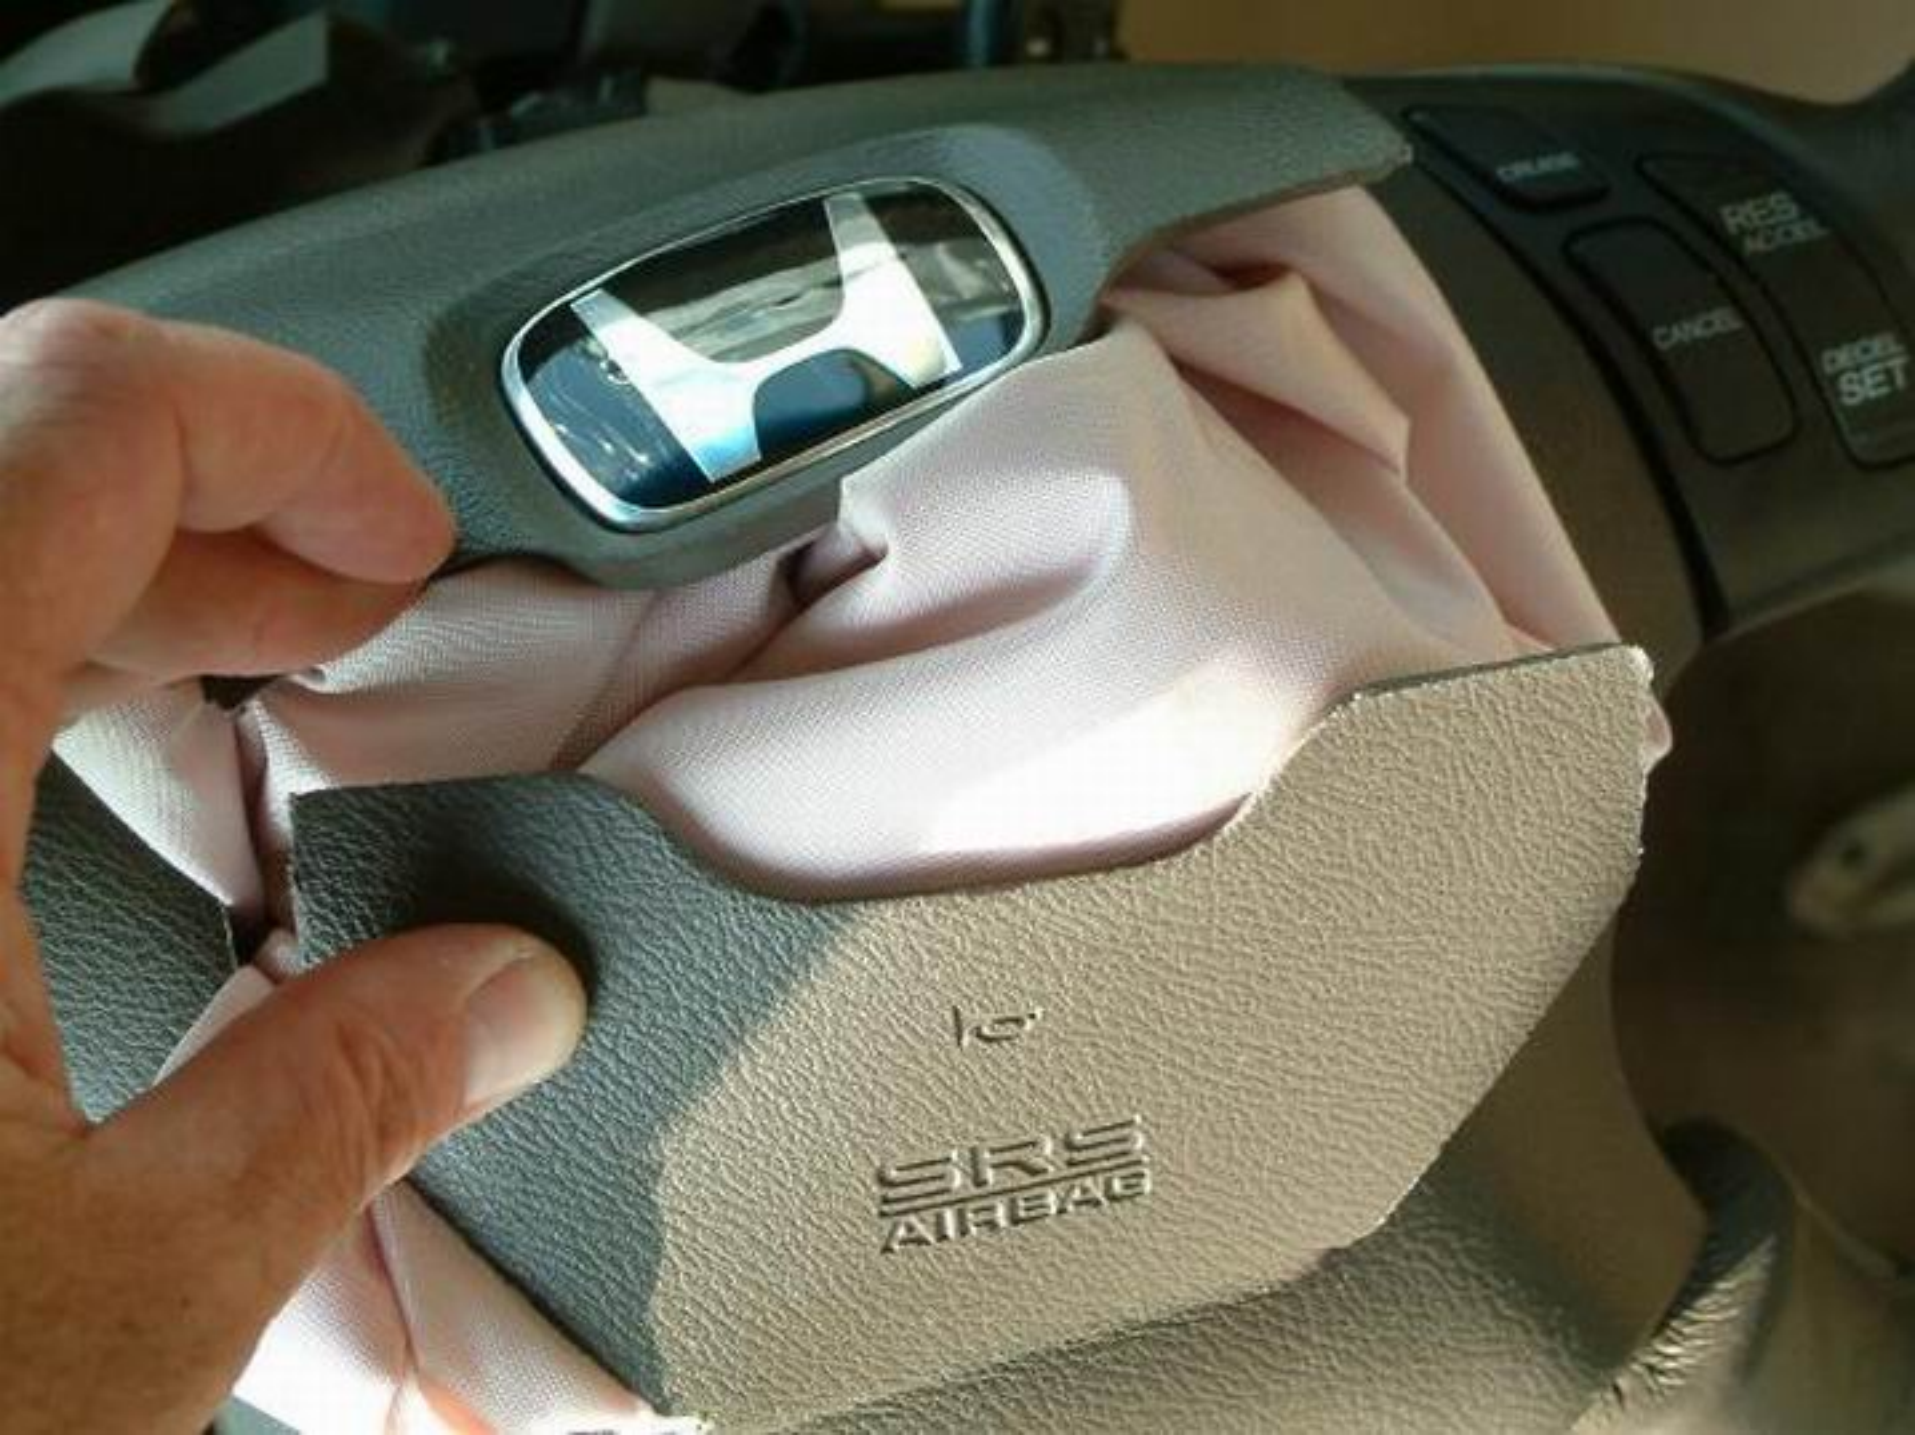
SIDE  
AIRBAG

A close-up photograph of a light-colored leather car seat. A small, dark blue rectangular label is sewn into the stitching on the side of the seat. The label has the words "SIDE" and "AIRBAG" printed in white, stacked vertically. To the right of the seat, a brown fabric seatbelt strap is visible, with a light-colored plastic buckle. The scene is lit with bright, natural light, creating strong highlights and shadows on the leather surface.
