Case 424 : Narrative

Case Vehicle (A): 2003 Saturn	Vehicle (B): 2004 International-Bluebird
Type: ION, 4-door sedan	Type: 3800 T44E, 4x2 school bus
Driver: 42-year-old female	Driver: 58-year-old female
CDC: 01-FZEW-3	TDC: 11-FYEW-1

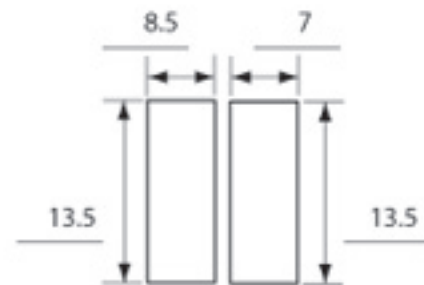
Driver Airbag Doors

I-Pattern

Vents: Y N
if yes, how many: 2

Tethers: Y N
if yes, how many: 2

vents located at 11 and 1 o'clock

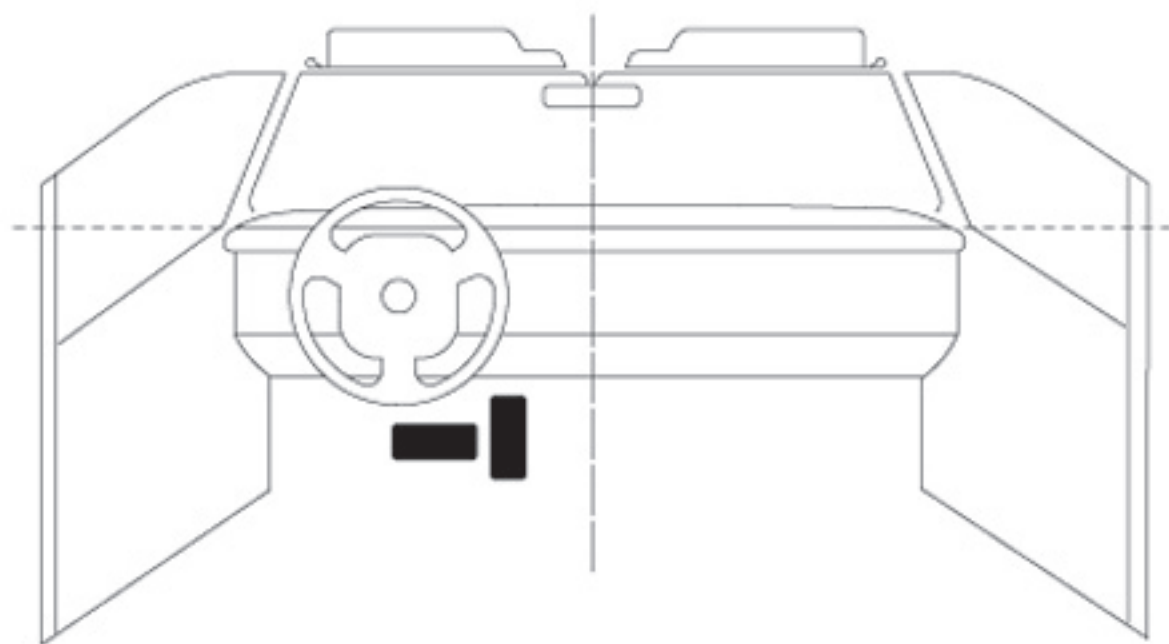
No evidence of contact

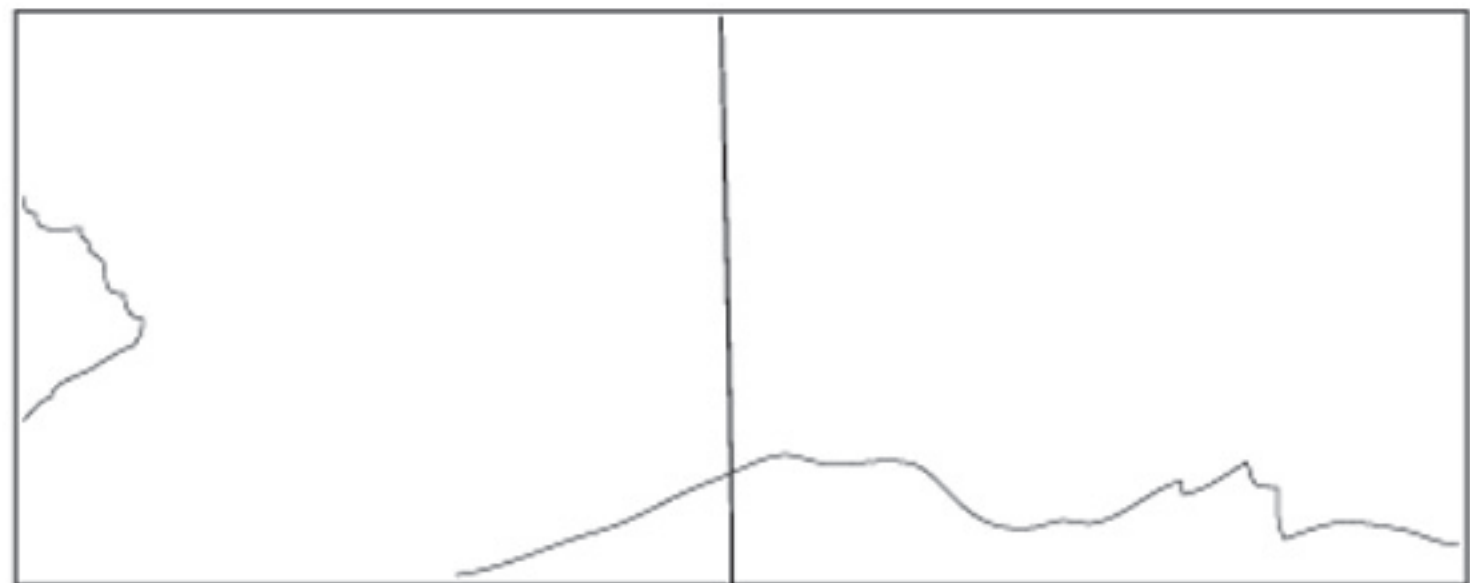
windshield cut by rescue and holed by hood and instrument panel

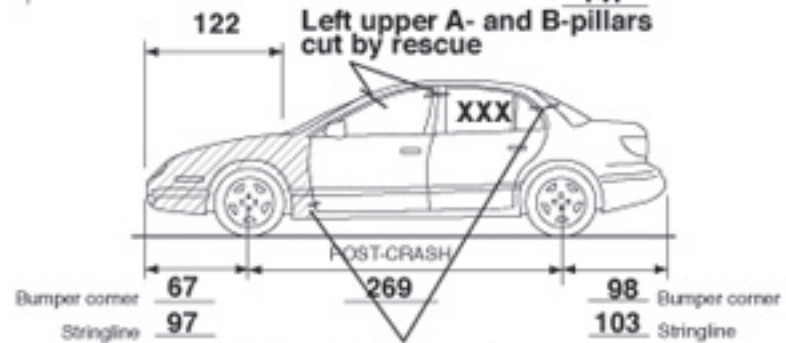
Left lower A-pillar and upper C-pillars partially cut

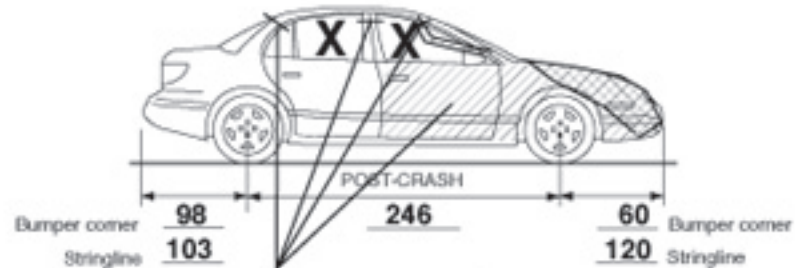
Right upper A-, B- and C-pillars cut and right-front door removed by rescue personnel

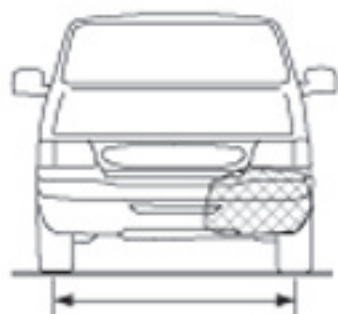
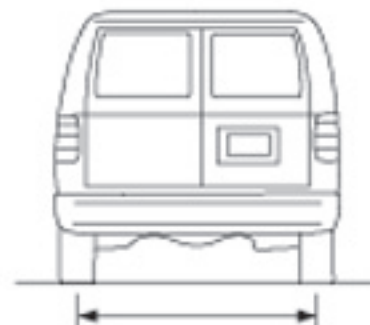
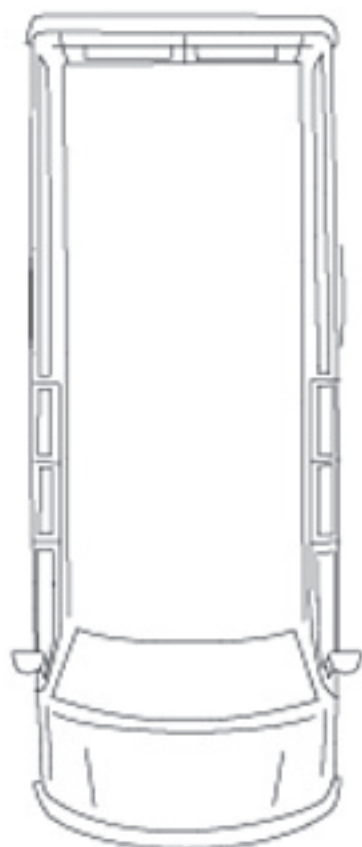
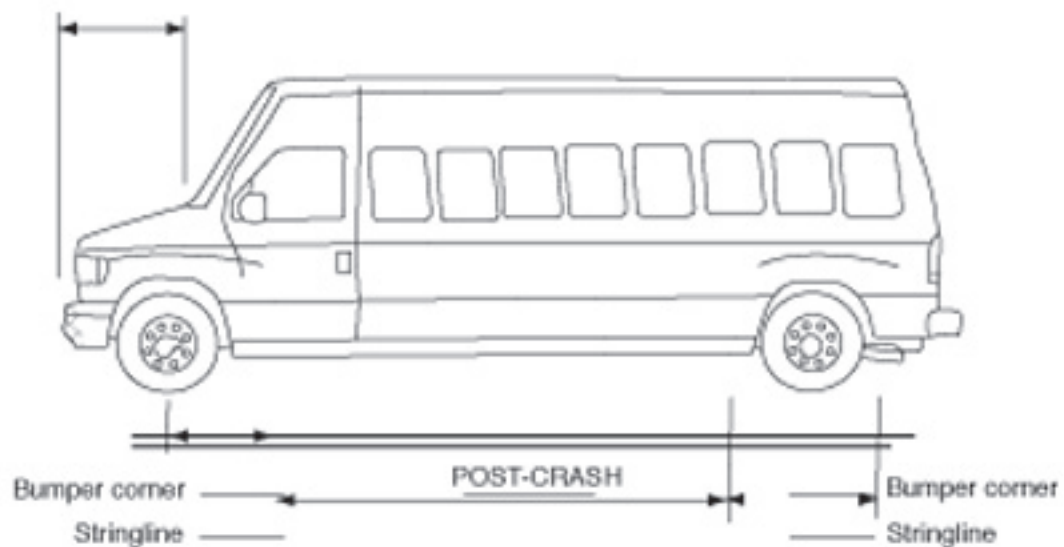
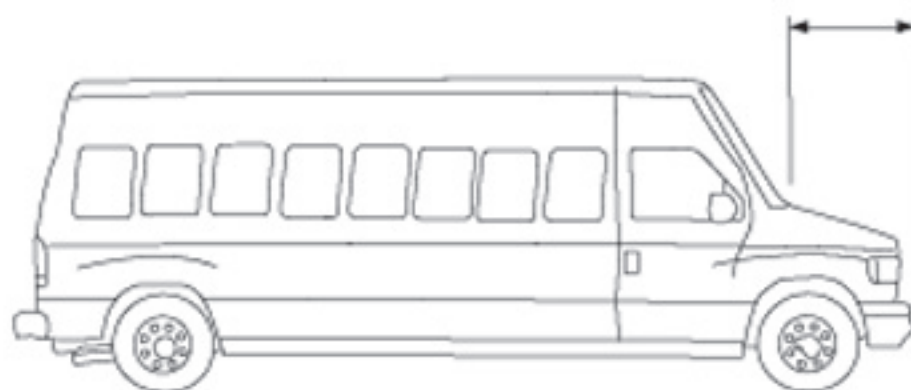
This vehicle was unavailable for inspection, damage shown is taken from on scene pictures.

[13](#) [14](#) [15](#) [16](#) Damage to vehicle (B) was minor. Direct damage began at the left-front bumper corner and extended about halfway across the vehicle front. The left-front tire was partially deflated.

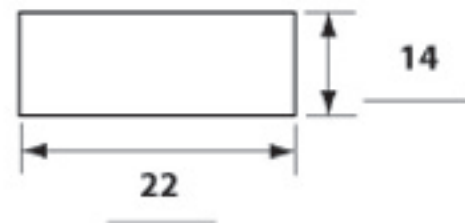
Passenger Airbag Door

Single Door

Vents: Y N
if yes, how many: 2

Tethers: Y N
if yes, how many: 2

**vents at 3 and 9 o'clock
on the side**
