## Case 426 : Narrative

Case Vehicle (A): 2003 Saab	Vehicle (B): 1998 Dodge
Type: 9-3 Linear, 4-door sedan	Type: Neon Sport, 2-door coupe
Driver: 36-year-old male	Driver: 20-year-old male
CDC: 12-FDEW-2	CDC: 99-0000-0

Case No.: **UM-4232**  
Case Veh. (A): **2003 Saab**  
Type: **9-3 Linear, 4-door sedan**  
Driver: **36-year-old male**  
Veh. (B): **1998 Dodge Neon, 2-door coupe**

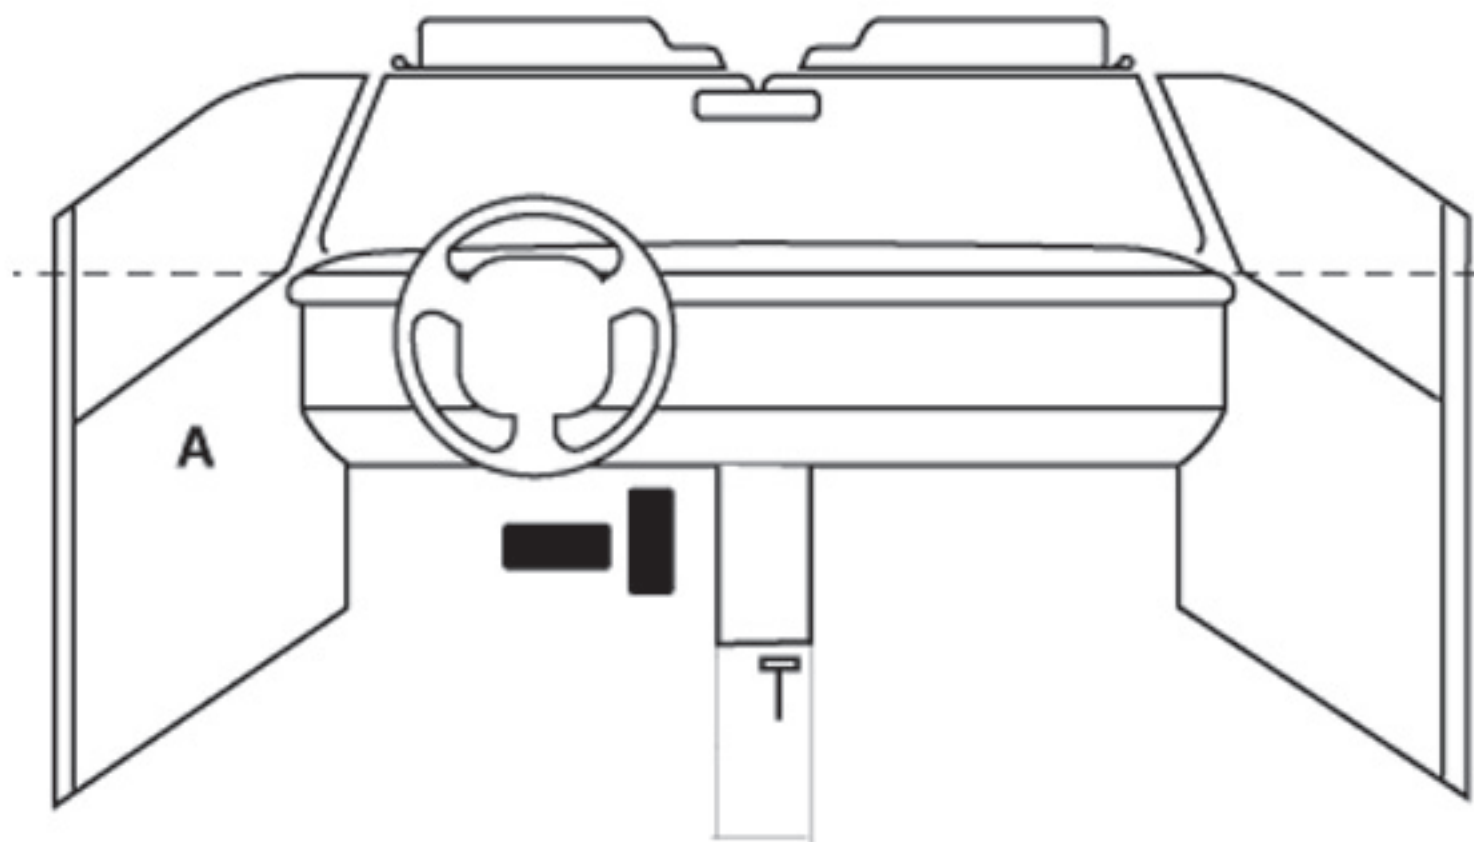
OCCUPANT CONTACT WORKSHEET

**A = door panel, scuffmark**

Contact	Interior Component Contacted	Occupant No. if Known	Body Region if Known	Supporting Physical Evidence	Confidence Level of Contact Point
A	Door panel	DR	Unknown	scuffmark or airbag powder	3
B					
C					
D					
E					
F					
G
