## Case 429 : Narrative

Case Vehicle (A): 2002 Chevrolet	Vehicle (B): 1997 Chevrolet
Type: Venture, 4-door minivan	Type: S10, 4x2, 2-door pickup
Driver: 79-year-old male	Driver: 18-year-old male
CDC: 12-FYEW-3	CDC: 99-0000-0

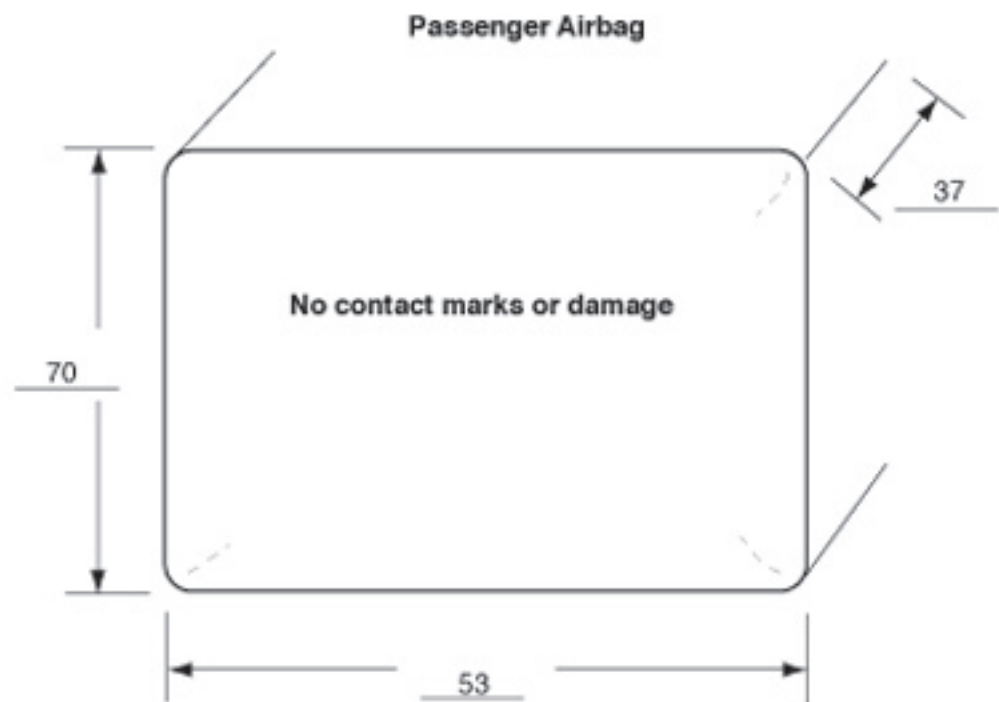
**Passenger Airbag Door**

Single Door
