## Case 436 : Narrative

Case Vehicle (A): 2002 Dodge	Vehicle (B): 1990 Buick
Type: Stratus SE Plus, 4-door sedan	Type: Century Custom, 4-door sedan
Driver: 14-year-old female	Driver: 22-year-old male
CDC: 12-FZEW-2	CDC: 99-0000-0

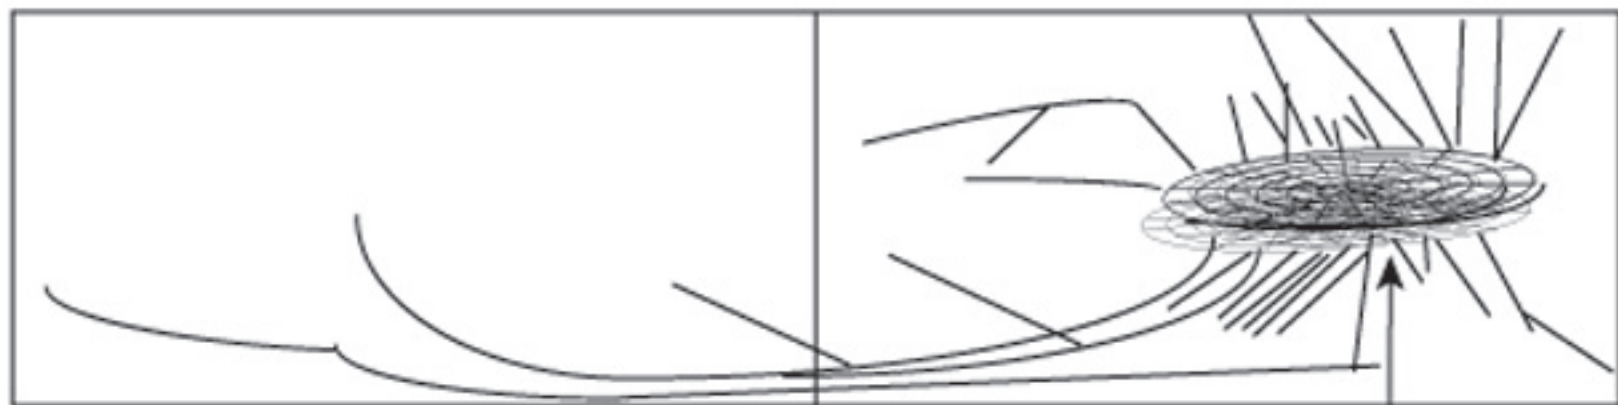
**OCCUPANT CONTACT WORKSHEET**

**A= Knee bolster, scuffmark**

**B= Knee bolster, scuffmark**

Contact	Interior Component Contacted	Occupant No. if Known	Body Region if Known	Supporting Physical Evidence	Confidence Level of Contact Point
A	Knee bolster	1	Lx	Scuffmark	2
B	Knee bolster	1	Lx	Scuffmark	2
C	Glovebox	2	Unk	Numerous scuffmarks	3
D	Floor console	2	Unk	Scuffmark	3
E					
F					
G					
H					
I					
J					
K					
L					
M

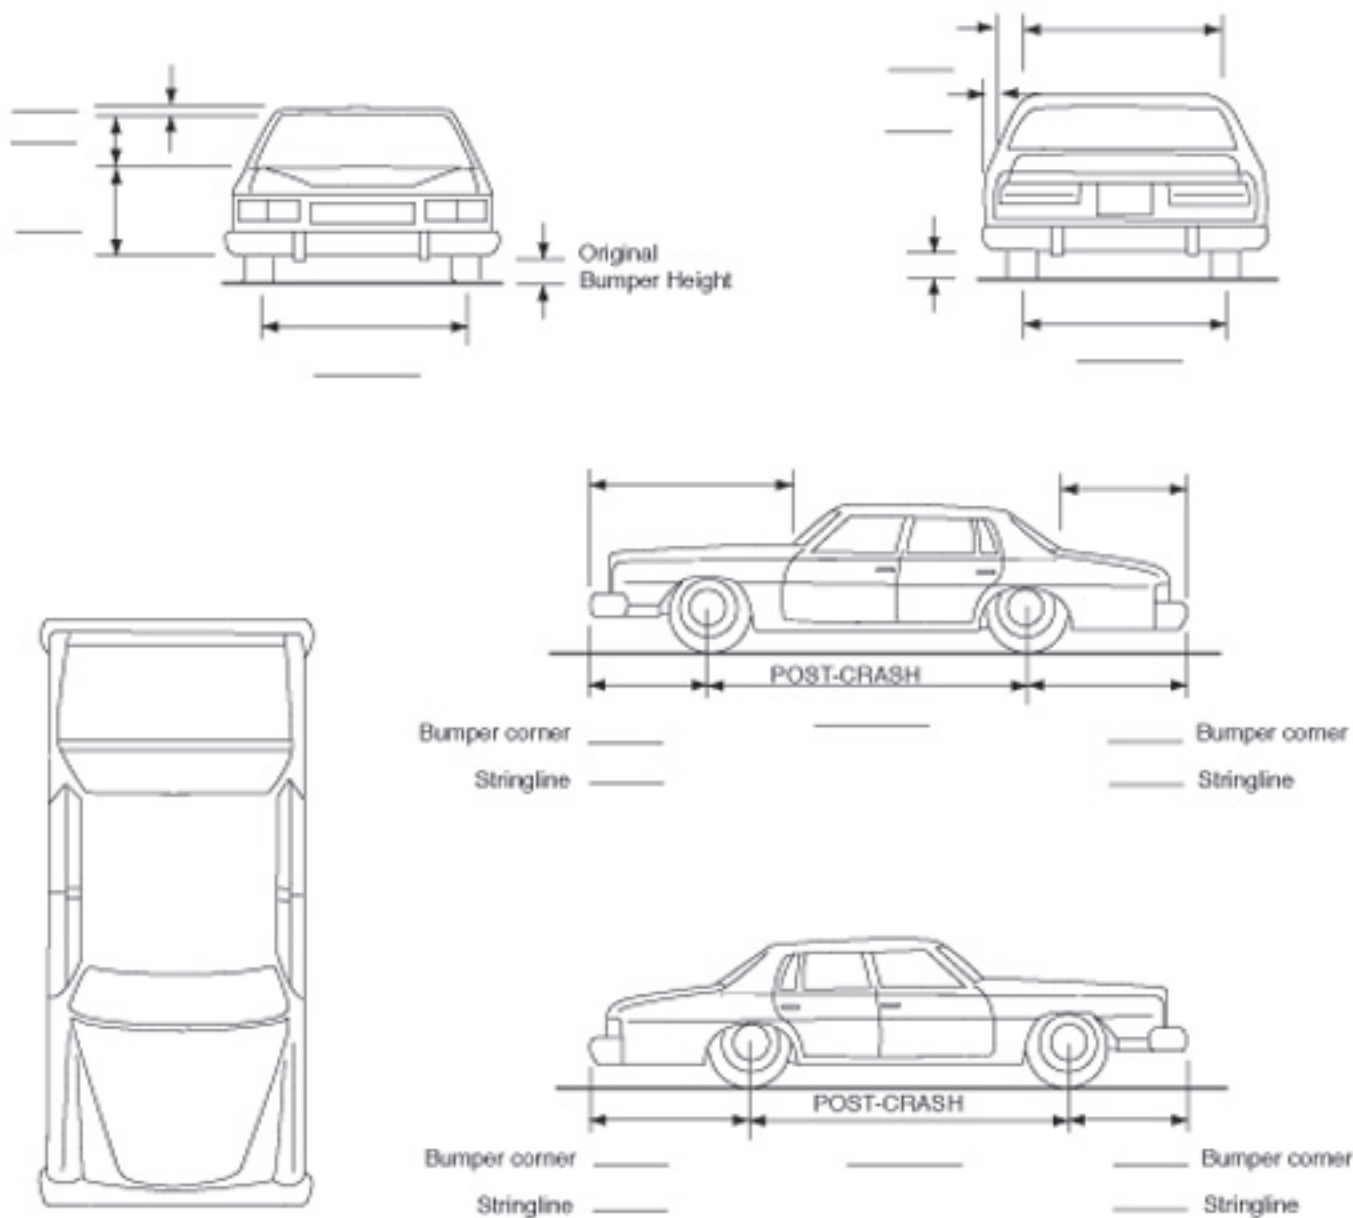
**VEHICLE (B) NOT INSPECTED**  
MEASUREMENTS IN CENTIMETERS

[10](#) Direct damage to case vehicle (A) began at the right-front bumper corner and extended 92-cm to the left, resulting in a 59-percent vehicle overlap (% VOL). The maximum rearward crush at bumper level was 44 cm, and it occurred 67-cm to the left of the right-front bumper corner.

Using the missing-vehicle algorithm of the WinSMASH crash-reconstruction program and crush profiles [11](#) [12](#) [13](#) for case vehicle (A), the following impact severities were estimated:
