## Case 439 : Narrative

Case Vehicle (A): 2002 Ford
Type: Escape XLT, 4-door SUV
Driver: 21-year-old male
CDC: 12-FYEW-4

# UM-4250: Vehicle Report

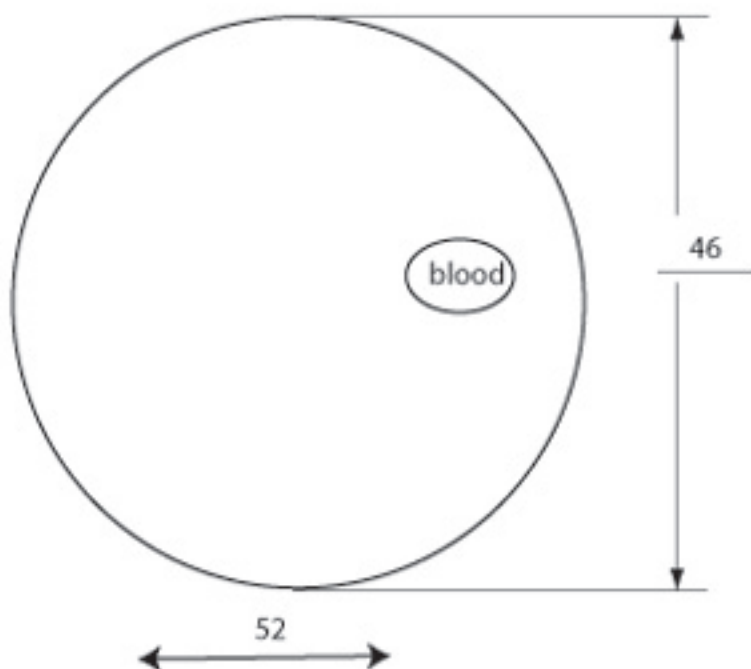
### Driver Airbag

Vents:  Y  N  
if yes, how many: 2

vents at 11 and 1 o'clock

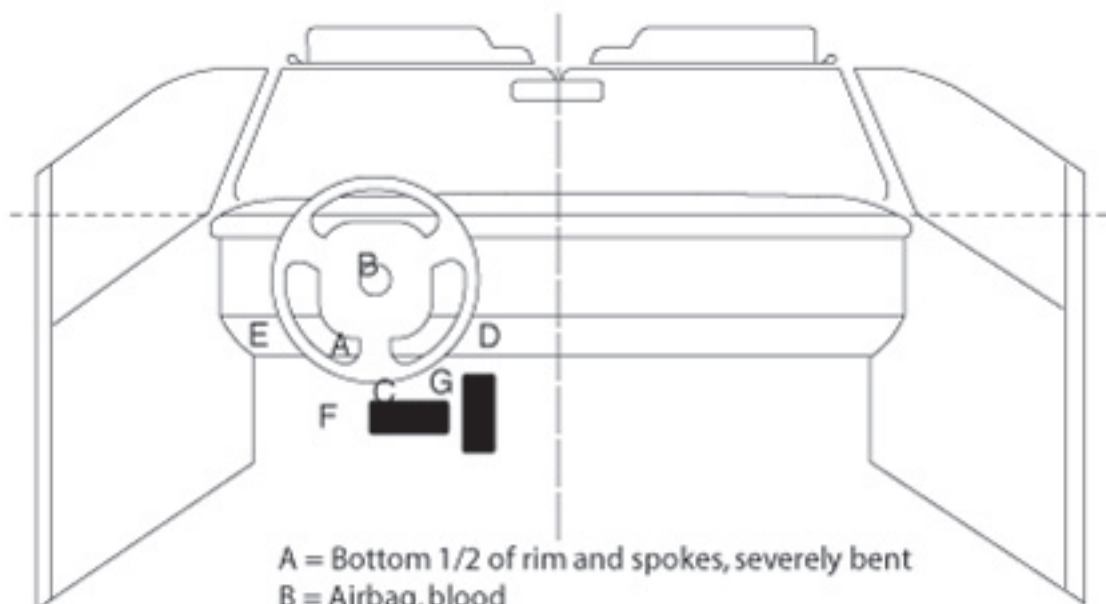
- A = Bottom 1/2 of rim and spokes, severely bent
- B = Airbag, blood
- C = Steering column, scuff
- D = Right knee bolster, scuff
- E = Left knee bolster, scuff
- F = Toepan/floor, intrusion
- G = Foot controls, brake pedal is bent, accelerator is broke off

Contact	Interior Component Contacted	Occupant No. if Known	Body Region if Known	Supporting Physical Evidence	Confidence Level of Contact Point
A	Steering wheel rim/spokes	1	Chest	Bottom half of rim is severely bent spokes are bent	1
B	Airbag	1	Chest	Blood	1
C	Steering column	1	Knee	Scuff	1
D	Right knee bolster	1	Knee	Scuff	1
E	Left knee bolster	1	Knee	Scuff	1
F	Toe pan/floor	1	Feet	Intrusion	1
G	Foot controls	1	Feet	Brake pedal is bent, accelerator pedal is broke off	2
H
