## Case 467 : Narrative

Case Vehicle (A): 2003 Honda	Vehicle (B): 2004 Ford
Type: Accord EX, 4-door sedan	Type: Escape XLT, 4-door, SUV
Driver: 47-year-old female	Driver: 48-year-old female
CDC: 12-FDEW-2	CDC: 99-0000-0

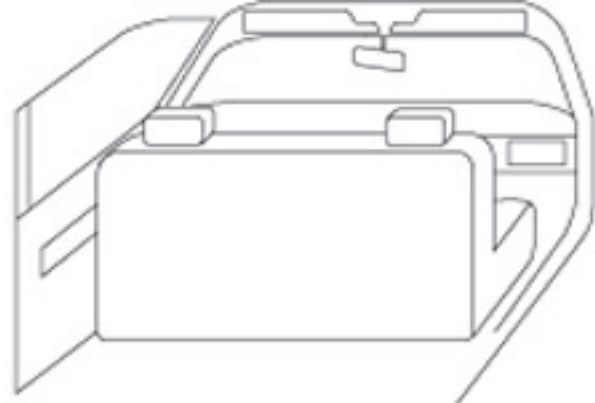
evidence of belt use:

driver: pretensioner activated and belts locked and extended

RF: pretensioner activated and belts locked and extended

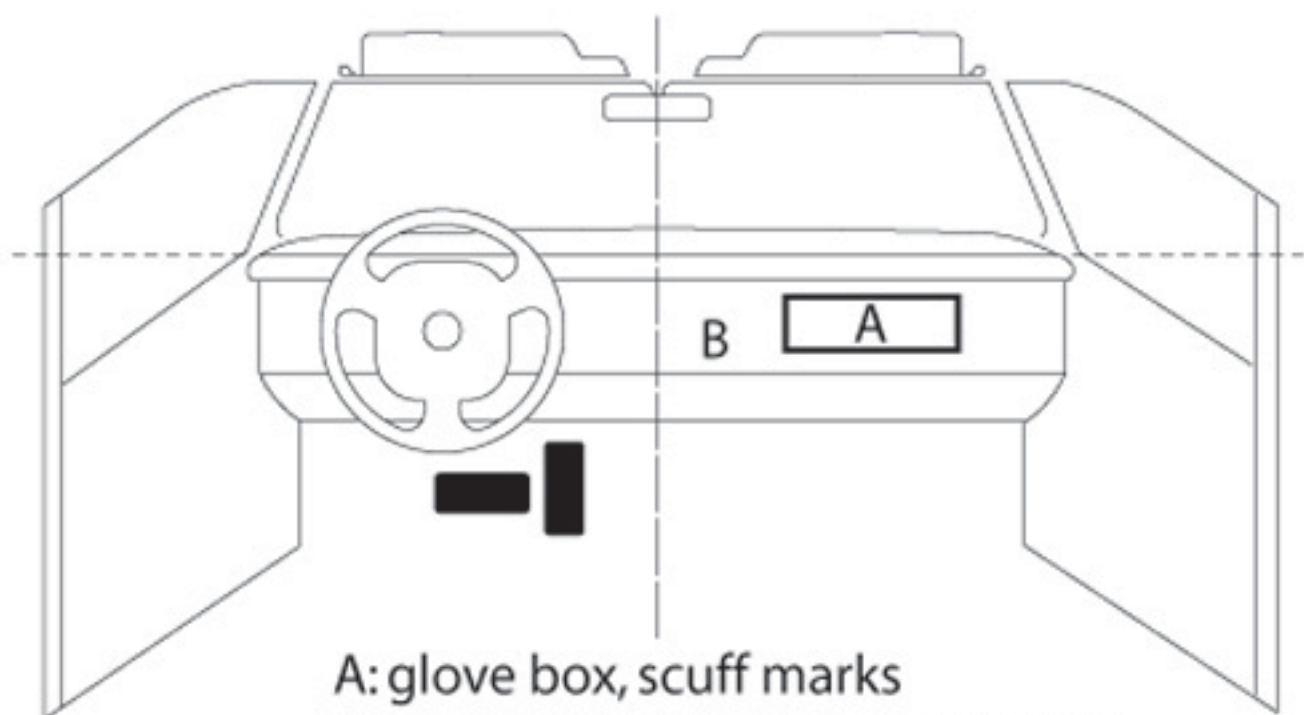
A: glove box, scuff marks

B: IP - left of glove box, scuff marks

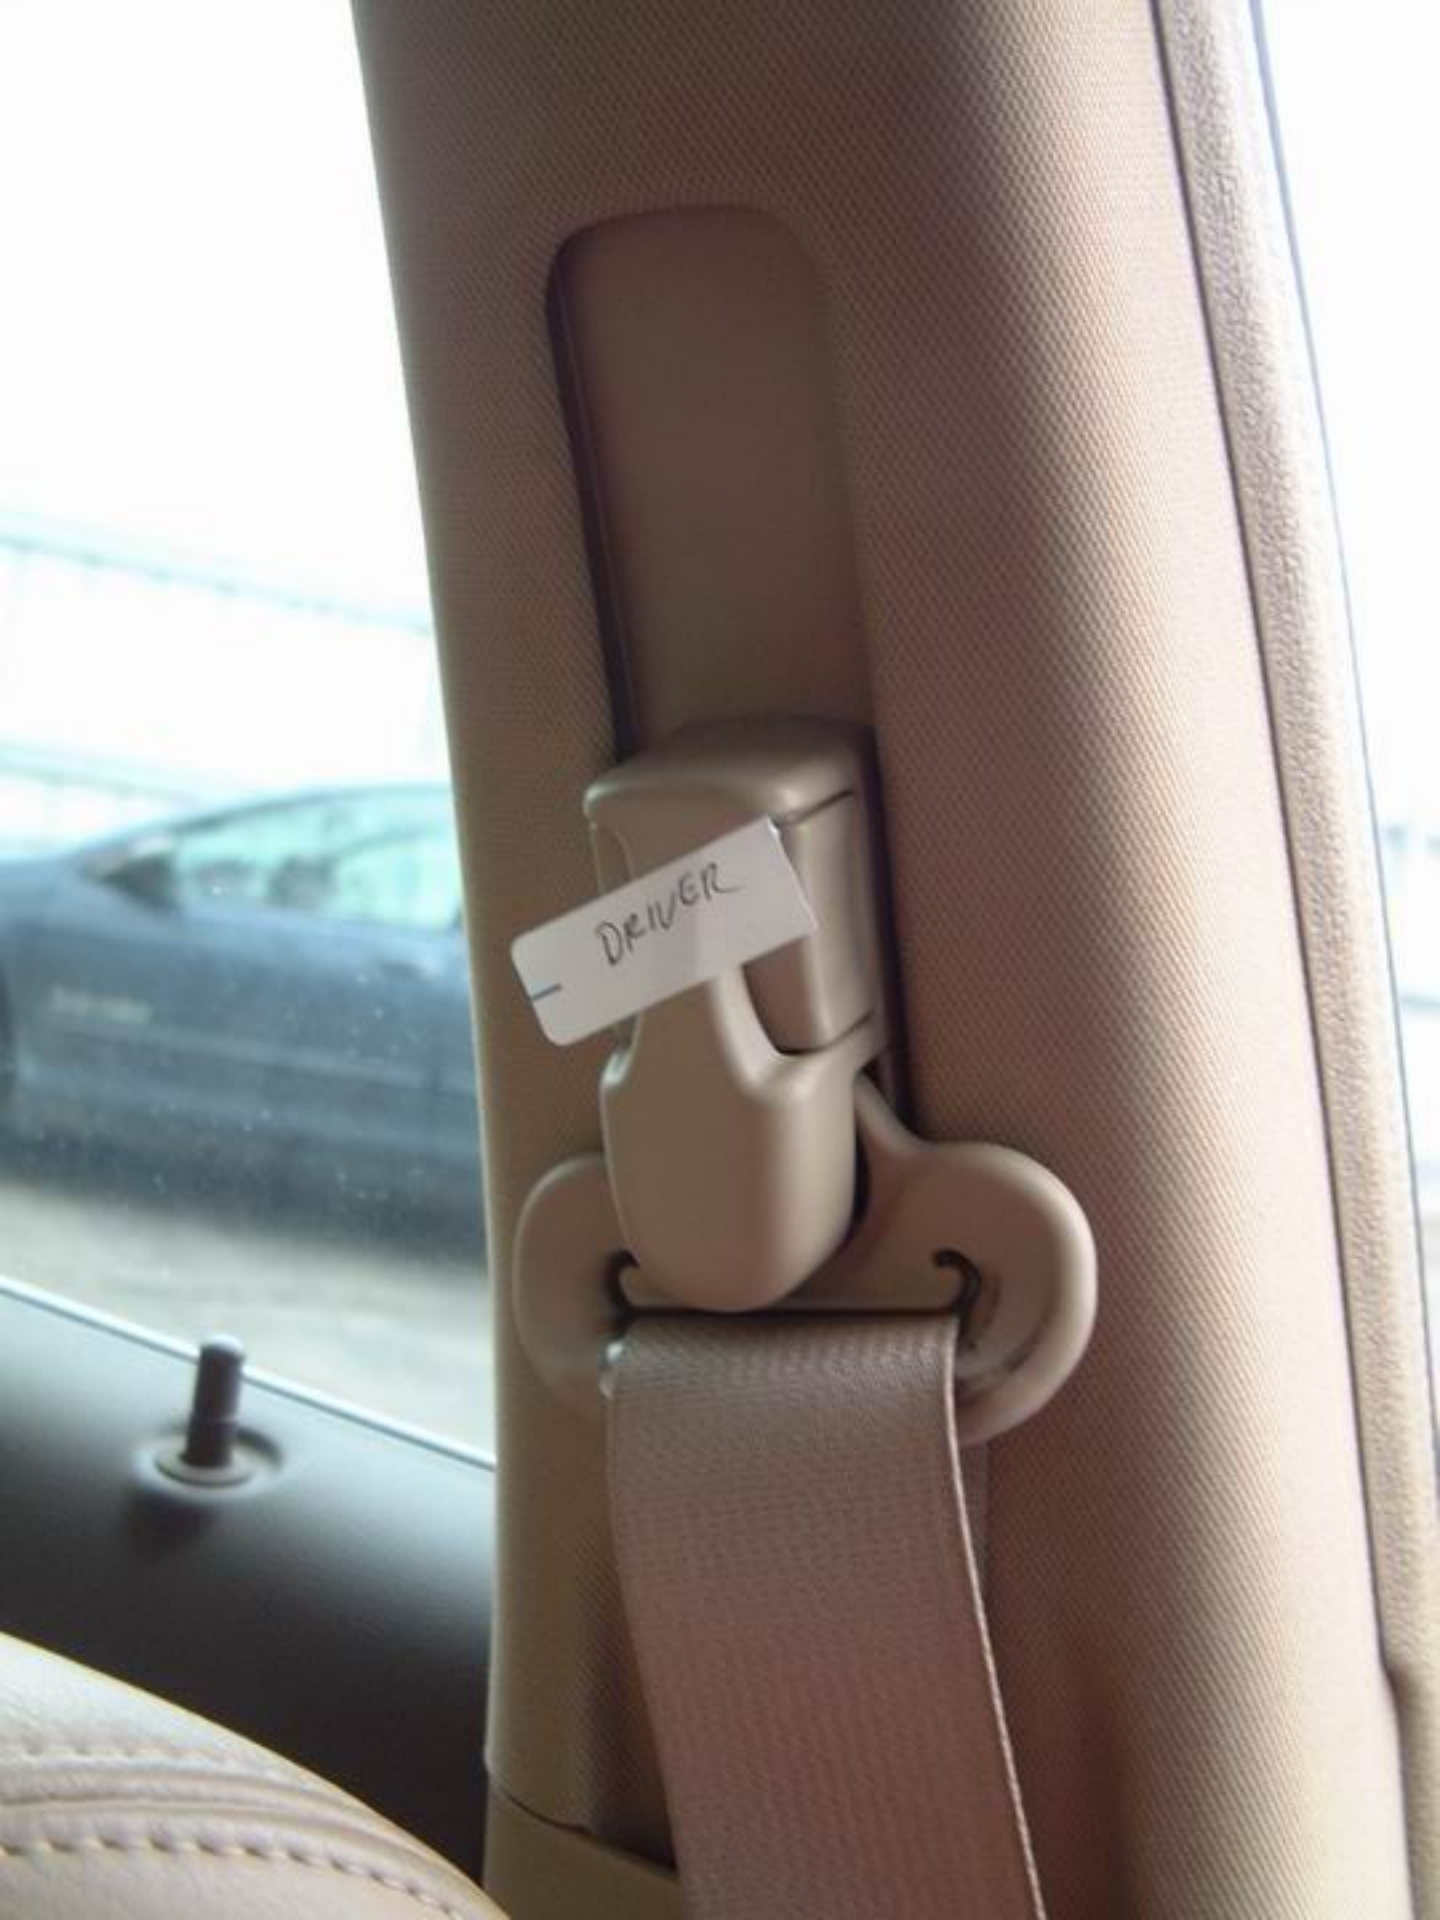
DRIVER

A close-up photograph of a tan car seat headrest. A white, rectangular tag with a blue horizontal line on the left side is attached to the top of the headrest. The tag has the word "DRIVER" written on it in black, uppercase, handwritten letters. The headrest is made of a textured, tan material and is mounted on a dark-colored seat. The background is a dark, textured surface, possibly asphalt or concrete.

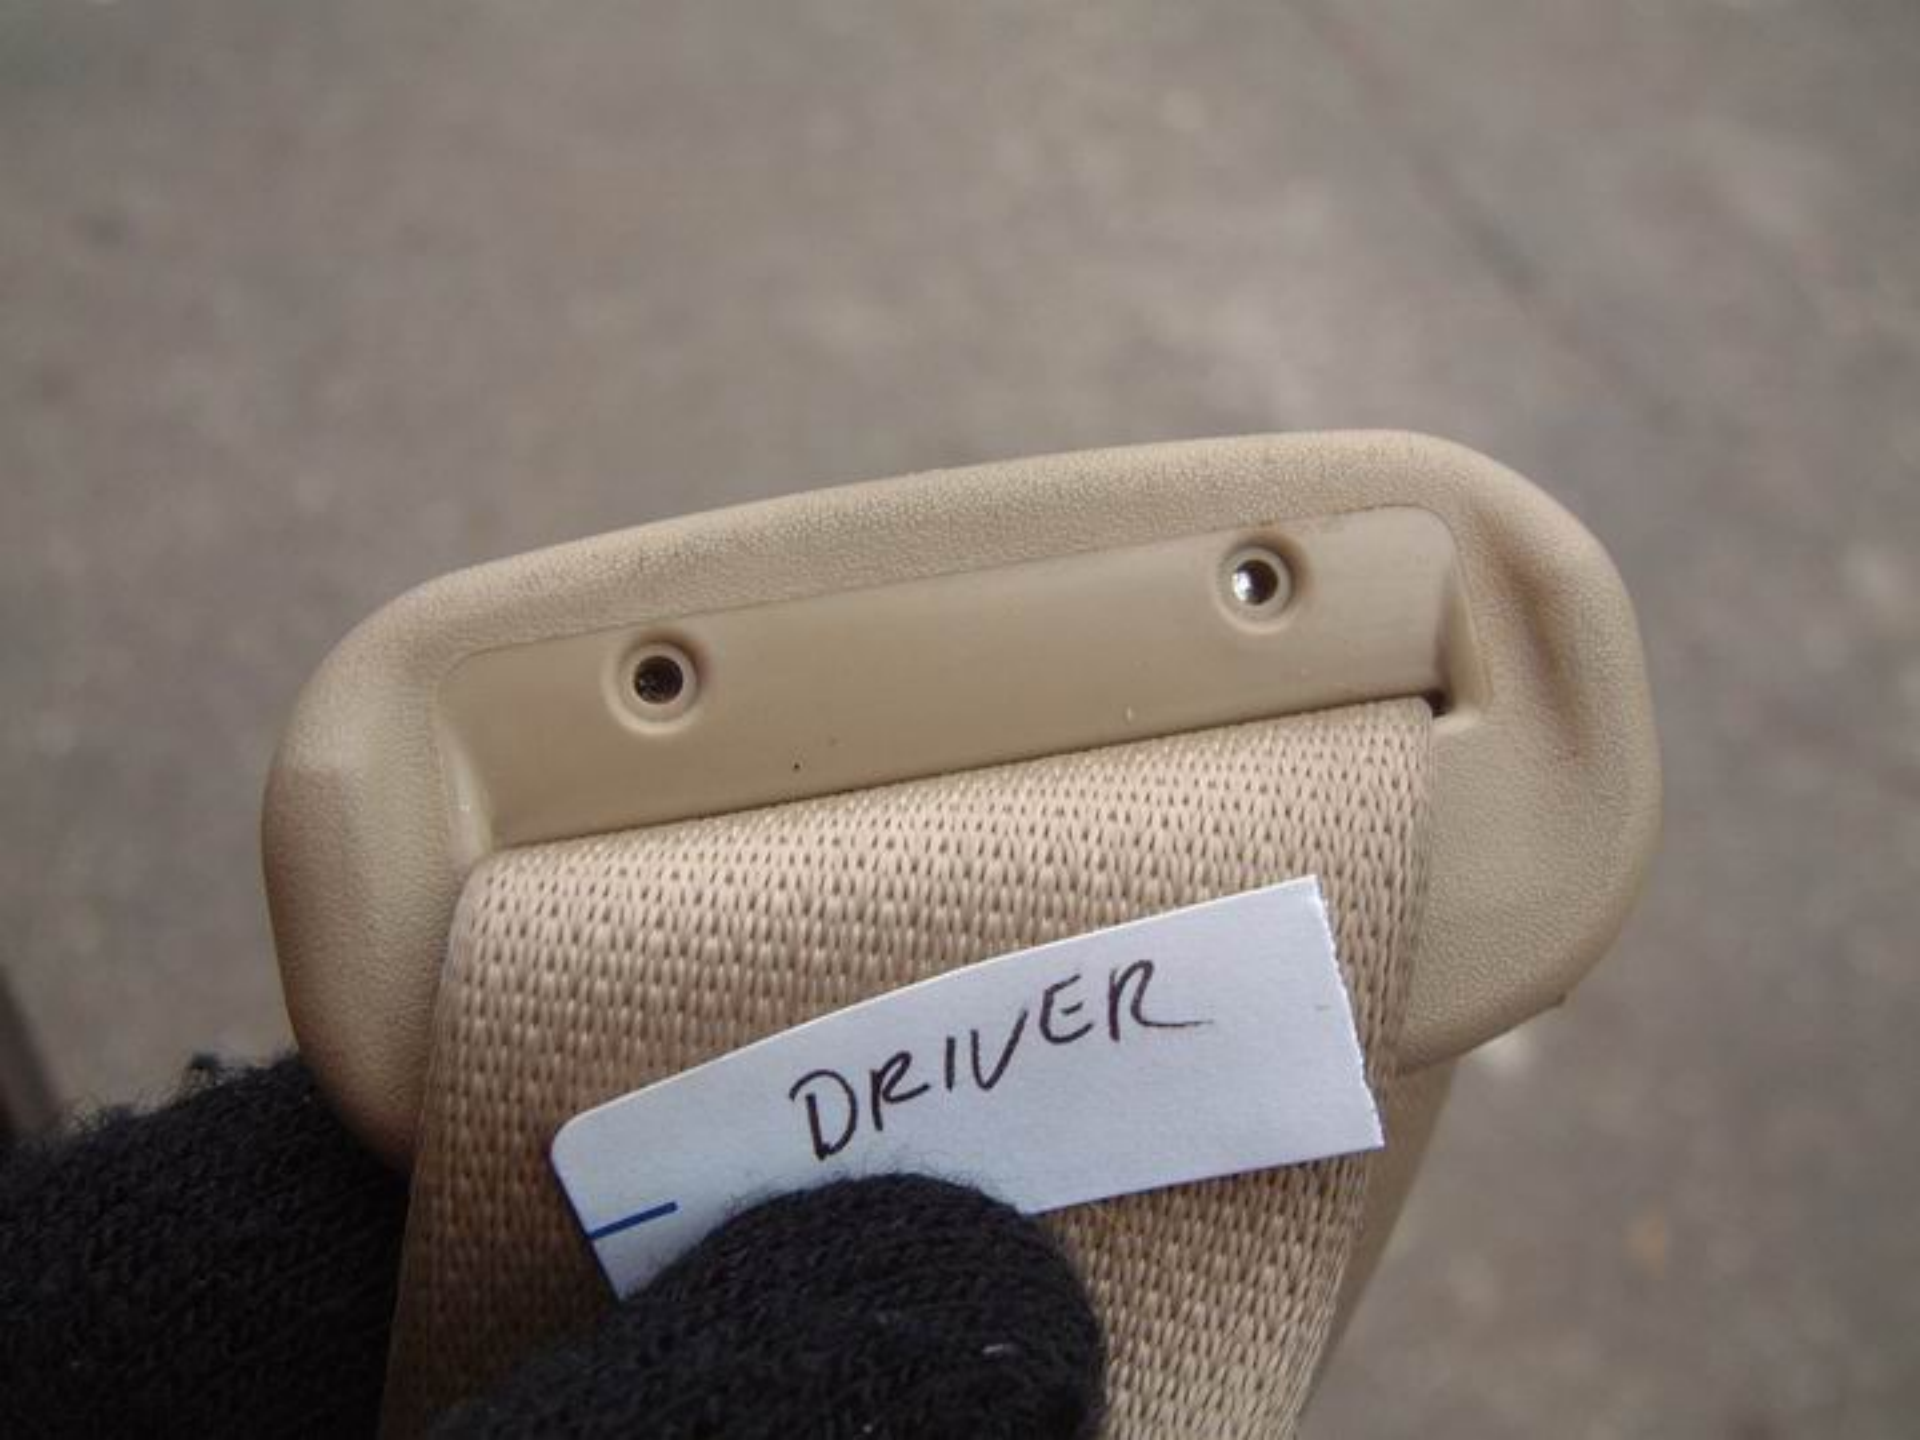
DRIVER

A close-up photograph of a tan car seat headrest. The headrest is made of a textured, woven fabric and is mounted on a tan plastic frame. Two circular holes are visible on the top edge of the plastic frame. A small white rectangular label is attached to the front of the headrest, with the word "DRIVER" written on it in black, handwritten capital letters. The background is a blurred, light-colored surface, possibly a concrete floor.
