Case 421 : Narrative

Case Vehicle (A): 2004 Pontiac	Vehicle (B): 1999 GMC
Type: Grand Am SE1, 4-door sedan	Type: Yukon, 4x4, 4-door SUV
Driver: 27-year-old male	Driver: 54-year-old female
CDC: 01-FDEW-1	CDC: 99-0000-0

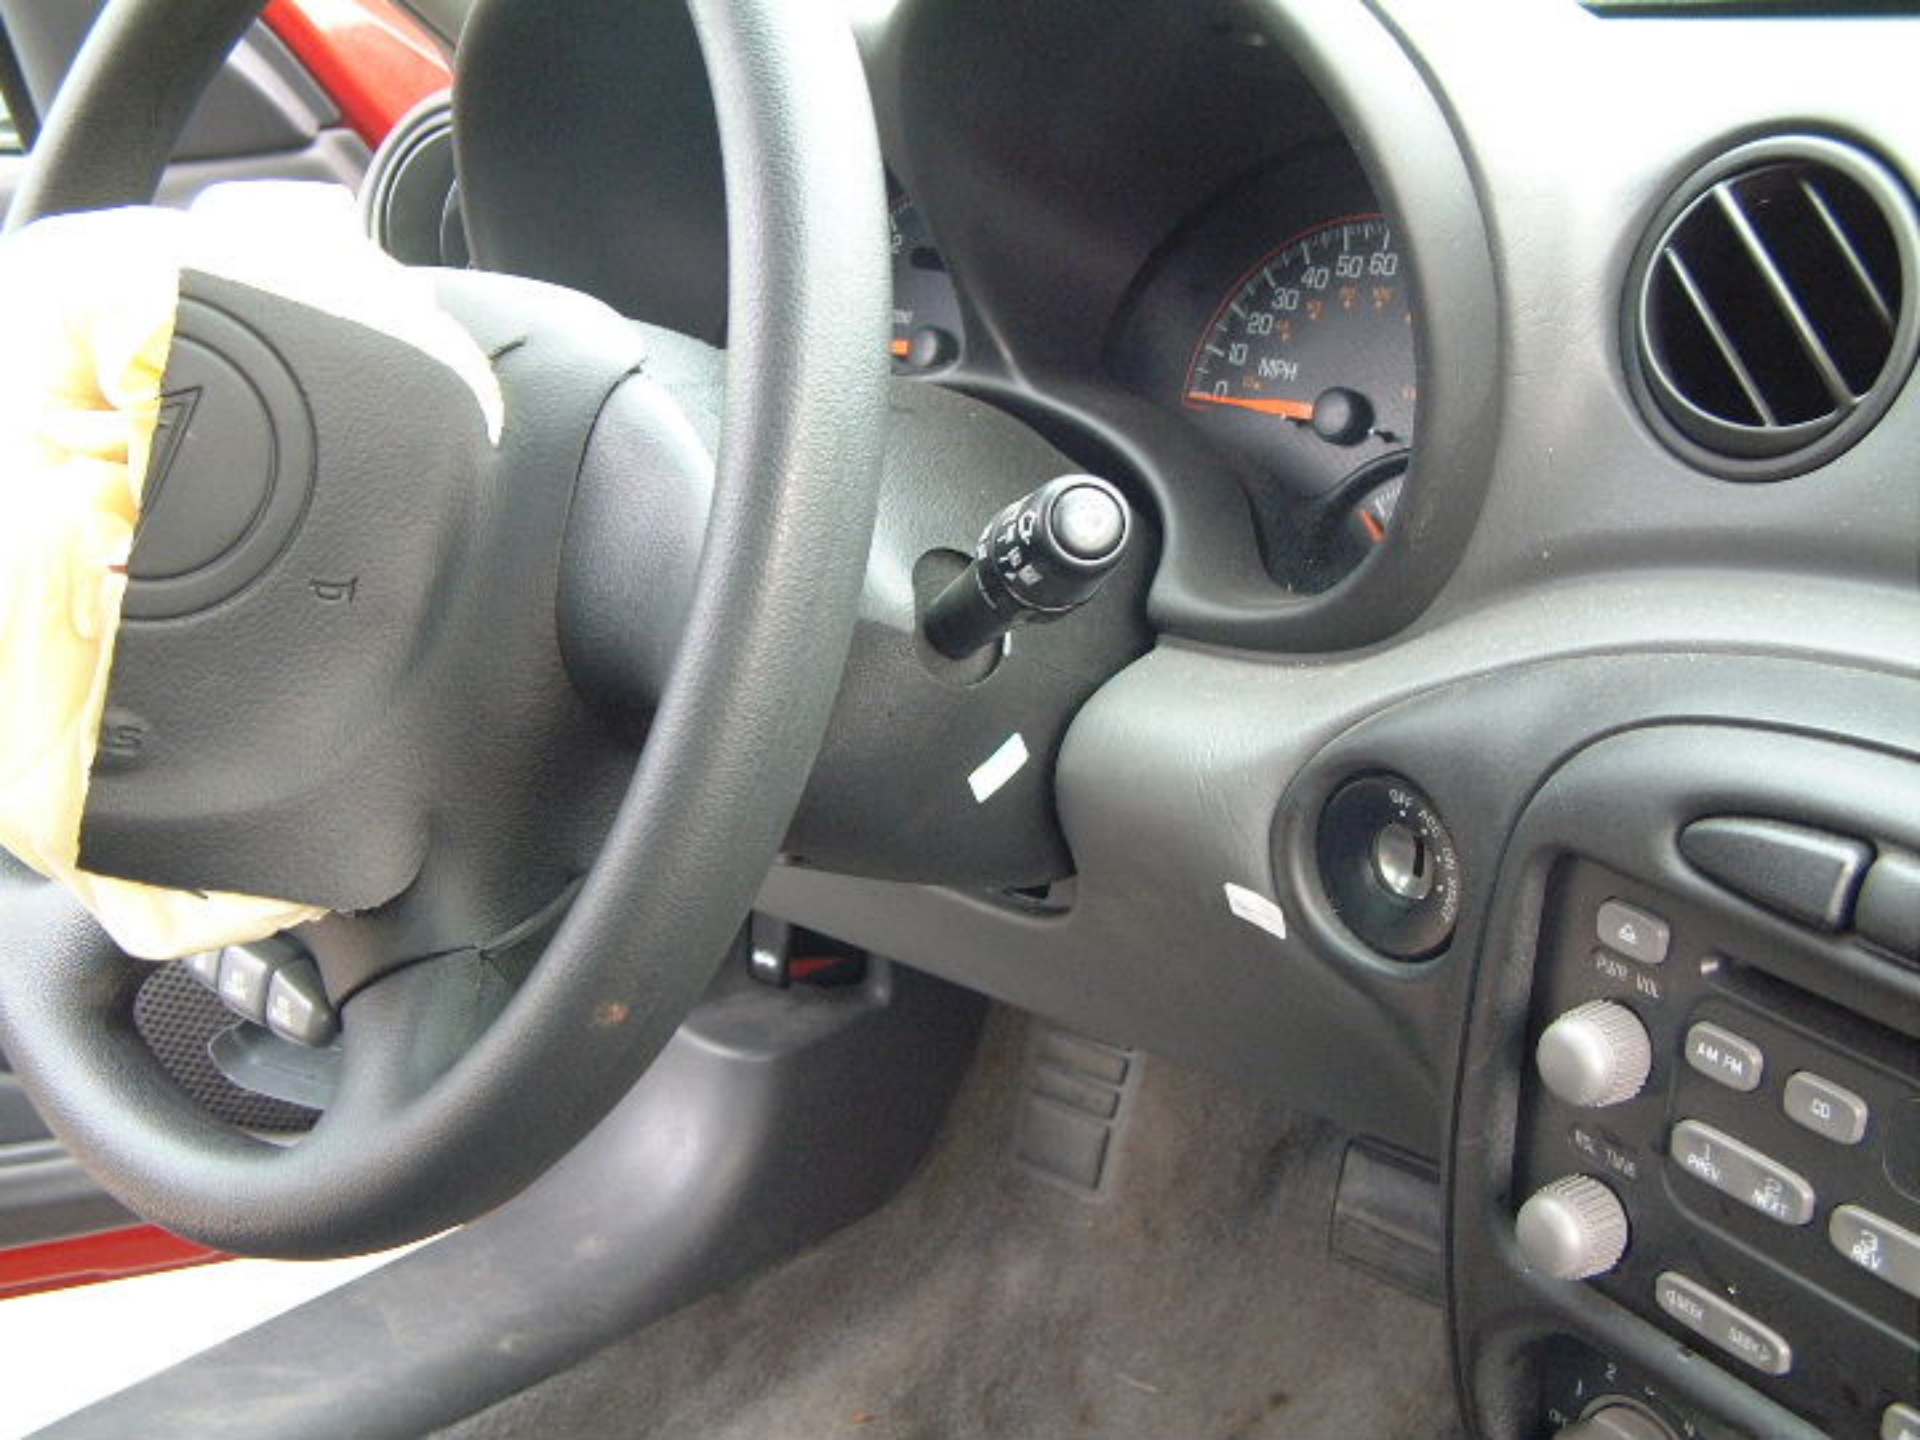
Yellow cloth covering the left side of the steering wheel.
