Case 427 : Narrative

Case Vehicle (A): 1999 Ford
Type: F150 Supercab, 4x4, 4-door pickup
Driver: 61-year-old male
CDC: 12-FCEN-3

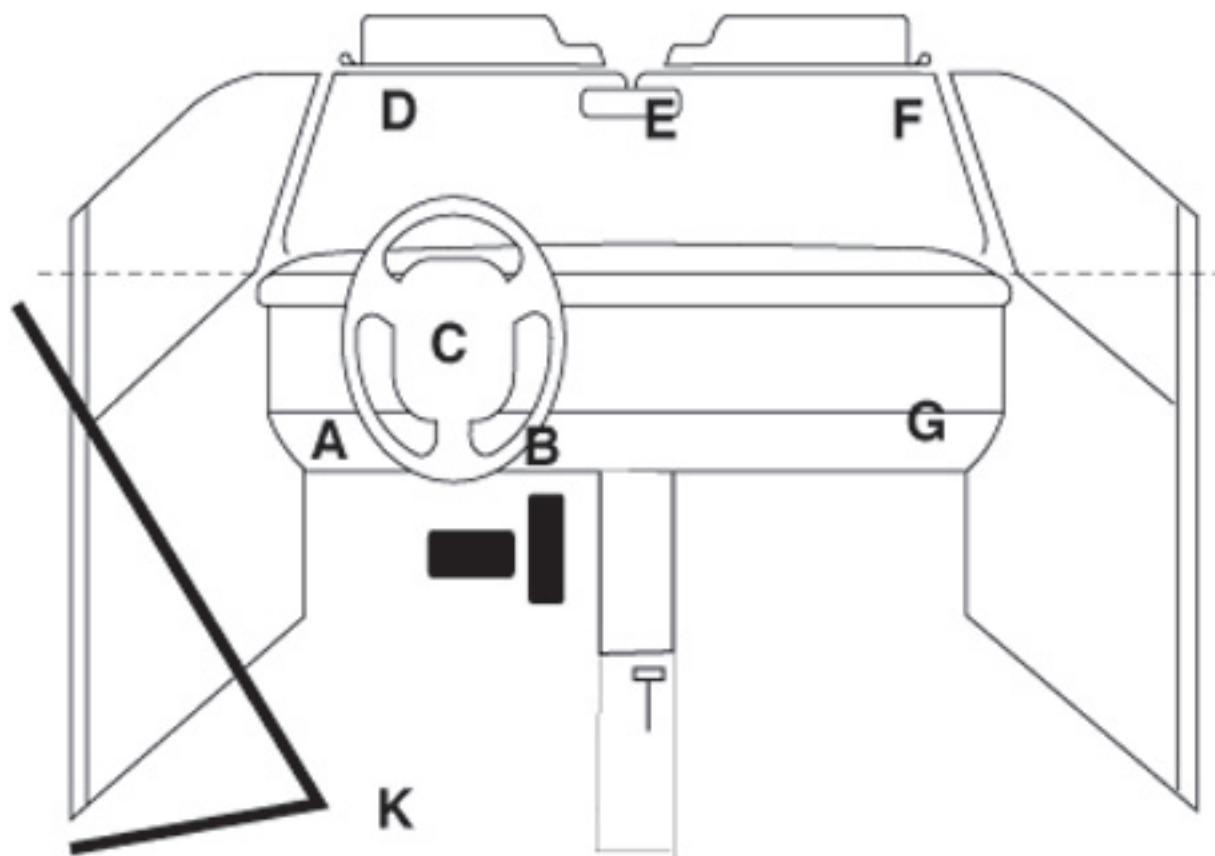
- A = knee bolster**
- B = knee bolster**
- C = SW airbag, rim & column**
- D = W/S spiderweb**
- E = RV mirror & W/S**
- F = W/S spiderweb**
- G = glovebox**
- H = RF seatback**
- I = LF seatback**
- J = LF seat cushion**
- K = DR seat belt**

Contact	Interior Component Contacted	Occupant No. if Known	Body Region if Known	Supporting Physical Evidence	Confidence Level of Contact Point
A	knee bolster	1	Left knee	Panel deformed	1
B	knee bolster	1	Right knee	Panel deformed	1
C	Airbag, SW rim, column	1	Chest	SW rim deflected forward, column compressed	1
D	W/S	1	Hand	Spiderweb crack	2
E	RV mirror & W/S	2	Unknown	Cracked and dislodged	3
F	W/S	2	Right shoulder	Spiderweb crack	2
G	Glovebox	2	Right knee	Deformed	1
H	RF seat backrest	4	Face	Slightly twisted	1
I	LF seat backrest	3	Face	Deflected forward	1
J	LF seat cushion	3	Legs	Deformed	1
K	DR belt system	1	Chest	Load marks on D-ring and webbing	1
L					
M
