**Re: Defect Information Report – Supplemental Report No. 2  
11V-283, FL-607, Western Star Airlines  
Interim Notification**

**August 2011  
FL607  
NHTSA #11V-283  
Interim Recall Notice**

**Subject: Western Star Airlines**

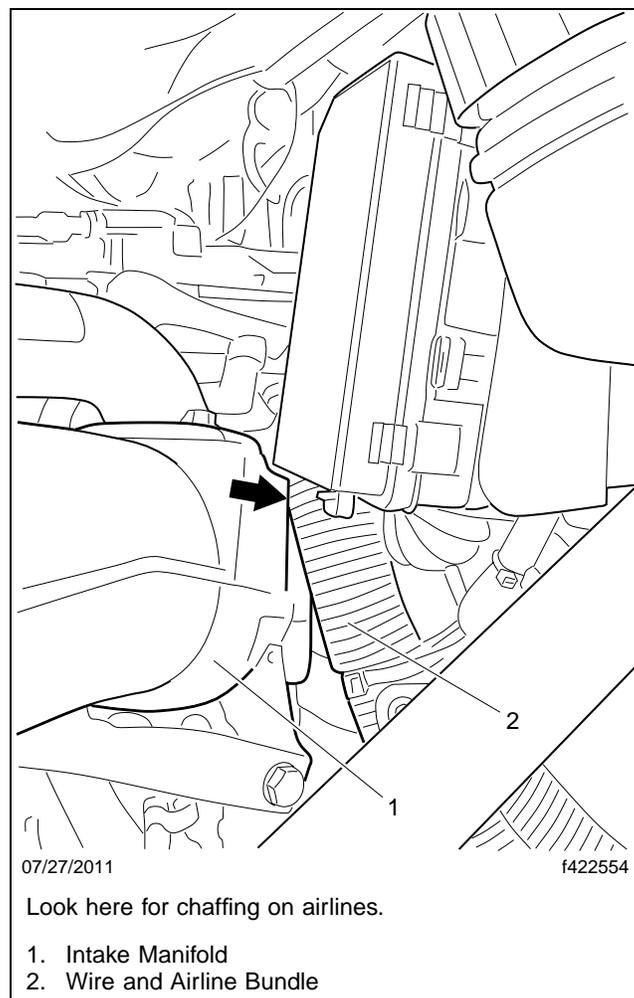
**Fig. 1**

The supply and delivery airlines for the foot valve may contact the engine air intake. Relative motion between the cab and engine may allow the delivery airlines to chafe on the air intake. Over time, a hole in a delivery airline may develop. This could eventually lead to reduced braking capacity to the front or rear brakes and increase the risk of a vehicle crash.

1. Park the vehicle on a level surface, shut down the engine, and set the parking brake. Chock the tires.
2. Open the hood.
3. Inspect the airlines and wire harnesses between the PDM and the air intake manifold in the area indicated in **Fig. 1**.

Before the remedy is available, there are steps you can take to reduce the risk of your vehicle developing this condition. As part of your daily pre-trip inspection, inspect the airlines and be sure they are not chafed or contacting the air intake (see the diagram on the next page). If no chafing or contact is found, no action is needed until the final remedy is available. If you find chafing on the airline bundle or it is contacting the air intake, please take your vehicle to an authorized Daimler Trucks North America location for an interim repair (your vehicle still requires the final remedy).

If there is evidence of chaffing or the lines are within 0.75 in (19 mm) of the intake manifold, take the vehicle to an authorized Daimler Trucks North America dealership for repair.

If there is no chaffing and adequate clearance (0.75 in (19 mm) or more from the intake manifold), no action is needed.
