REPORT NUMBER 110-STF-09-003

# SAFETY COMPLIANCE TESTING FOR FMVSS 110 TIRE SELECTION AND RIMS

HYUNDAI MOTOR COMPANY  
2009 HYUNDAI GENESIS  
FOUR-DOOR PASSENGER CAR  
NHTSA NO. C90501

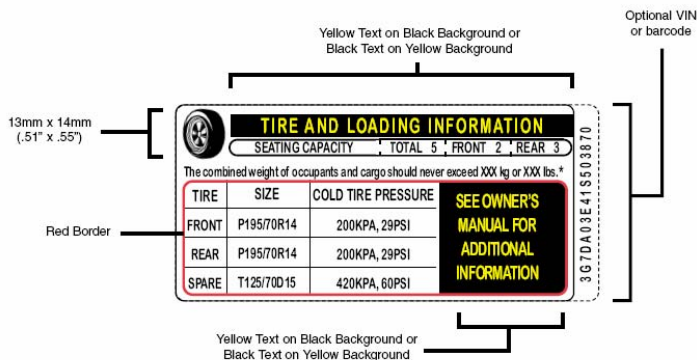
**FIGURE 1  
(70 FR 14425)**

**Vehicle Placard** has the exact color and format as specified in Figure 1 and text is in English language. ( X )YES ( )NO

**Vehicle Placard** is permanently affixed. ( X )YES ( )NO

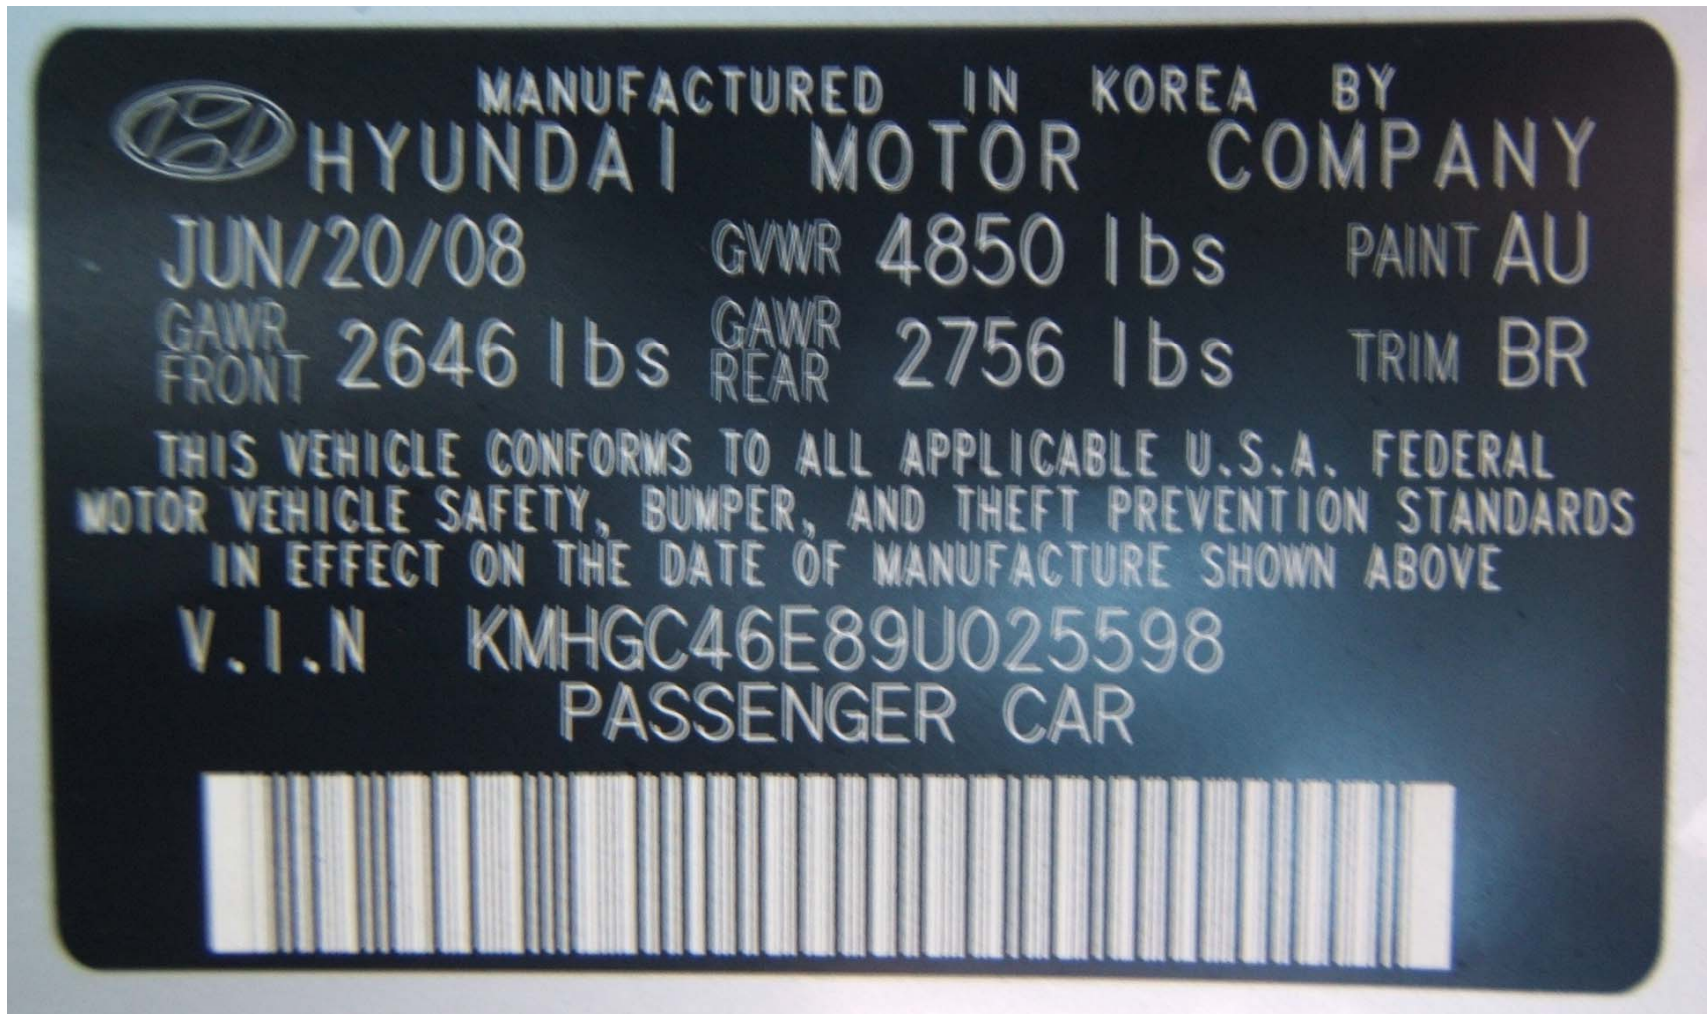
FIGURE 5.3  
VEHICLE CERTIFICATION LABEL

Yes/No	Location	PASS/FAIL
1. Certification Label	<u>Yes</u>	<u>Driver's side B pillar</u>	<u>PASS</u>
2. Vehicle Placard	<u>Yes</u>	<u>Driver's side B pillar</u>	<u>PASS</u>
3. Tire Inflation Pressure Label	<u>No</u>	<u></u>	<u></u>

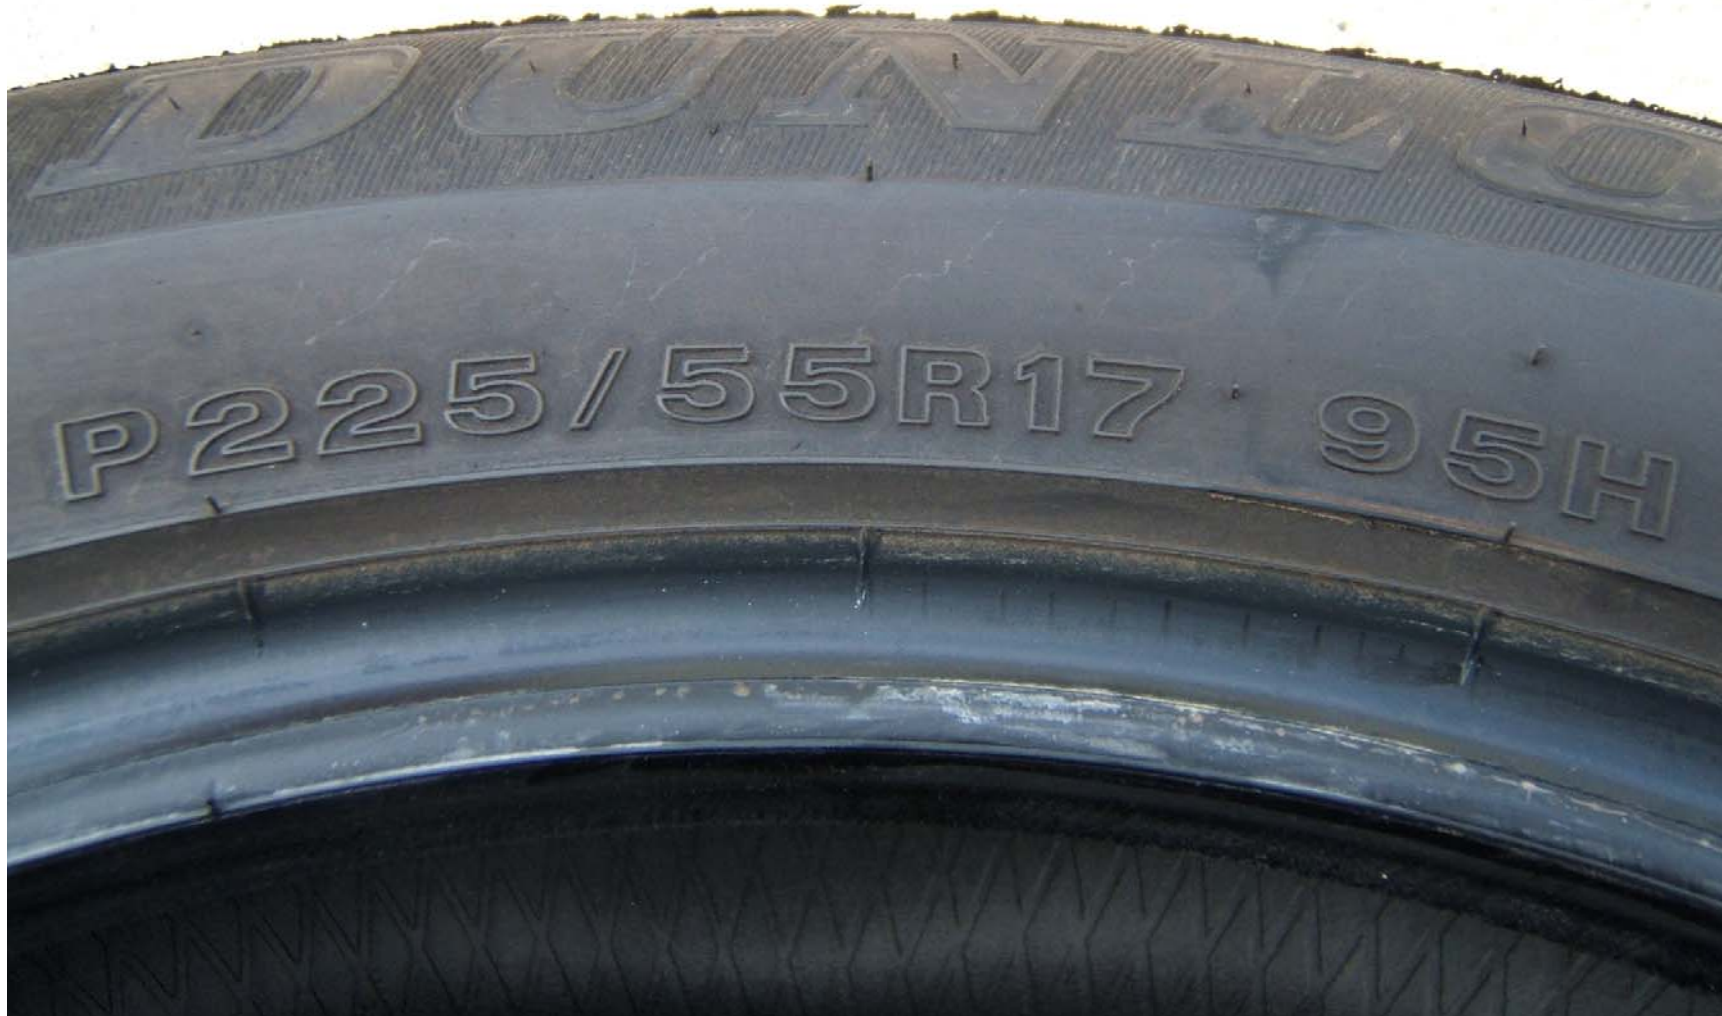
FIGURE 5.7  
TIRE SHOWING SIZE, LOAD INDEX, AND SPEED SYMBOL

Tire size: Front P225/55R17 Rear P225/55R17

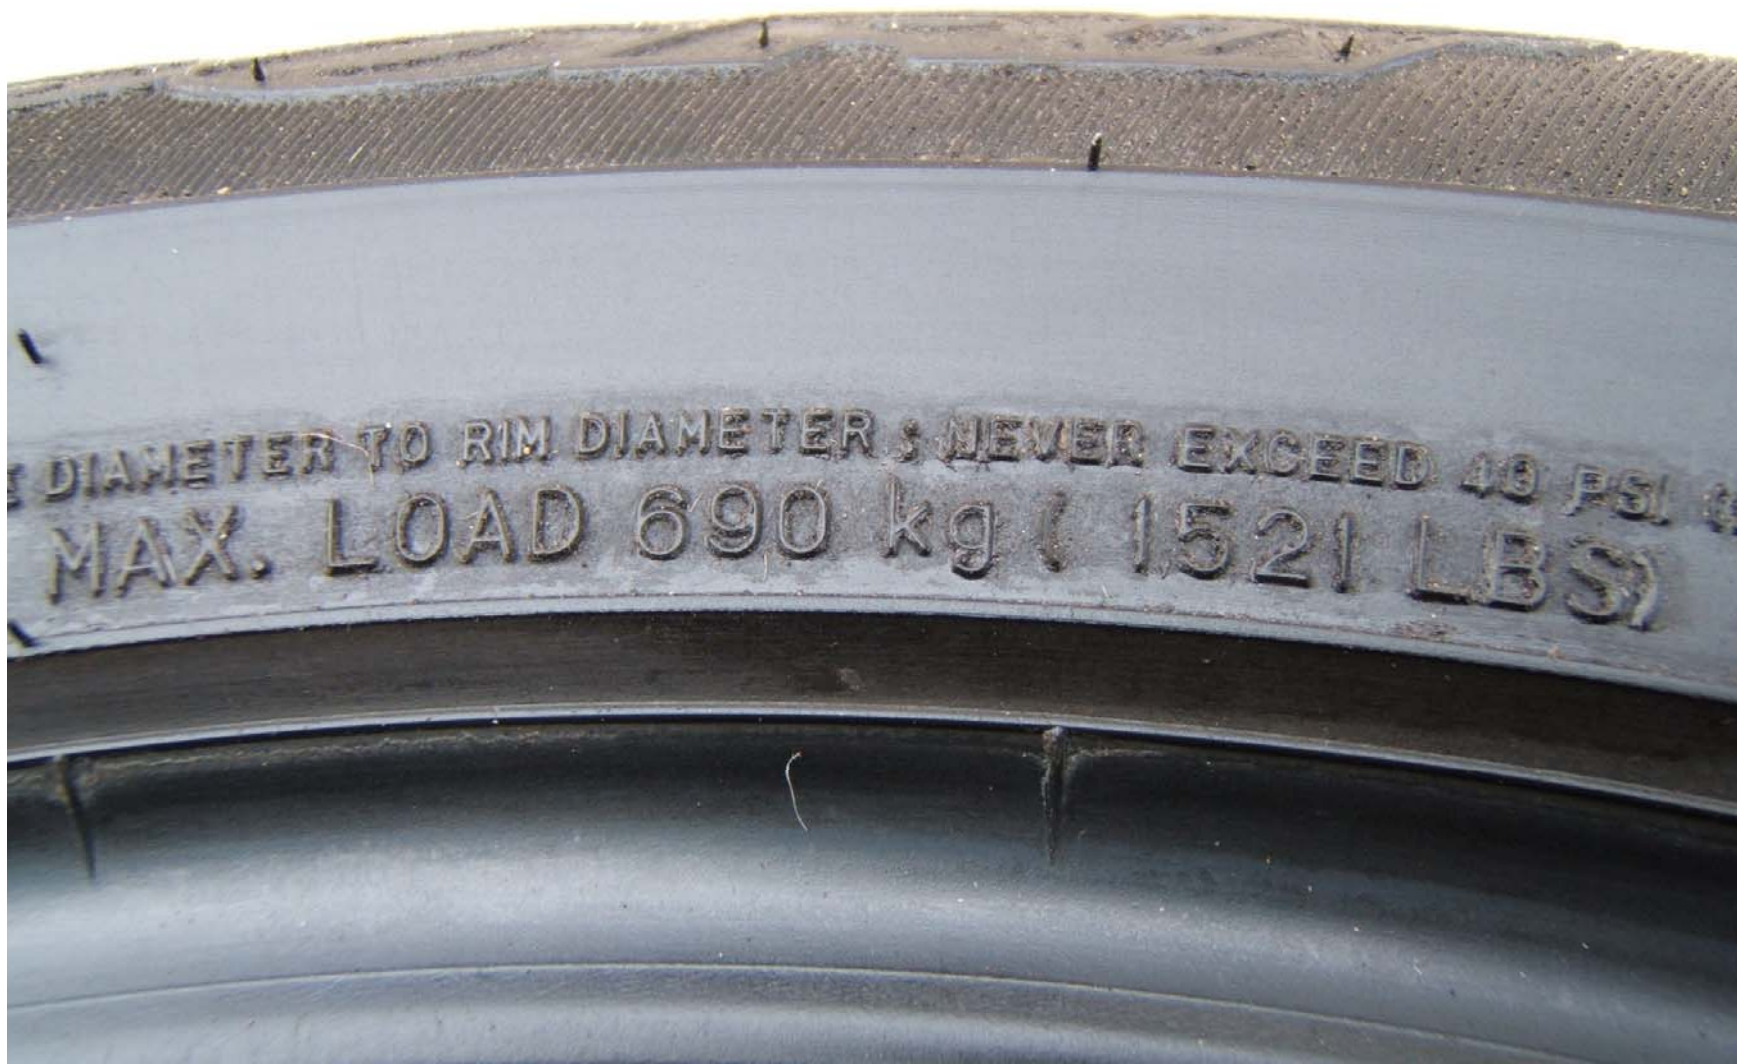
FIGURE 5.8  
TIRE SHOWING MAX LOAD RATING

Max. Load Rating on Sidewall	<u>690 kg (1,521 lb)</u>	<u>690 kg (1,521 lb)</u>
------------------------------	--------------------------	--------------------------

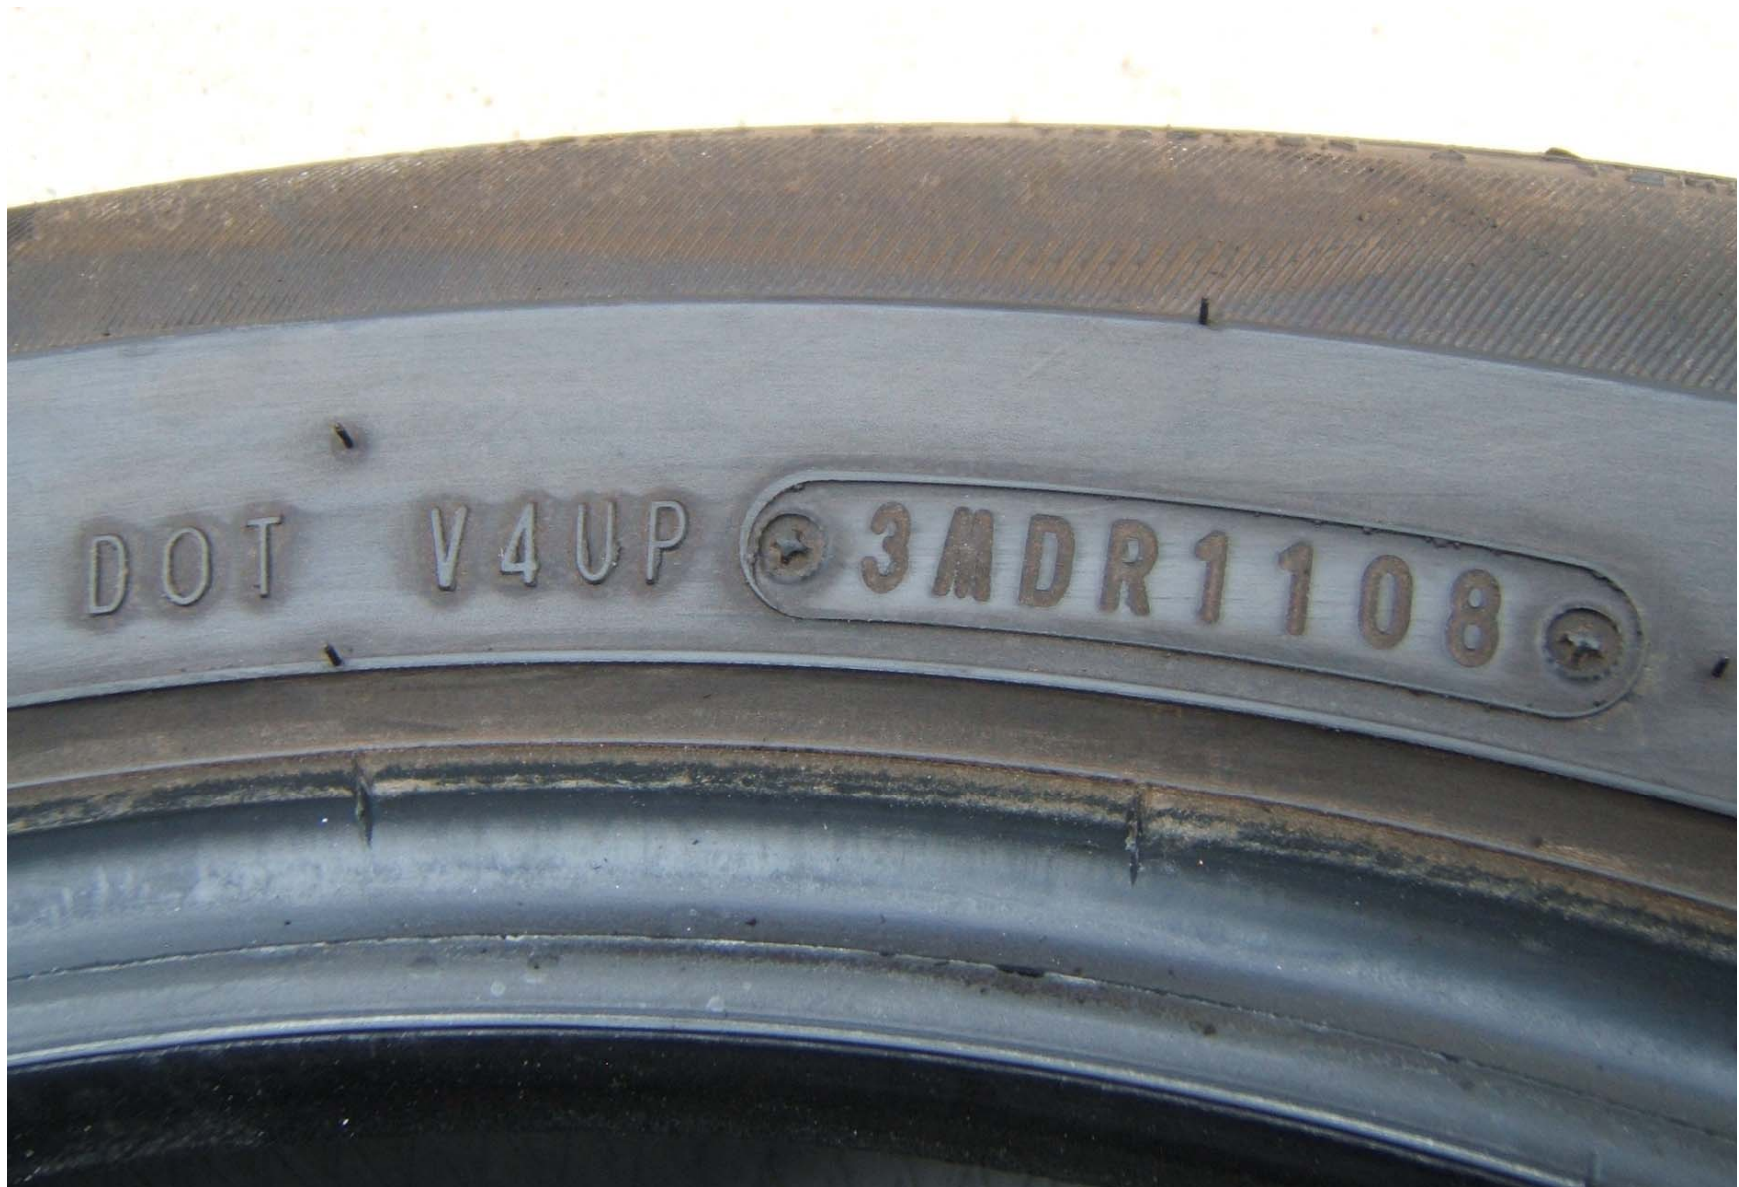
FIGURE 5.10  
TIRE SHOWING SERIAL NUMBER

Serial Number: Right Front V4UP3MDR1108 Left Front V4UP3MDR1108

Right Rear V4UP3MDR1108 Left Rear V4UP3MDR1108

Spare H6MLBBH2308

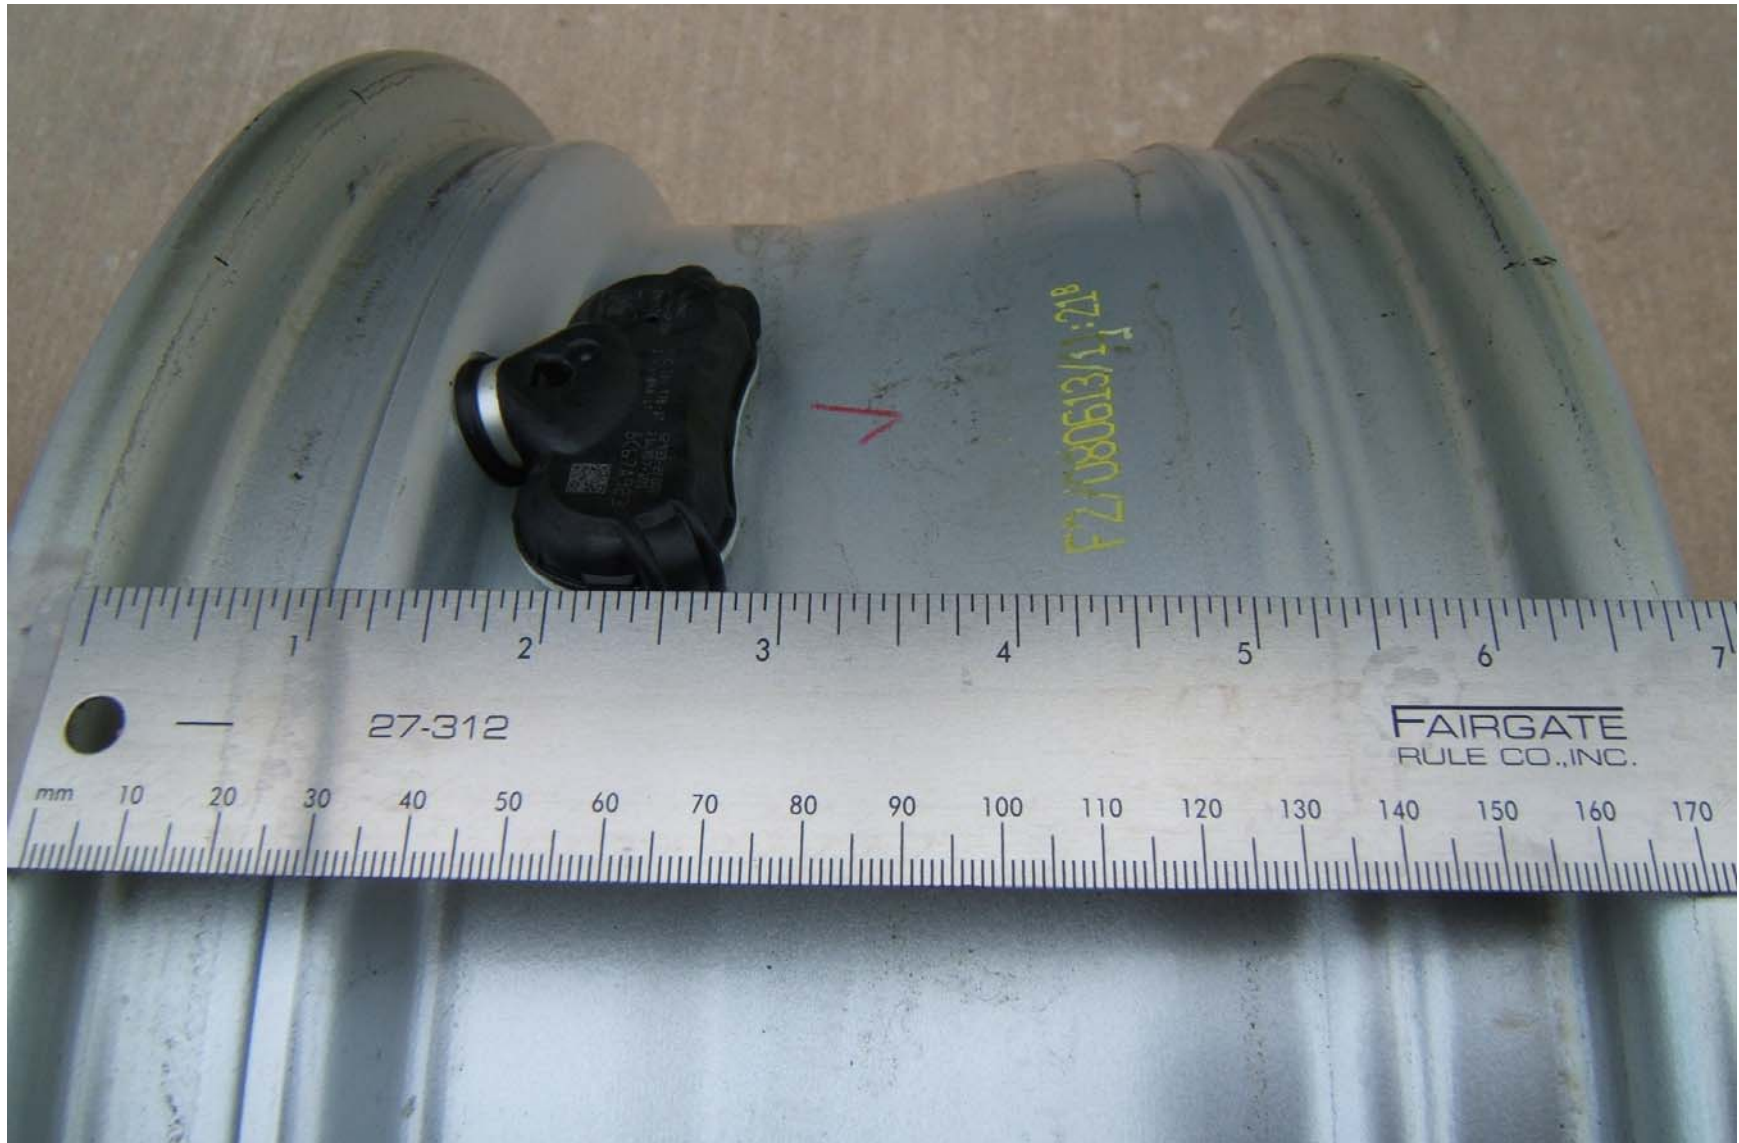
FIGURE 5.11  
RIM CONTOUR FOR FULL WIDTH OF CROSS SECTION

<b>Rim Size:</b>	<b>Tire Size</b>	<b>Measured Rim Width</b>	<b>Measured Rim Diameter</b>
Right Front Wheel	<u>P225/55R17</u>	<u>6.5 in (16.5 cm)</u>	<u>17.0 in (43.2 cm)</u>
Left Rear Wheel	<u>P225/55R17</u>	<u>6.5 in (16.5 cm)</u>	<u>17.0 in (43.2 cm)</u>

REMARKS: The 6.5" rims used are T&RA approved rim size for this size tire, with the 7.0" rim being the T&RA recommended rim.

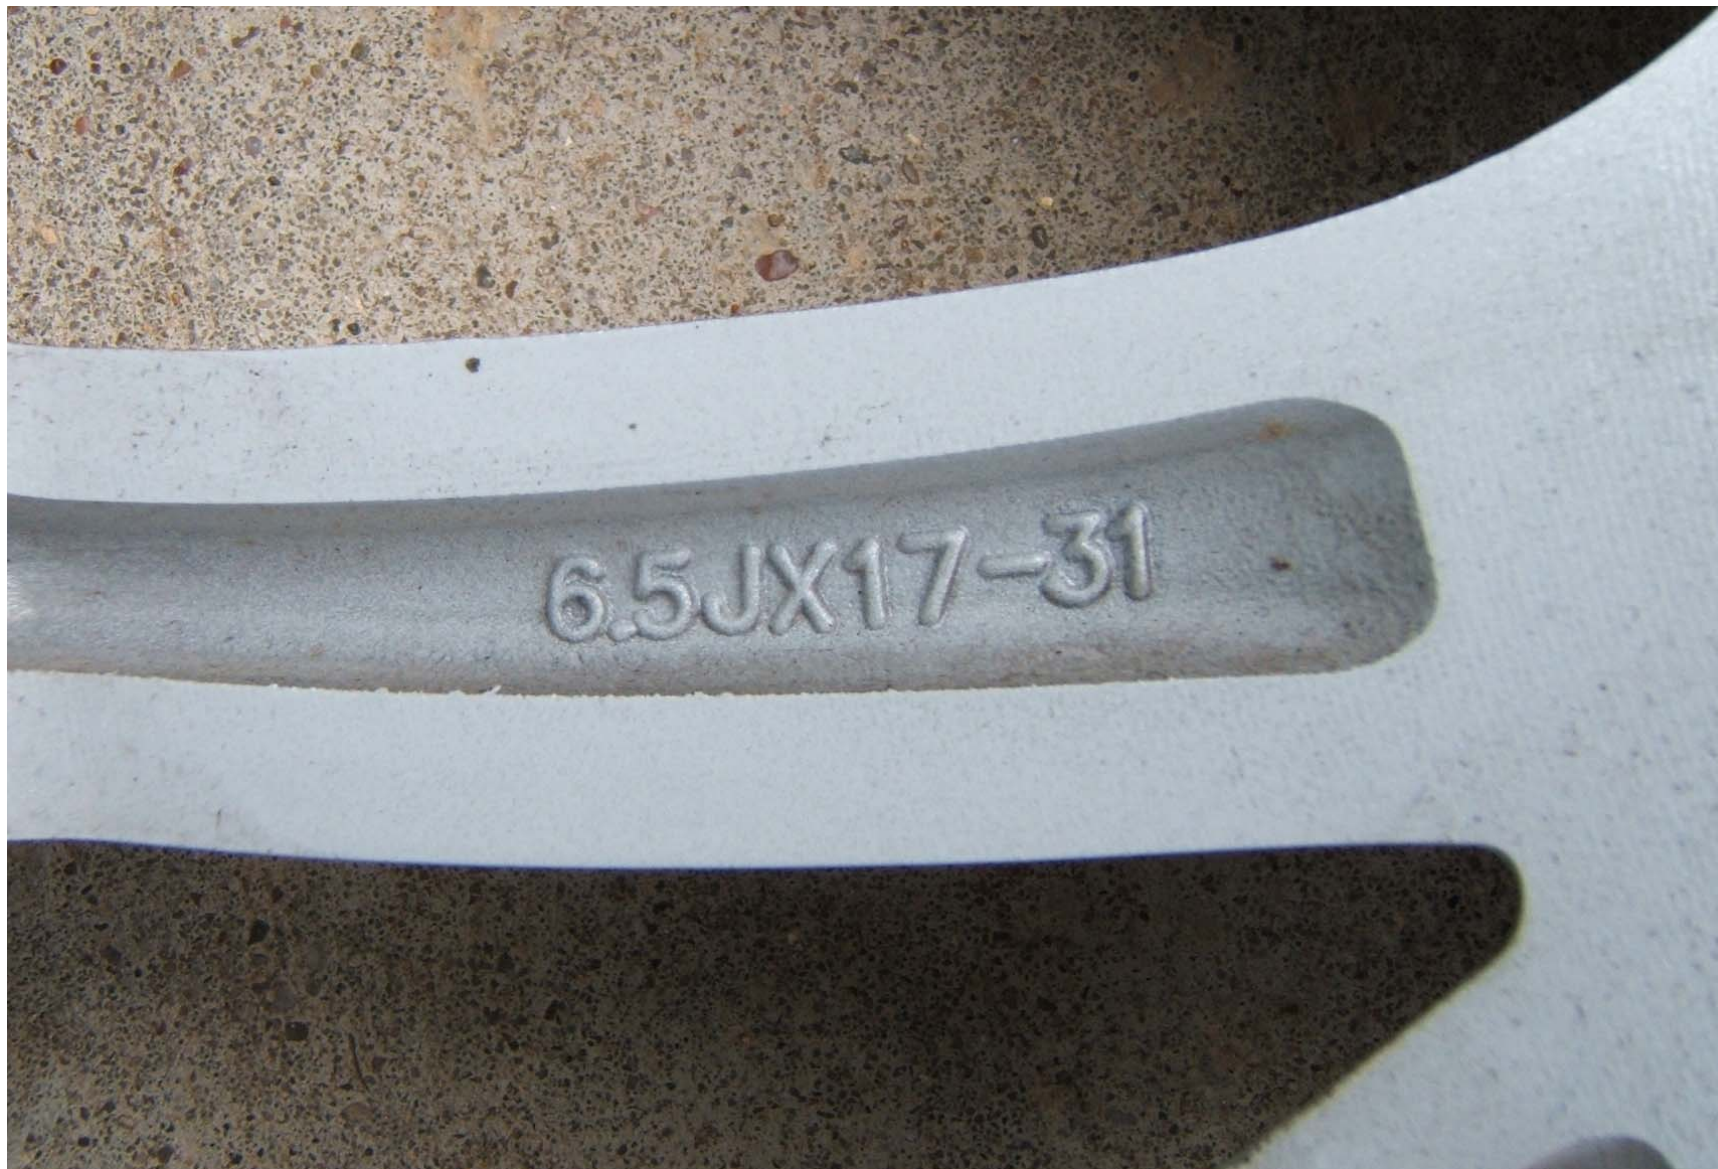
FIGURE 5.12  
RIM SHOWING SIZE

16.5JX17

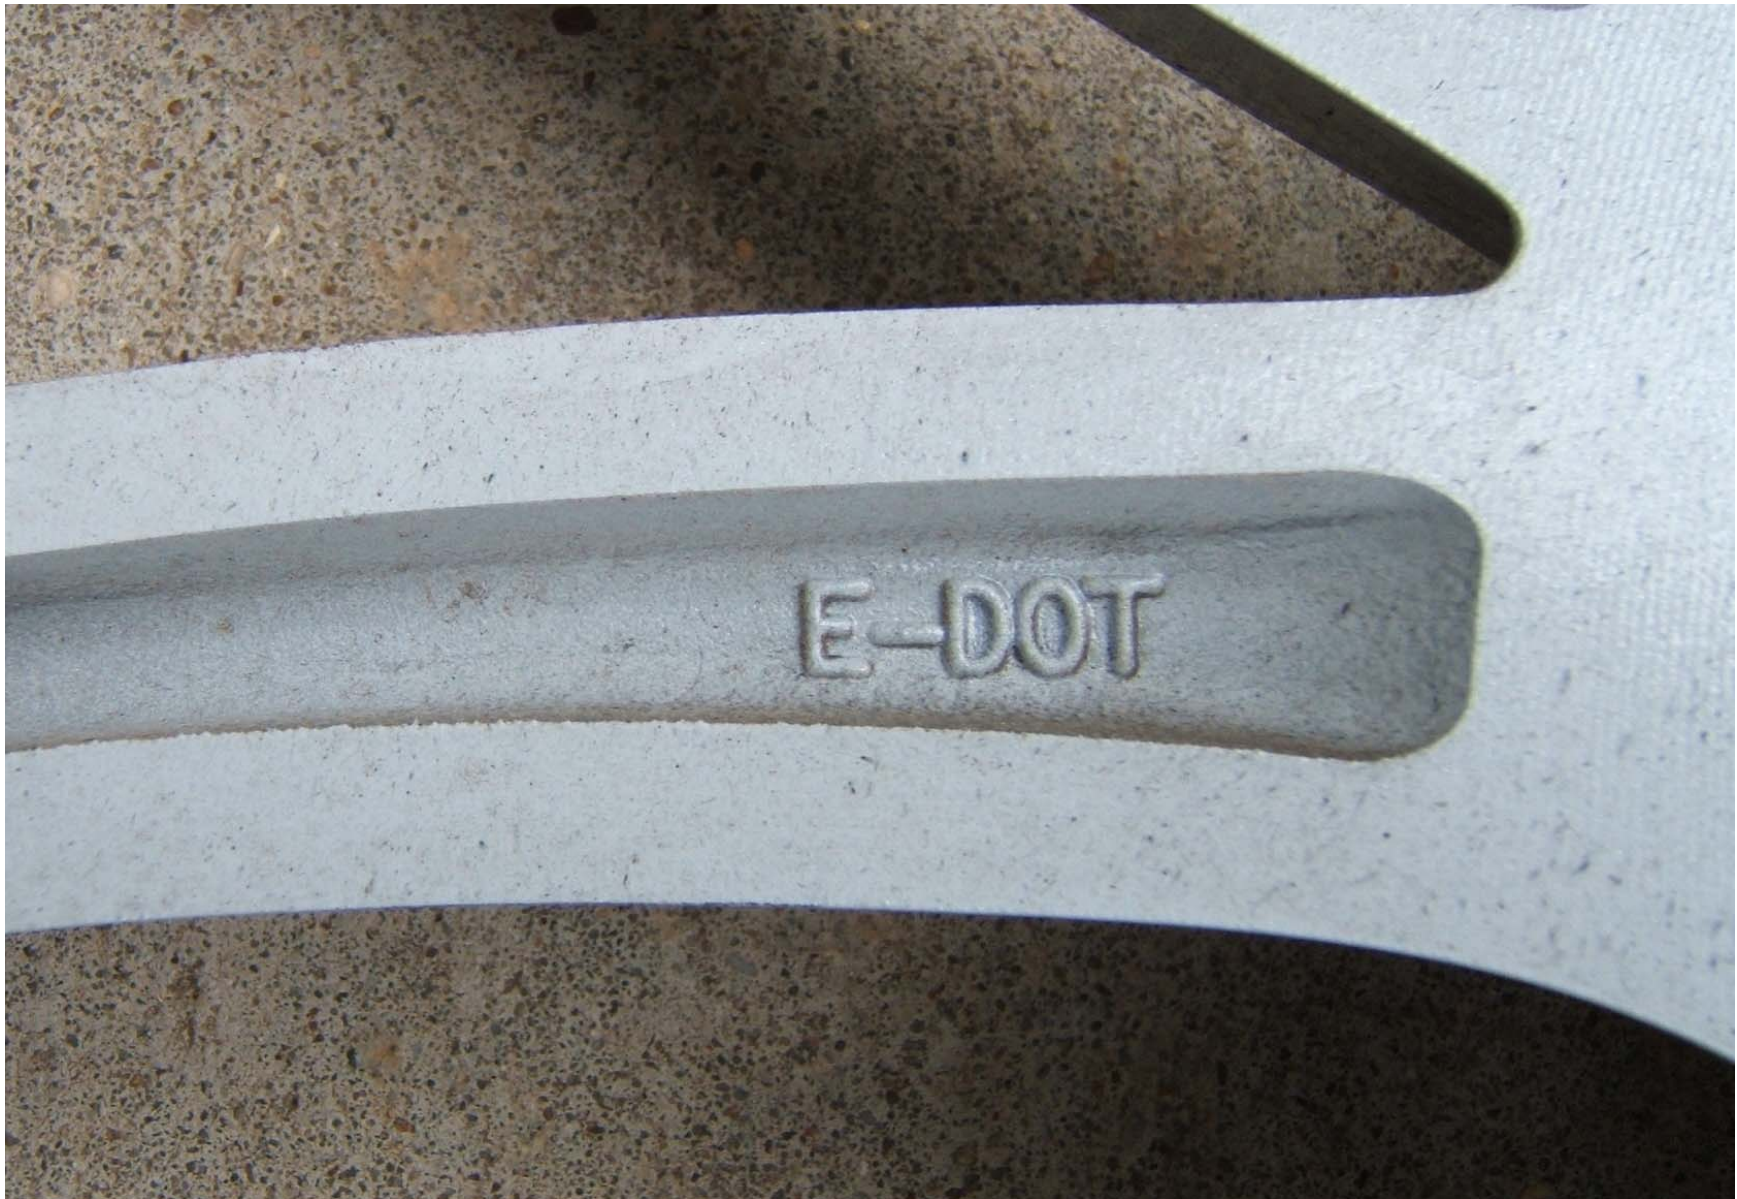
FIGURE 5.13  
RIM SHOWING LETTER DESIGNATION FOR SOURCE  
OF PUBLISHED DIMENSIONS AND DOT SYMBOL

Yes

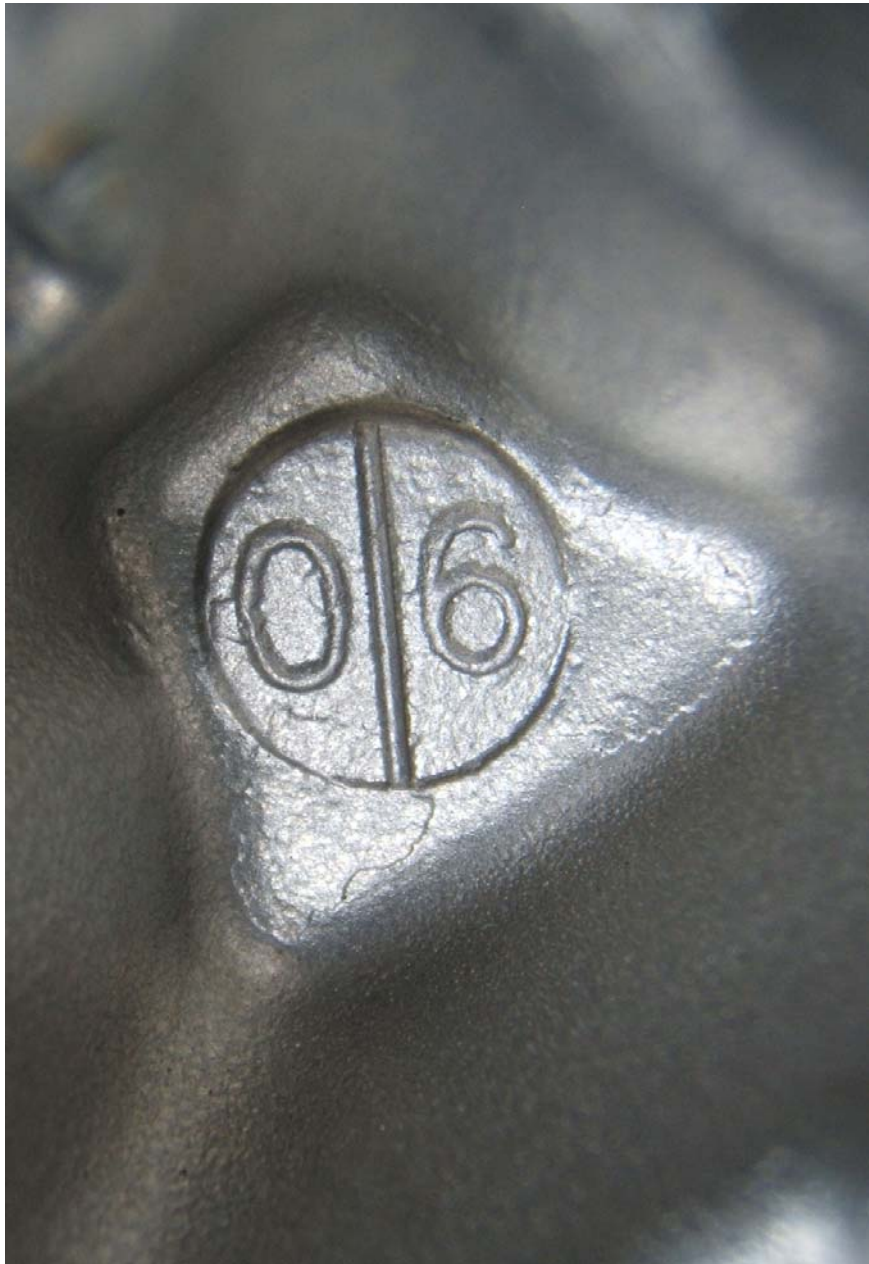
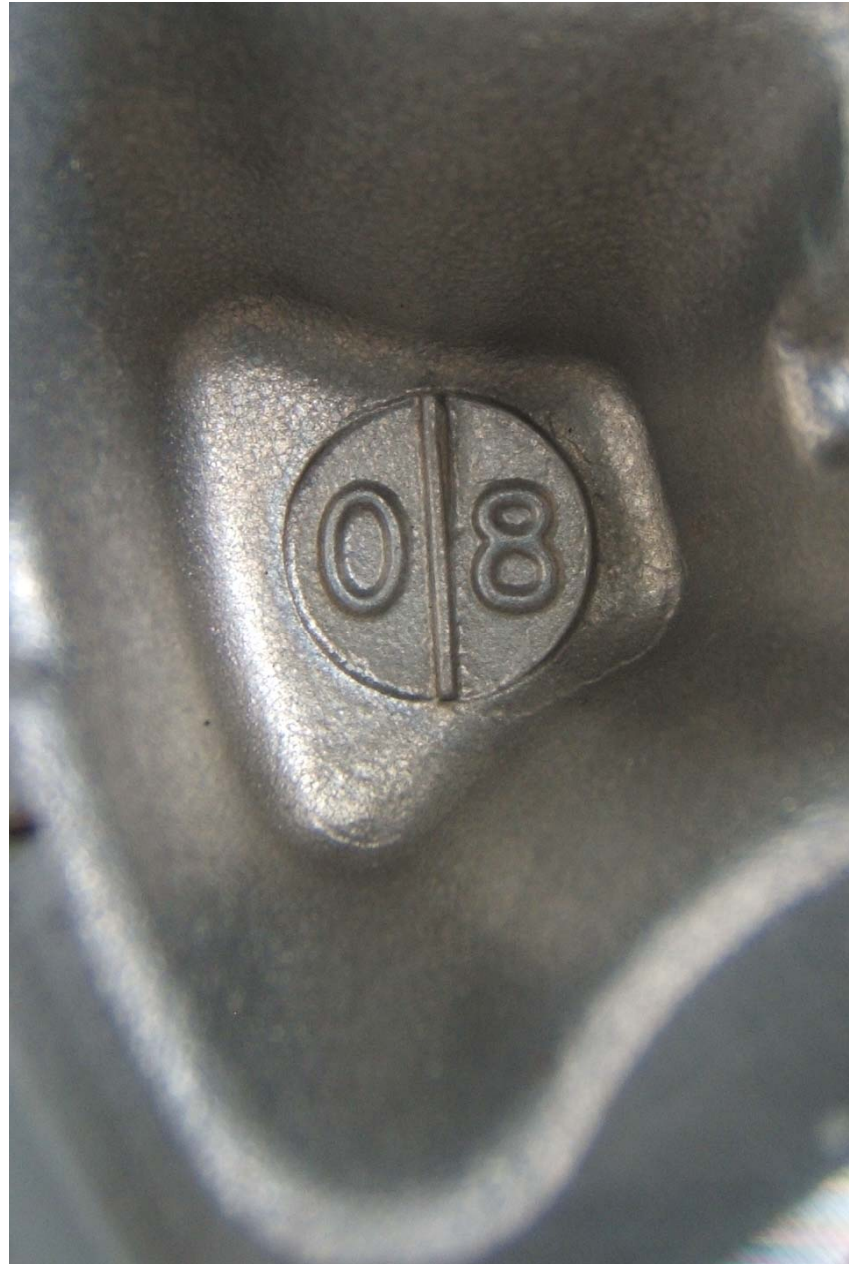
FIGURE 5.15  
RIM SHOWING DATE OF MANUFACTURER

080613

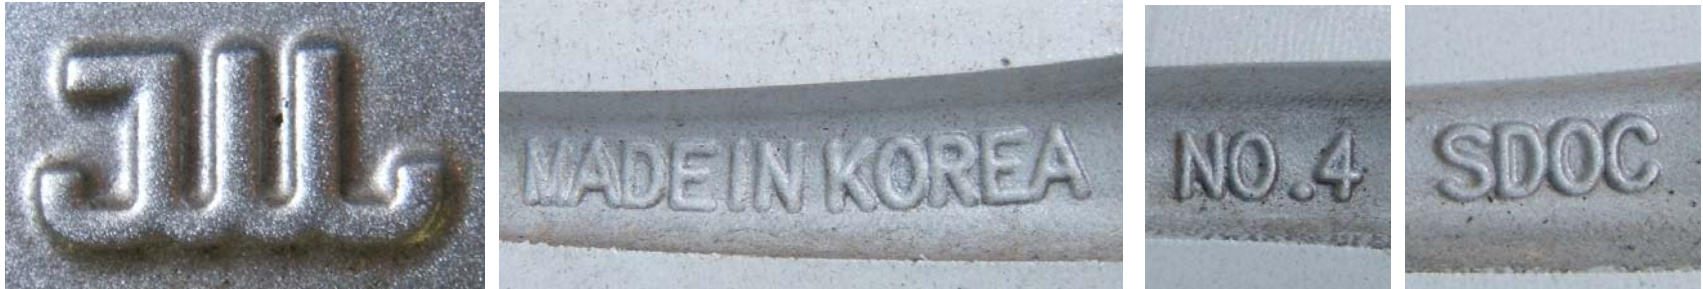
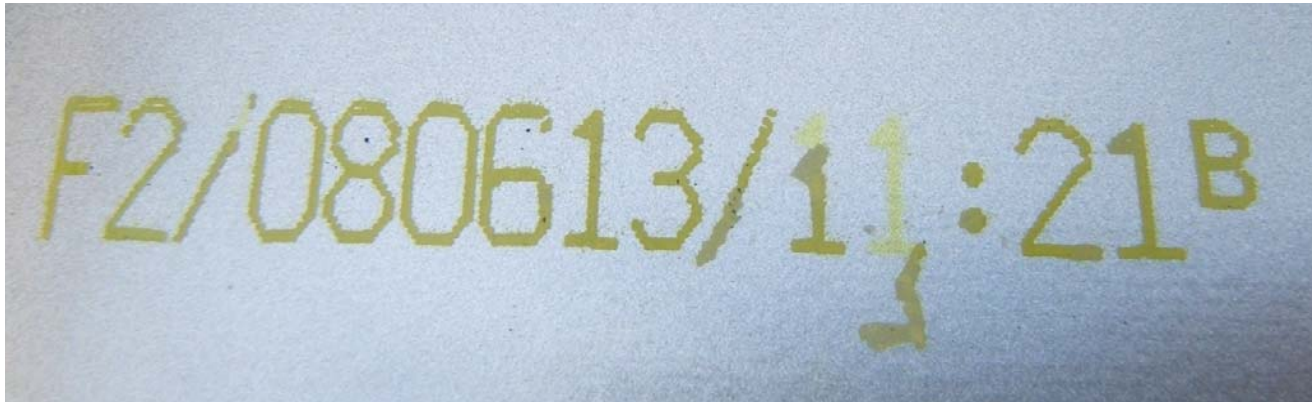
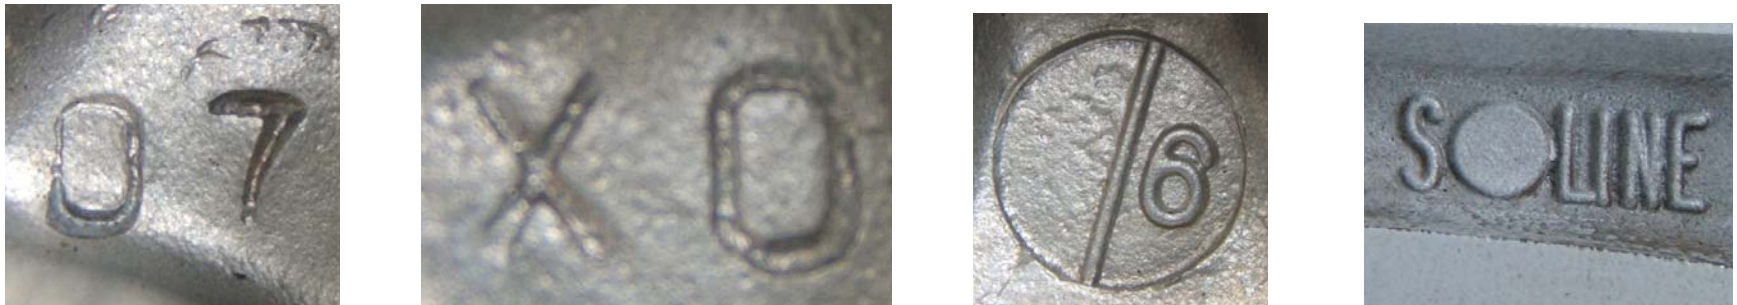
FIGURE 5.16  
RIM SHOWING OTHER RIM MARKINGS

See Figure 5.16

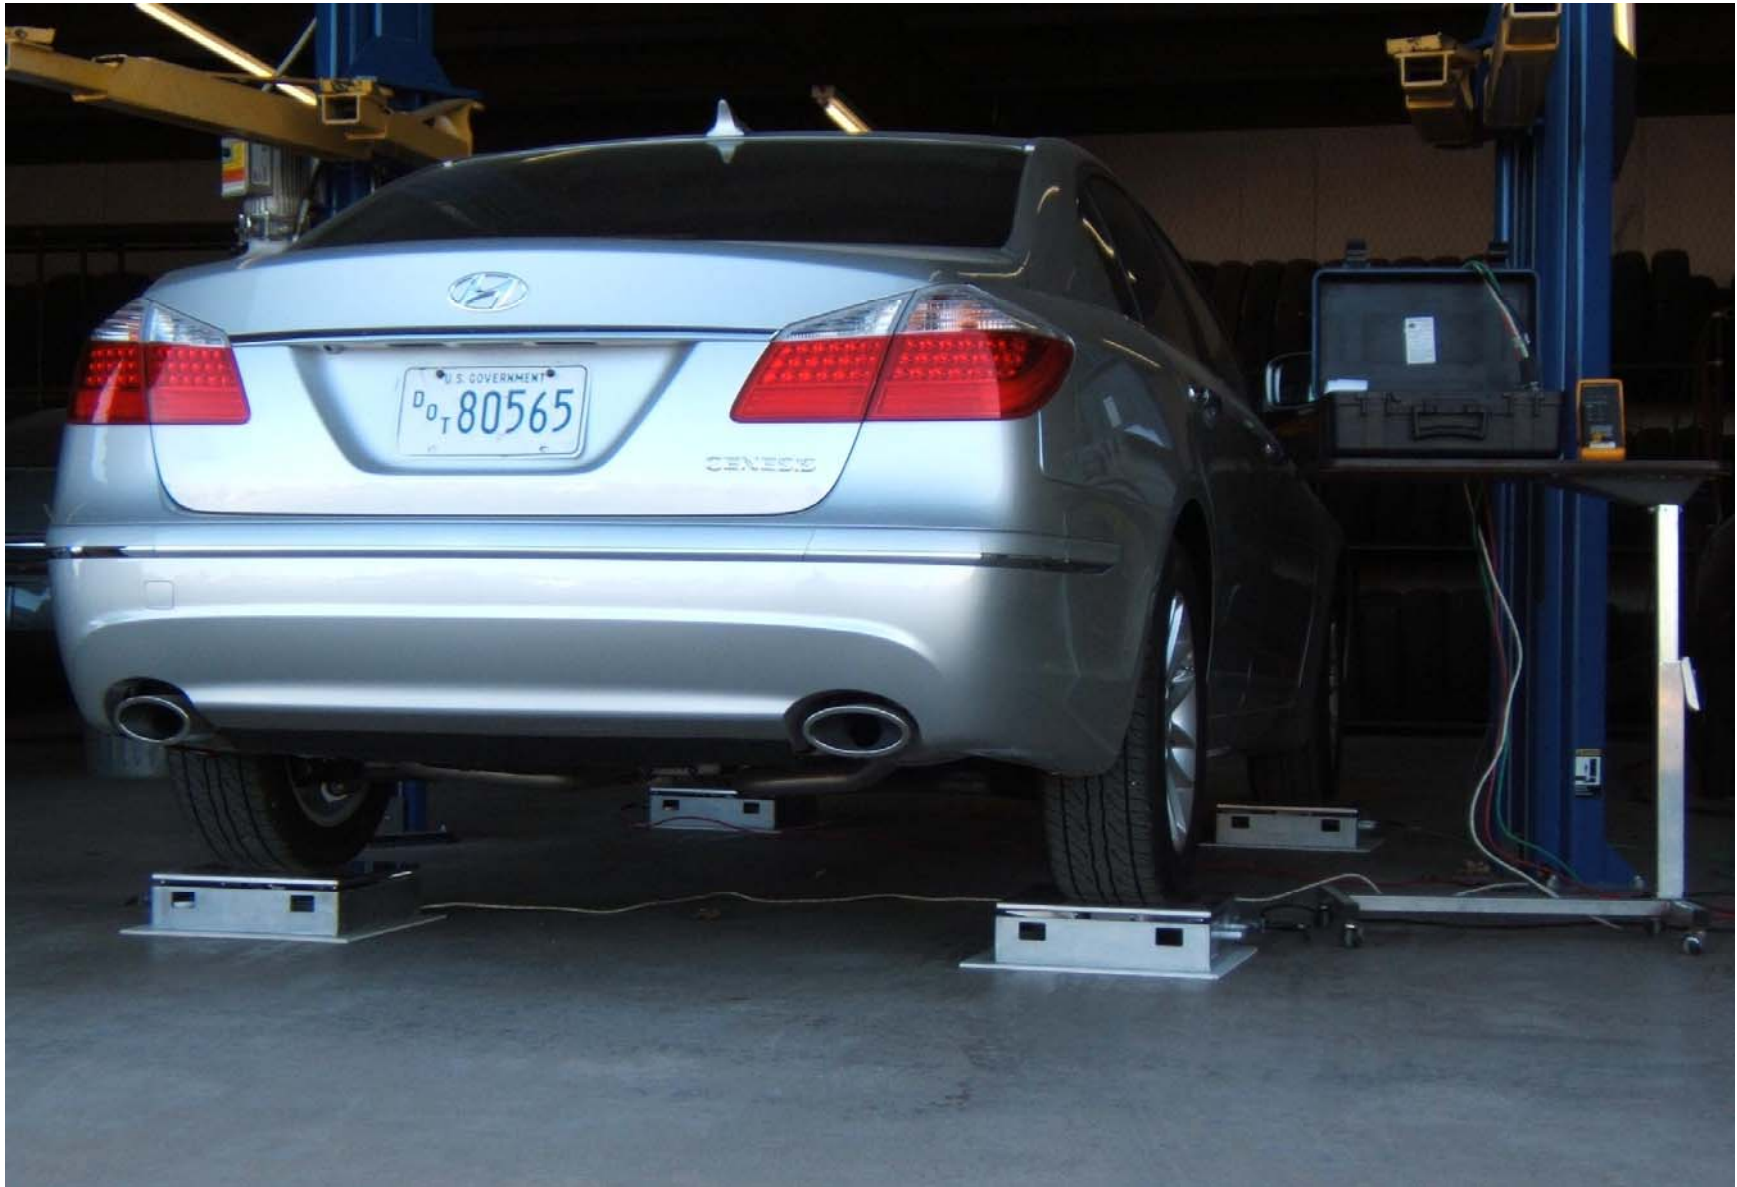
FIGURE 5.21  
VEHICLE ON WEIGHT SCALES

LF 457 kg (1,008 lb) LR 406 kg (894 lb)  
RF 441 kg (972 lb) RR 409 kg (902 lb)  
Front Axle 898 kg (1,980 lb) Rear Axle 815 kg (1,796 lb)  
Total Vehicle 1,713 kg (3,776 lb)

LF 501 kg (1,104 lb) LR 465 kg (1,024 lb)  
RF 481 kg (1,061 lb) RR 470 kg (1,037 lb)  
Front Axle 982 kg (2,165 lb) Rear Axle 935 kg (2,061 lb)  
Total Vehicle 1,917 kg (4,226 lb)

Total Vehicle 2,103 kg (4,636 lb)
