**IN THE UNITED STATES DISTRICT COURT
FOR THE DISTRICT OF MARYLAND**

**UNITED STATES’ CLAIM AND ANSWER TO PETITIONERS
GRACE OCEAN PRIVATE LIMITED AND SYNERGY MARINE PTE LTD’S
PETITION FOR EXONERATION FROM OR LIMITATION OF LIABILITY**

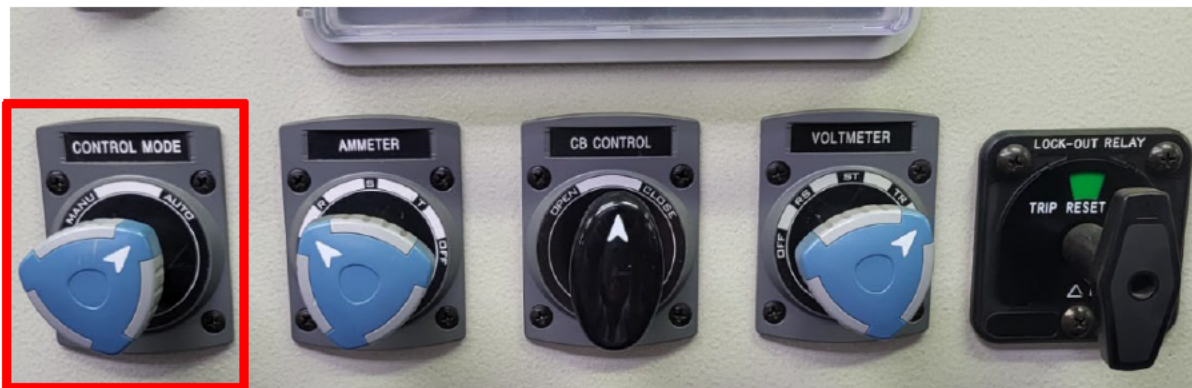
Step-down transformer controls, with the Auto/Manual Control Mode selector at far left. This photograph was taken post-accident.

68. When in the automatic mode, if there is a loss of power through one of the step-down transformers, then the electrical system automatically transfers power to the other step-down transformer. Automatic transfer does not require crew intervention and results in the restoration of electrical power to the ship in a small number of seconds.

69. In contrast, when in manual mode, if there is a loss of power through one of the step-down transformers, the DALI's crew must manually transfer electrical power to the other step-down transformer—while in the darkness of a power outage.

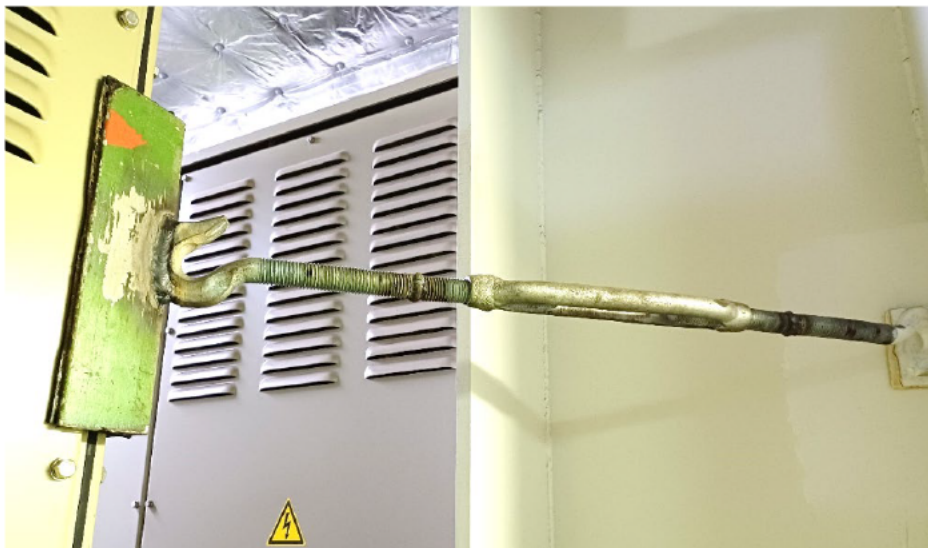
75. The DALI also had a vibration dampening rod wedged between the number 1 step-down transformer and a steel beam in the transformer room. It was jury-rigged, in the literal sense, from spare cargo equipment and painted white on one end. The anti-vibration rod is an after-market modification, not original to the build of the ship.

Cargo chain turnbuckle, welded to angle iron, and wedged between the number 1 step-down transformer (left) and a steel beam (right).

76. Problems obviously persisted after the rod's installation, since the steel bracket atop the number 1 step-down transformer cracked again.
