**Re: Defect Information Report – Supplemental Report No. 3
11V-207, FL-605, Gunite Automatic Slack Adjusters**

REF #: ICI11-024

SUBJECT: FL605 – Parts in Recall Kits

This letter provides additional information about the replacement parts included in the kits for FL605.

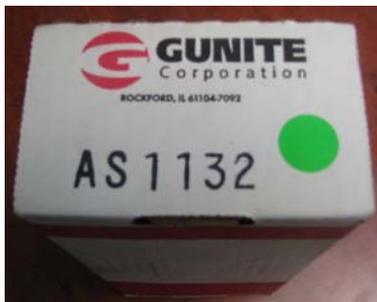
Photo 1

Any Gunitite slack adjuster that has passed inspection can be identified by a green dot appearing on the box, on the part, or on both, see **Photos 1, 2, and 3** below. In addition, a capital letter "C" at the end of the run number, see **Photo 4** below, also signifies the slack adjuster housing has been certified and may be used.

All slack adjusters have been inspected and certified by Gunitite and may be used to complete the Recall, regardless of the mold line or lot number on the part. If there is a concern about a replacement part with a mold line and lot number that matches a combination from **Table 4**, Suspect Slack Adjuster Lot Number and Mold Line Identification, in the Work Instructions, the information below will allow you to confirm the part is good and should be used.
