# Safety Recall Notice

Recall No: 12106C

Subject: Automatic Transmission Shift Cable

Models: 2008-2010 Chevrolet Malibu  
2005-2010 Pontiac G6  
2007-2010 Saturn Aura  
Equipped with 4-Speed Automatic Transmission (ME7/MN5)

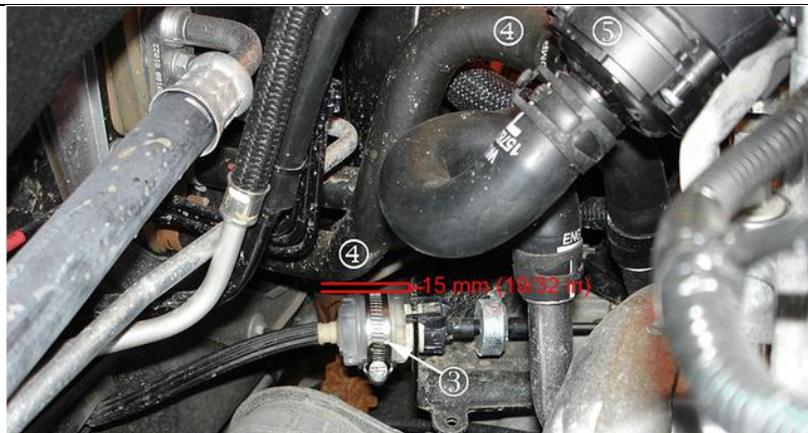
Hybrid vehicle shown. Combustion engine vehicle is similar.

**Cable Kit consists of:**

- (1) Clam Shell in Two Pieces
- (2) Clam Shell Around Shift Cable Locking Tabs
- (3) Clamp on Clam Shell
- (4) Inlet Coolant Hose and
- (5) Heater Cooler Pump.

This bulletin requires the use of a reinforcement kit on some transmission shift cables. The affected cables are “second design” cables, as defined in the bulletin. These cables were sold prior to February 8, 2013 and may have been sold without the reinforcement kit.
