## Case 408 : Narrative

Case Vehicle (A): 2000 Chevrolet	Vehicle (B): 2001 Toyota
Type: Suburban LS, 4 x 4, 4-door SUV	Type: RAV4, 4 x 2, 4-door SUV
Driver: 35-year-old female	Driver: 50-year-old female
CDC: 12-FYEW-2, 06-BDEW-1	CDC: 99-0000-0

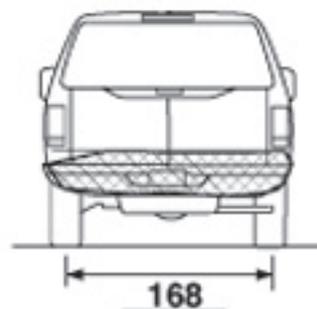
Max. crush to rear at right bumper corner
