Case 432 : Narrative

Case Vehicle (A): 2004 Jeep	Vehicle (B): 1997 Ford
Type: Liberty Sport, 4x4, 4-door SUV	Type: Taurus GL, 4-door sedan
Driver: 36-year-old female	Driver: 79-year-old female
CDC: 12-FYEW-1	CDC: 01-FDEW-3

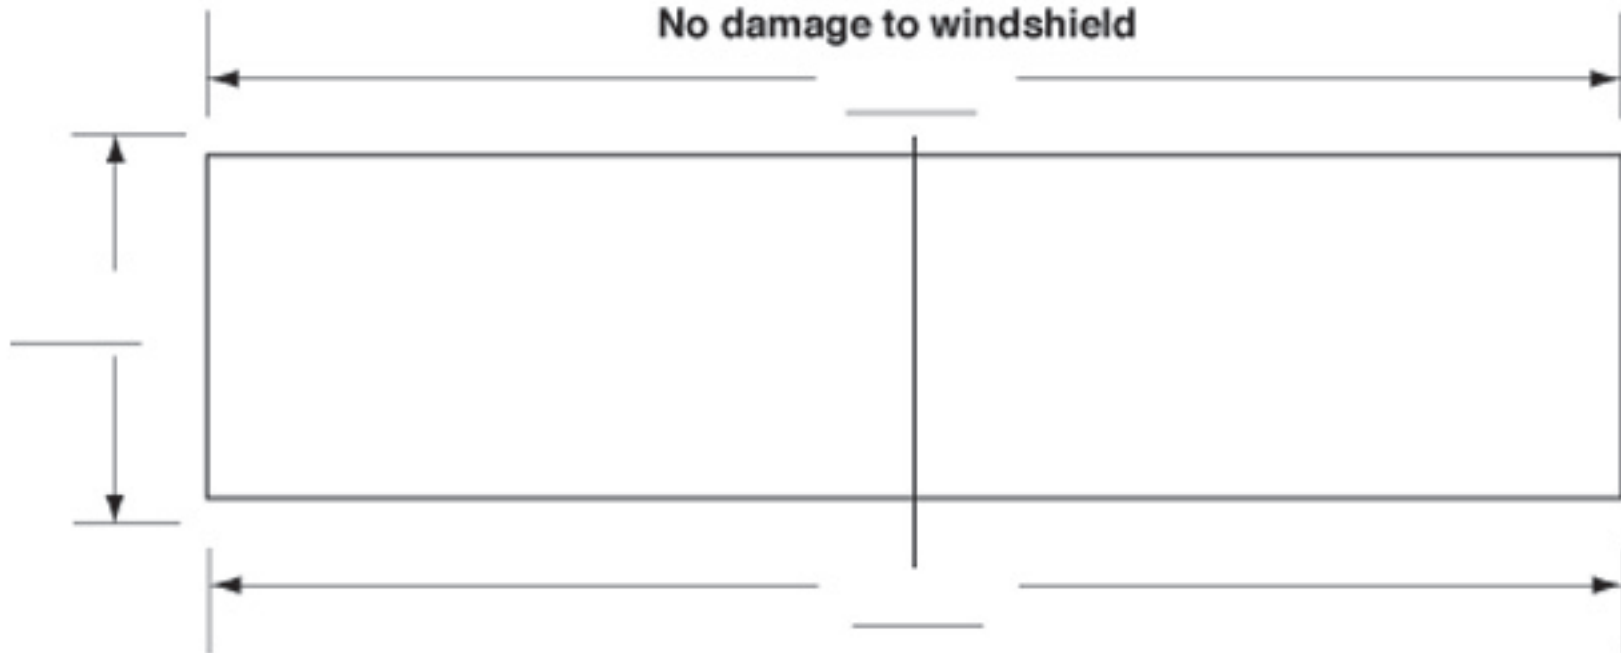
No damage to windshield
