Case 435 : Narrative

Case Vehicle (A): 1999 Chevrolet	Vehicle (B): 2001 Chrysler
Type: Blazer LS, 4-door SUV, 4x4	Type: Sebring LX, 4-door sedan
Driver: 31-year-old female	Driver: 45-year-old male
CDC: 12-FDEW-2	CDC: 10-LPAW-3

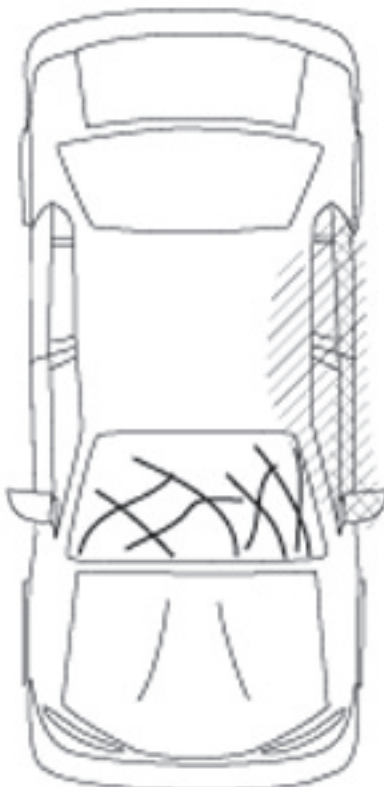
198 cm direct damage
38 cm maximum crush
