## Case 450 : Narrative

Case Vehicle (A): 2000 Hyundai	Vehicle (B): 1998 Ford
Type: Accent GL, 4-door sedan	Type: Explorer Sport, 4x2, 2-door SUV
Driver: 59-year-old female	Driver: 38-year-old female
CDC: 01-FZEW-2	CDC: 12-FYEW-2

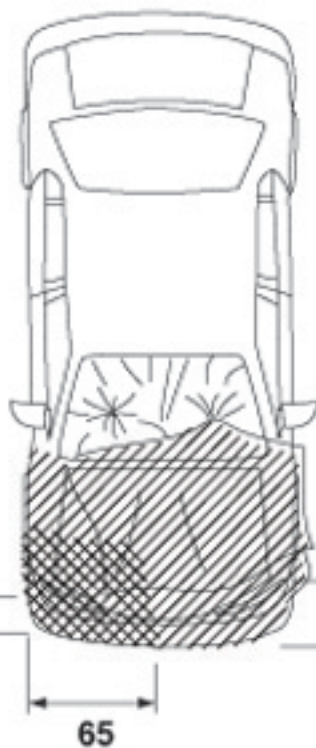
**Bumper corners shifted to left**
