## Case 445 : Narrative

Case Vehicle (A): 2002 Ford	Vehicle (B): 2002 International
E150 Econoline Van, 4x2	Type: 4300 Series Straight truck, 4x2
Driver: 62-year-old female	Driver: 50-year-old male
CDC: 12-FDEW-3	CDC: 99-0000-0

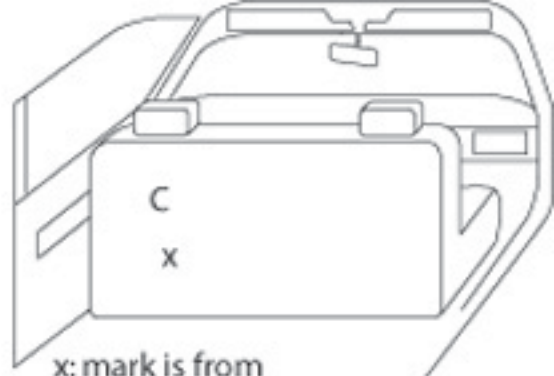
x: mark is from  
hood in car
